Columbia County Building Permit

TYPE DEVELOPMENT FOUNDATION STAB. ESTIMATED COST OF CONSTRUCTION 124875.00

CLAIM No. 59-D210-403
 ALLISON RESIDENCE
 LAKE CITY, COLUMBIA COUNTY, FLORIDA
 GSE PROJECT No. 10299A

**SUMMARY REPORT OF A
SUBSIDENCE EXPLORATION**

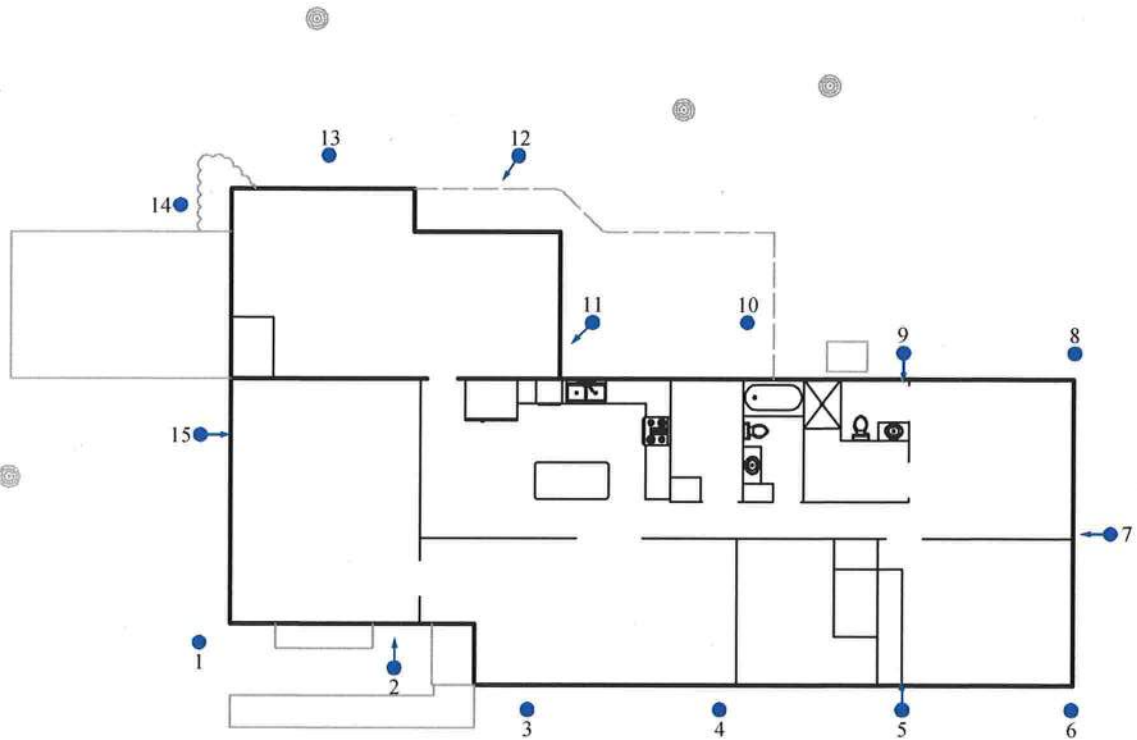
- GSE and Certified Foundations, Inc. (CFI) representatives met at the site to establish the grout point locations. The actual number and locations of grout points were established and field adjusted considering on site access and providing appropriate lateral coverage across the residence.

Based on the above information, it is our opinion that the deep injection grouting program has been completed in substantial compliance with GSE's engineering recommendations and local grouting practices. This grouting procedure was implemented to stabilize the subsurface conditions related to sinkhole activity in the immediate vicinity of the foundation of the residence. This procedure may not prelude development of new sinkhole activity in the future.

GSE understands that cosmetic repairs will be performed following the underpinning operations that will be performed at a later date. Accordingly, any existing damage and/or collateral damage associated with the grouting operations should be repaired at that time by a qualified restoration contractor.

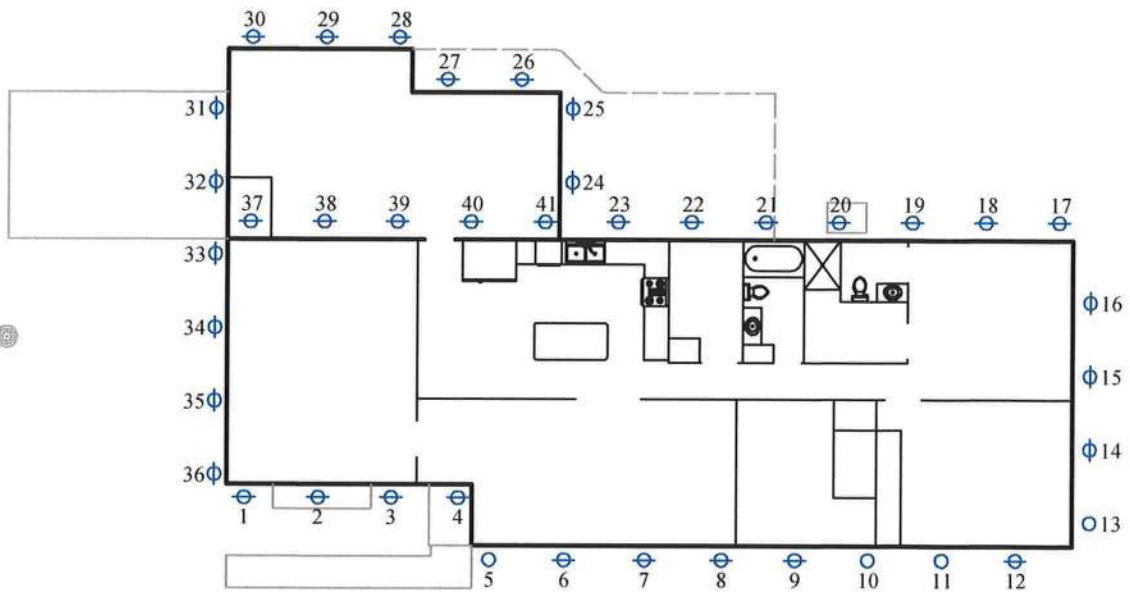
- Spreader beams were installed at all pile locations except piles 5, 10, 11 and 13 to reduce the potential for collateral damage to the structure during pile installation. The short distance from the bottom of the windows to the foundation necessitated the installation of the spreader beams.

- Pile depths ranged from 14 to 56 feet with a total of approximately 1393 linear feet of steel pipe installed into the subsurface.
- The hydraulic final lift pressures ranged from approximately 900 to 2500 psi. The amount of associated measured foundation lift at the pile locations ranged from less than 1/16 inch to 1/8 inch.

Based on our observations, the underpinning pile installation was documented as substantially complying with GSE's recommendations. Table 1 in the Appendix summarizes the approximate underpinning pile installation. Figure 2 illustrates the location and numbering of the underpinning piles.

It is GSE understands that cosmetic repairs will be performed following the underpinning operations. Accordingly, any existing damage and/or collateral damage associated with underpinning operations should be repaired at that time by a qualified restoration contractor.

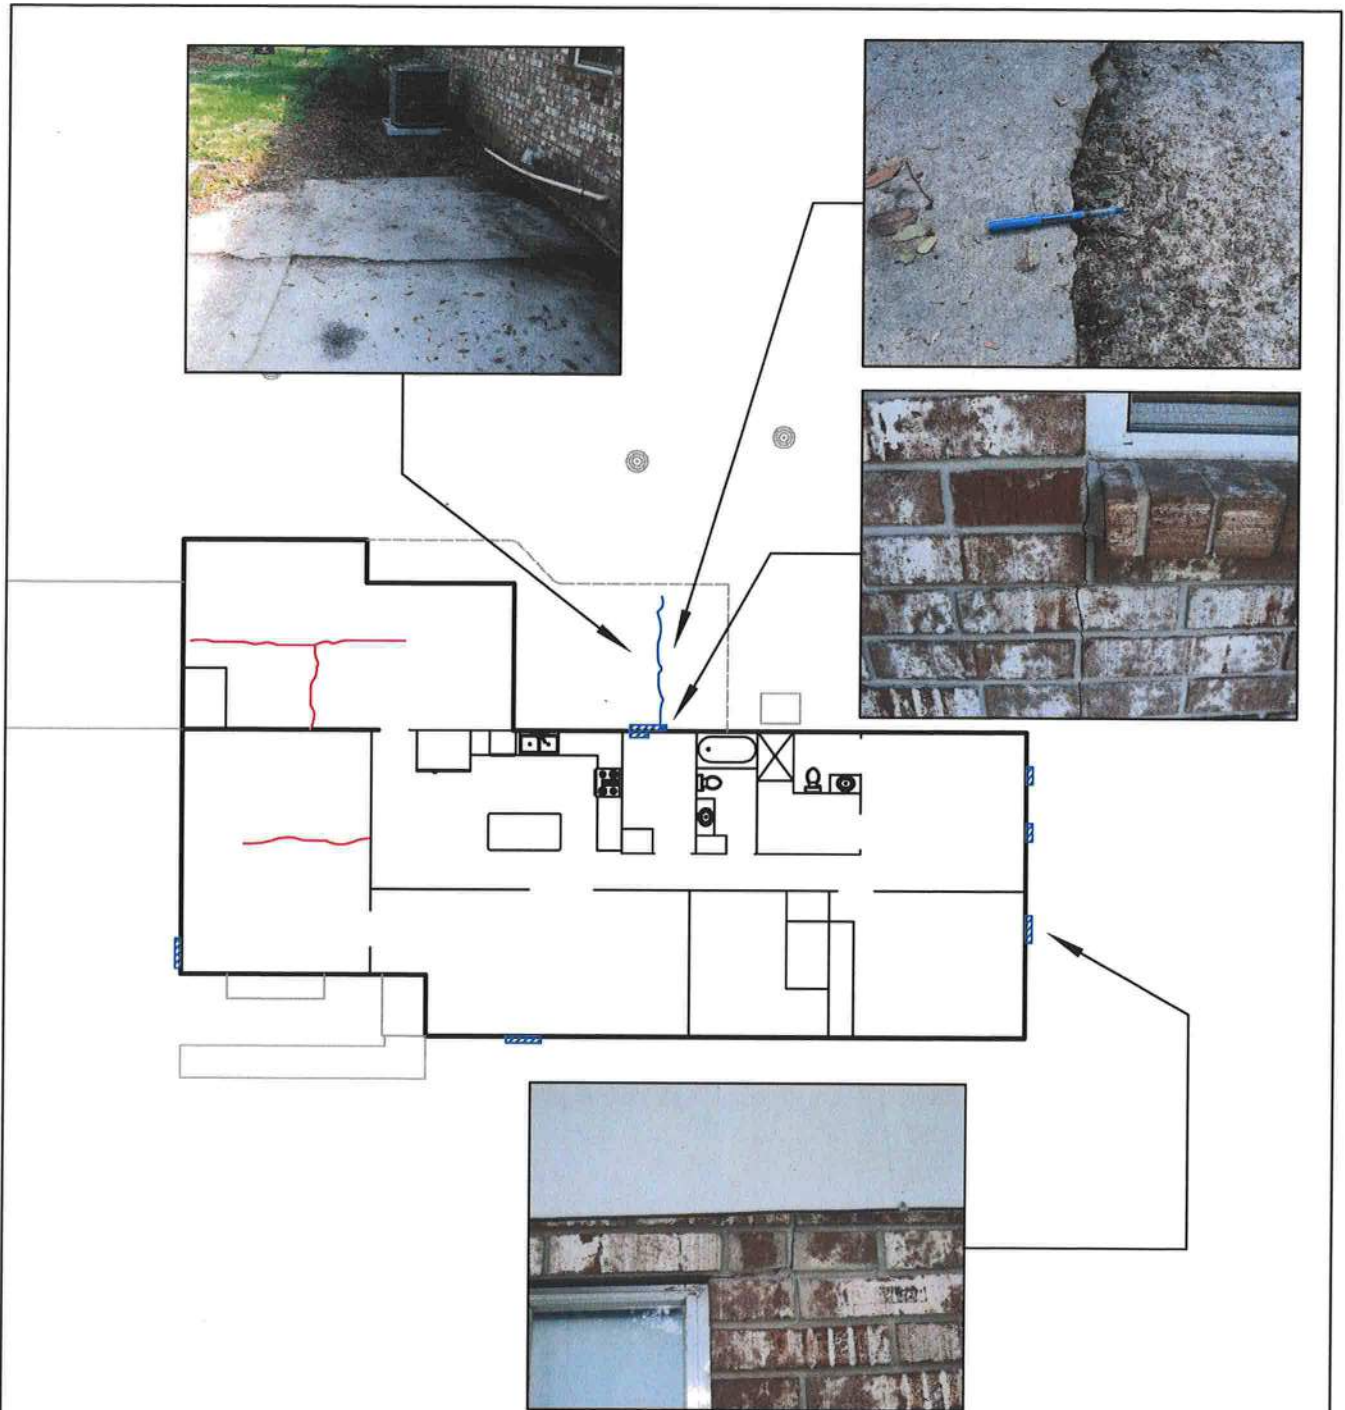
FIGURE
 2

Damage is present on the exterior and in the interior of the home. The majority of the damage is located on the west wall and in the rear patio slab.

The interior damage consists of a hairline width crack coming off a corner of the window in the pantry. A hairline width crack is present in the peak of the vaulted ceiling of the family room. Cracks are present in the ceiling of the addition, and Mr. Allison indicated these resulted from previous roof leaks.

Exterior damage consists of vertical cracks in the brick facing on the west, north and east walls of the home. The width of these cracks range from hairline to about 1/16 inch. These cracks are generally located above or below the corners of windows. A crack is present in the rear patio slab. This crack is approximately ¼ inch in width, and has about 1 inch of vertical displacement.

GSE recommends the subsurface soils beneath the area of the home be improved to minimize further subsidence damage. Soil improvement should be accomplished through grout injection to compact and improve the density of sandy soils beneath the home and swimming pool. Grout injection is also intended to seal the top of the limestone surface to reduce the potential for future raveling. Upon completion of the grouting program, GSE recommends the foundation along the perimeter of the home be stabilized using underpinning piles.

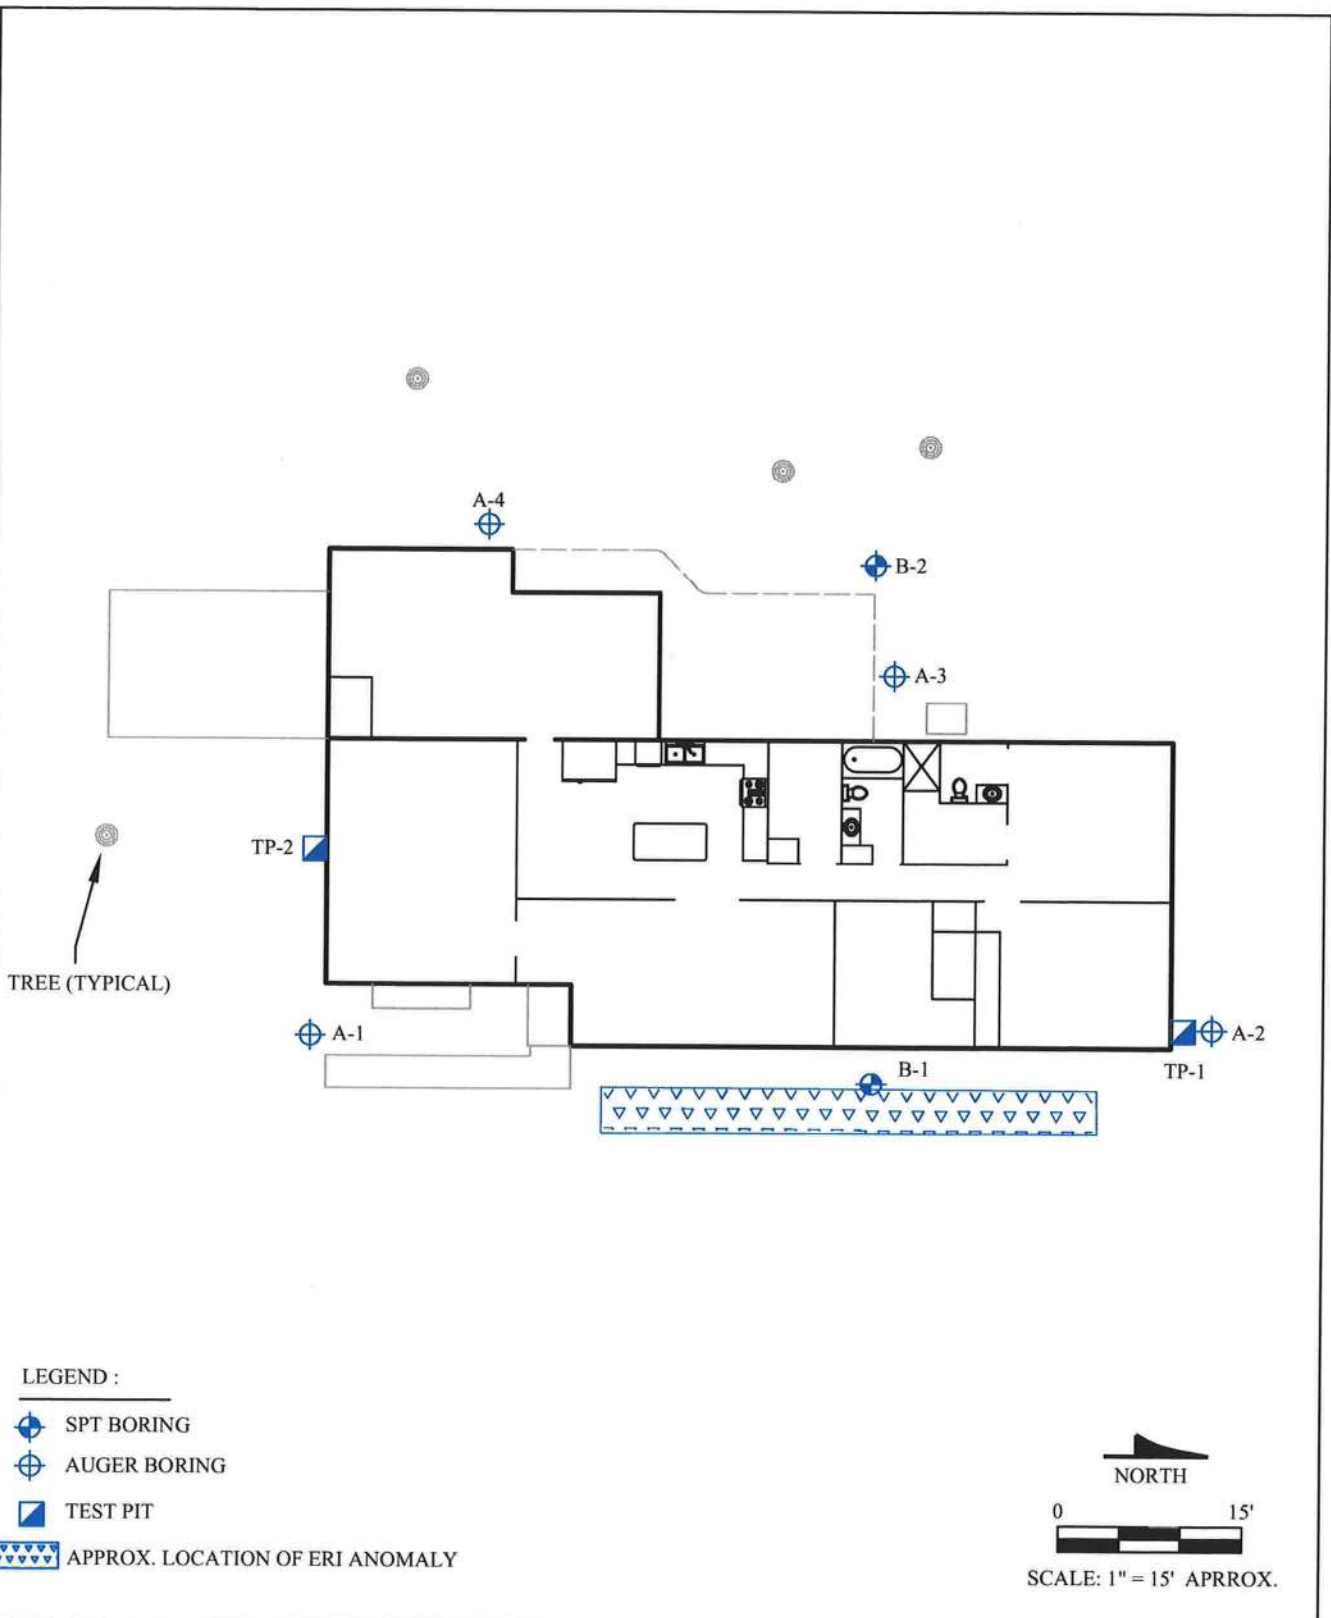
FIGURE
 3

One ERI anomaly was identified at the project site (Figure 3). The ERI anomaly was characterized by the localized occurrence of relatively less resistive soil materials at depth. These relatively less resistive sediments occurred at an estimated depth range of 10 to 25 ft bls. It is noted that no geological structures suggesting a possible downward raveling of sediments was observed within this area on either the GPR or ERI data. Accordingly, this ERI anomaly is likely associated with relic depositional or erosion activity, rather than possible karst activity.

Two test pits were excavated at the site to determine the foundation type and embedment depth. Figure 3 indicates the test pit locations.

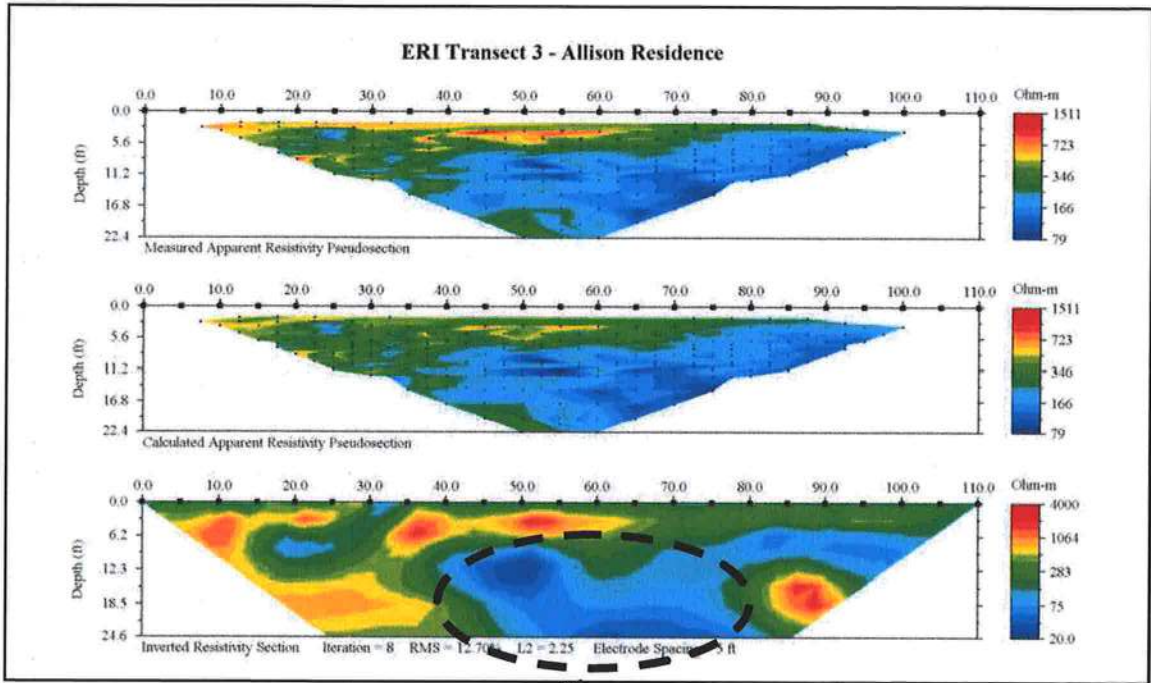
ERI Anomaly

There was a very poor correlation between the GPR and ERI results in terms of identifying layers at similar ranges in depth. This lack of correlation is likely due to the inability of the ERI to resolve the near surface transition between the sandy and sandy clay as observed on the GPR data. The ERI method did identify an anomaly east of the residence. This anomaly is characterized by low resistivity sediments observed at depth. The lack of any soil disturbances observed on the GPR data supports the interpretation that the ERI anomaly is associated with relic depositional or erosion activity, rather than possible karst activity.
