## Cal-Tech Testing, Inc.

REINFORCING STEEL INSPECTION

REPORT NO.: 2648001RSI07092026AB

PROJECT: FPL Columbia Storm Processing Facility P2

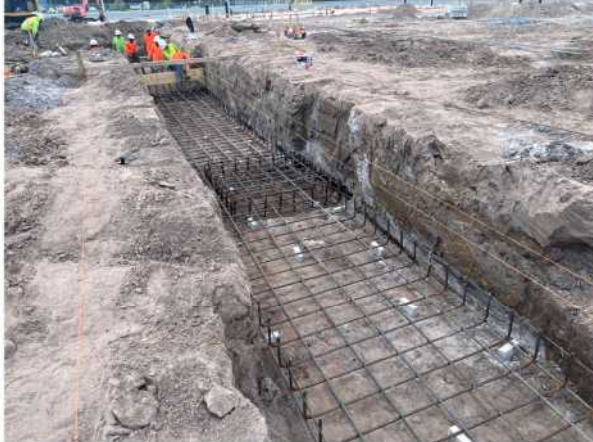
Picture 1: Overall view of reinforcing steel placement along Grid Line 1 between Grid Lines B and F.

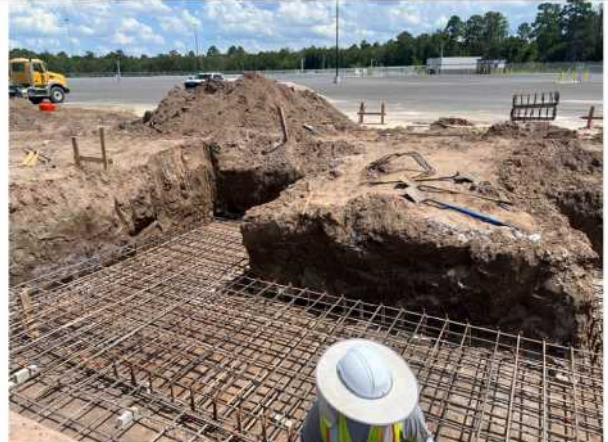
Picture 2: Overall view of reinforcing steel placement at the exterior WF-10 footing area.

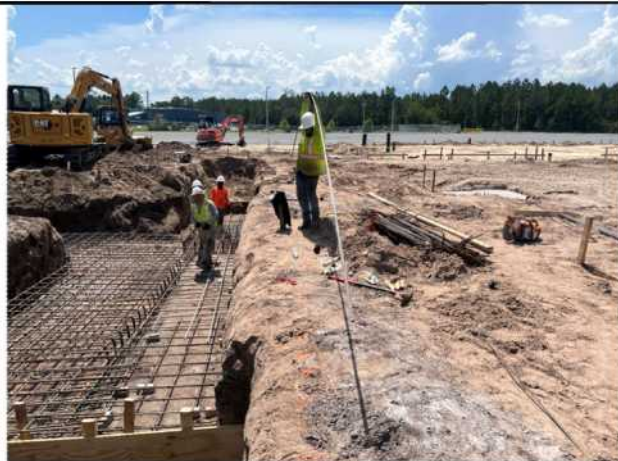
Picture 3: Overall view of reinforcing steel placement at the exterior WF-8 footing area.

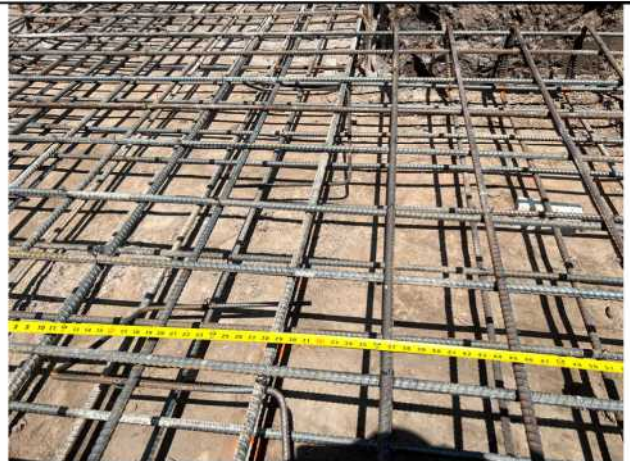
Picture 4: Verification of reinforcing steel spacing and configuration within the inspected footing area.
