REINFORCING STEEL INSPECTION

REPORT NO.: 2648001RSI07072026AB

DATE: 7/7/2026  
PROJECT #: 26-480-01  
PROJECT: FPL Columbia Storm Processing Facility P2  
LOCATION: 1855 NW County Road 25A Lake City, FL  
CAL-TECH P.M.: Chad Day

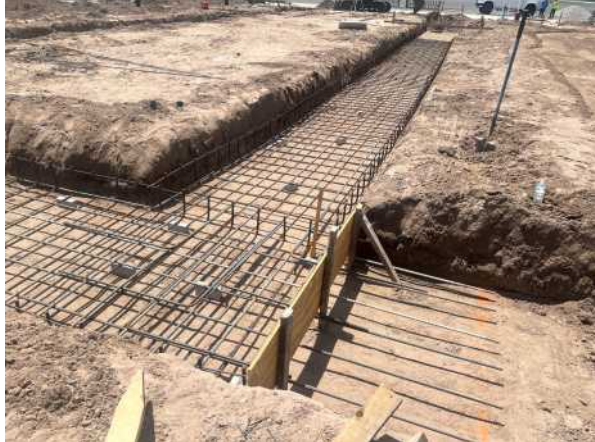
Picture 1: Reinforcing steel placement for footing construction within the inspected area along Grid Lines B and C between Grid Lines 1.5 and 5.

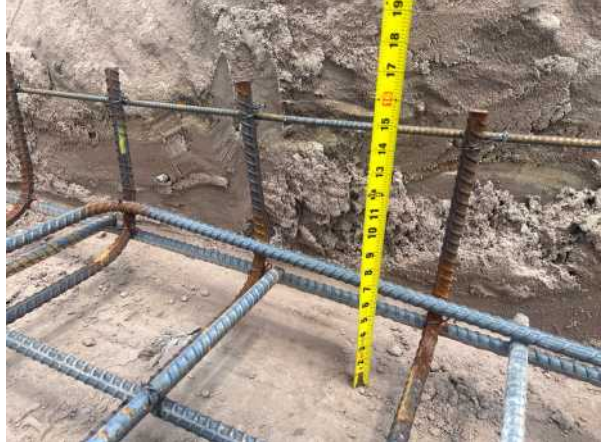
Picture 2: Field verification of reinforcing steel placement and elevation within the inspected footing area.

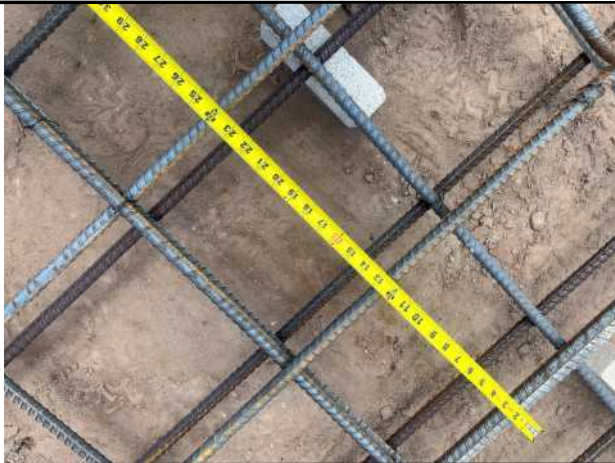
Picture 3: Field verification of #6 transverse bottom reinforcing steel spacing at approximately 10 inches on center within the inspected footing area.

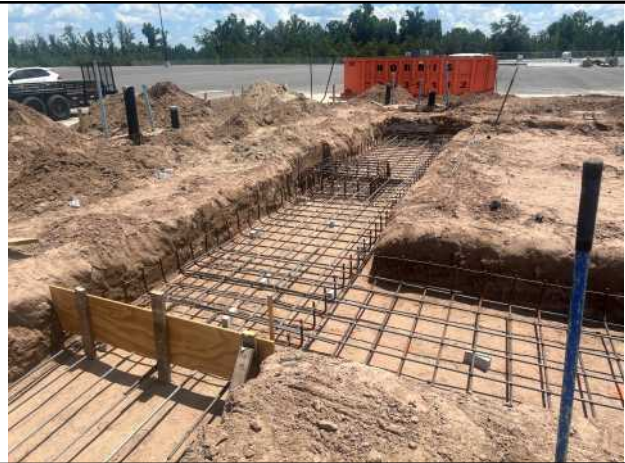
Picture 4: Reinforcing steel placement, including continuous wall footing reinforcement and intersecting footing reinforcement within the inspected area.
