**CONSTRUCTION MANAGEMENT REPORT
LIMITED ASBESTOS RENOVATION SURVEY**
(PERFORMED ON APRIL 10, 2014)

**FORMER LUMBER STORAGE FACILITY
1824 W. HIGHWAY 90
LAKE CITY, FLORIDA 32025**

**AGC ENVIRONMENTAL CONSULTING, INC.
13762 W. STATE ROAD 84
SUITE 408
DAVIE, FLORIDA 33325
PROJECT NO. AGC-14-1194**

April 14, 2014

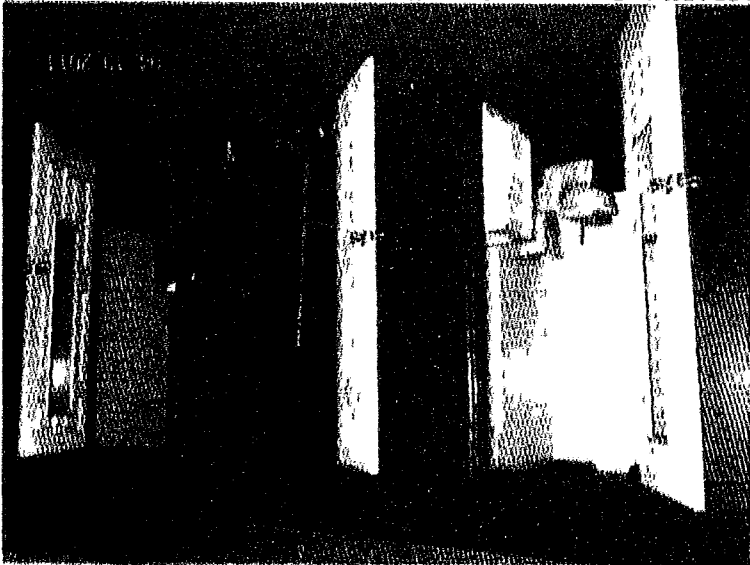
PHOTOGRAPH 1: Restrooms that will not be disturbed during future renovations

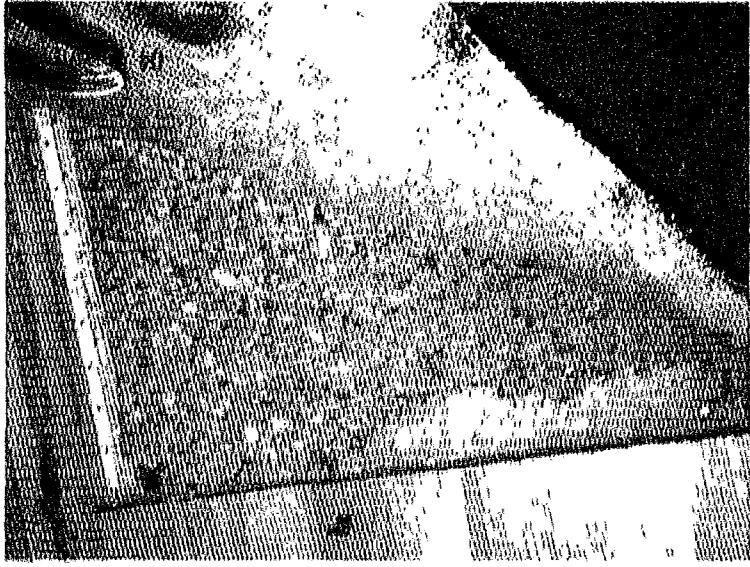
1. Flooring Materials: The flooring system is constructed of a grade on concrete decking with carpet over foam padding attached with tact strips located inside the office area. There were no finish materials present inside the renovation areas at the time of the survey.

PHOTOGRAPH 3: Carpet over foam in upstairs office

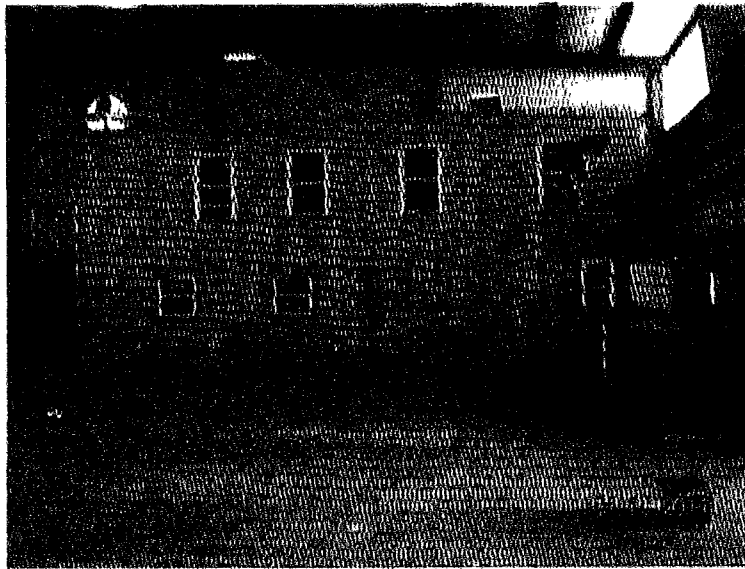
3. Ceiling Materials: The ceiling system is constructed of sheet metal decking over steel joist with finish materials consisting of approximately 400 ft² of drywall ceiling with an applied textured coating inside the office area. Representative samples were collected of the drywall ceiling and ceiling texture and all were reported by the laboratory to contain no detectable quantities of asbestos.

PHOTOGRAPH 4: Offices planning to be demolished inside the warehouse

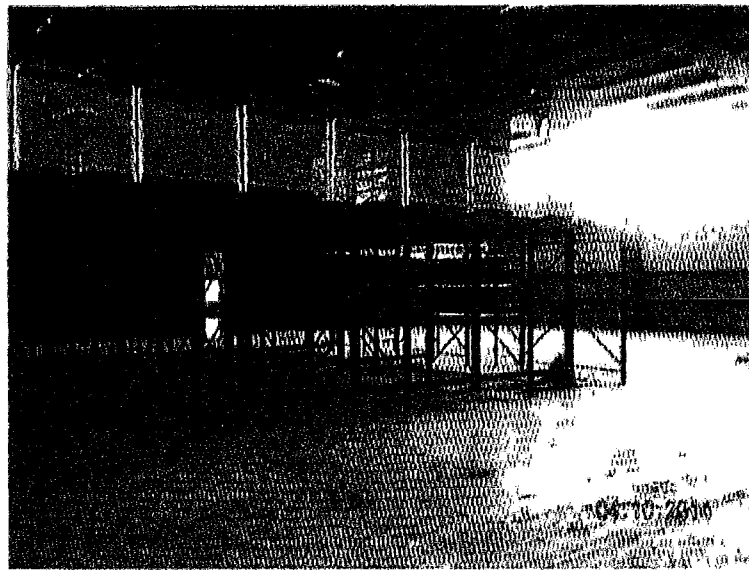
PHOTOGRAPH 5: Middle shelving inside the warehouse

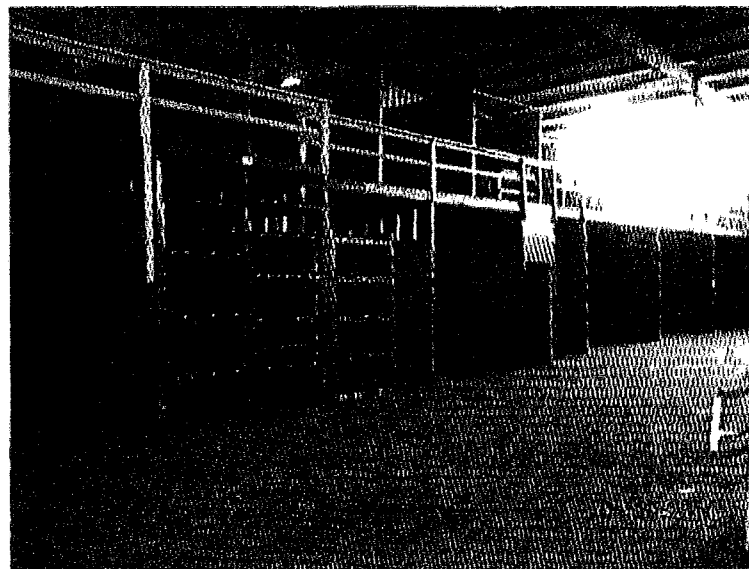
PHOTOGRAPH 6: Additional shelving inside the warehouse

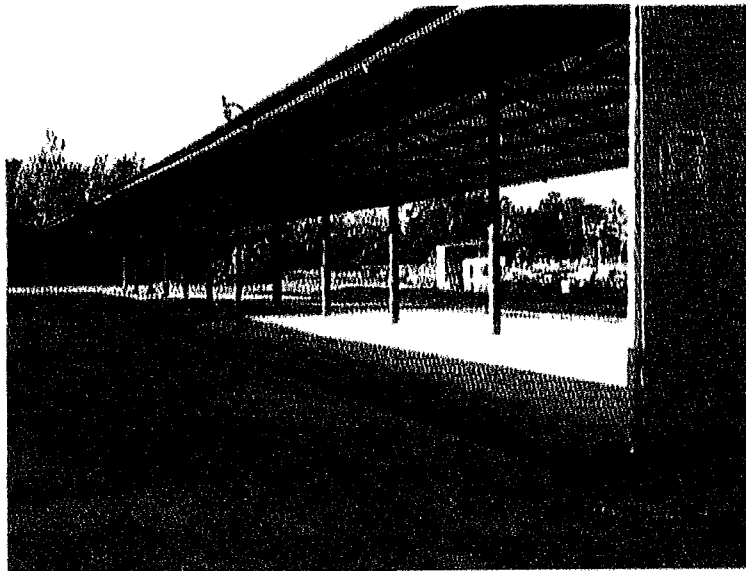
PHOTOGRAPH 7: Storage canopies in the rear of the property

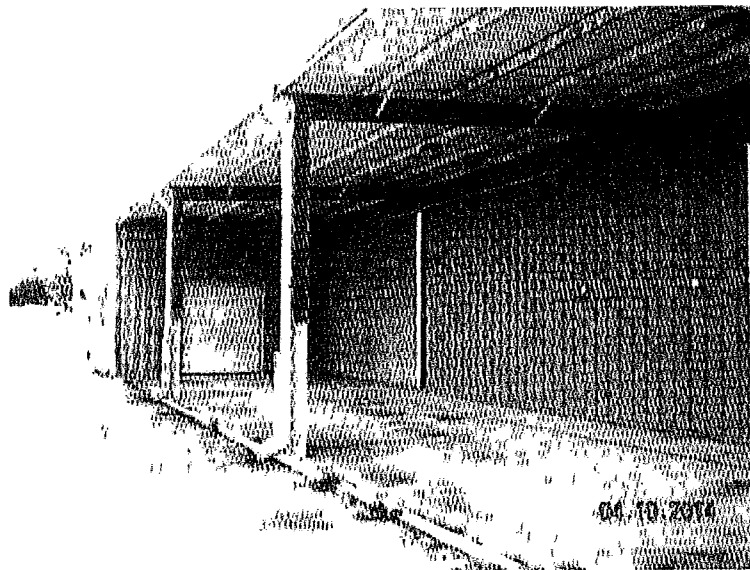
PHOTOGRAPH 8: Side of warehouse

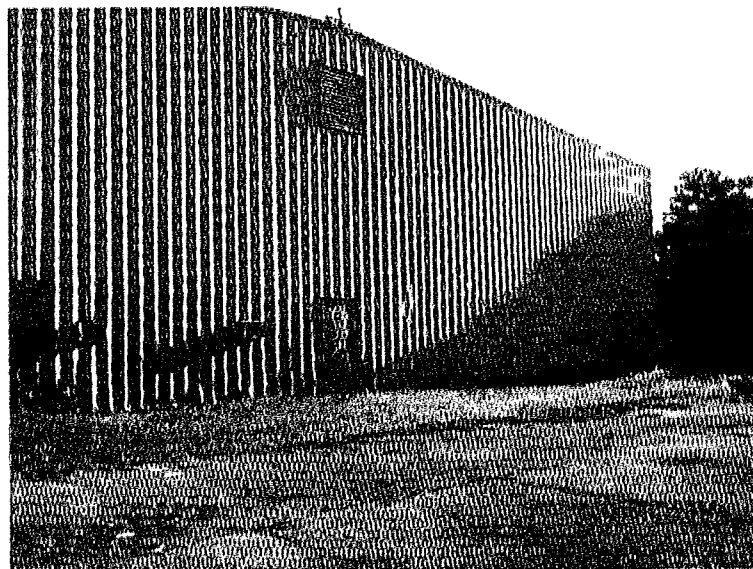
PHOTOGRAPH 9: Rear of warehouse

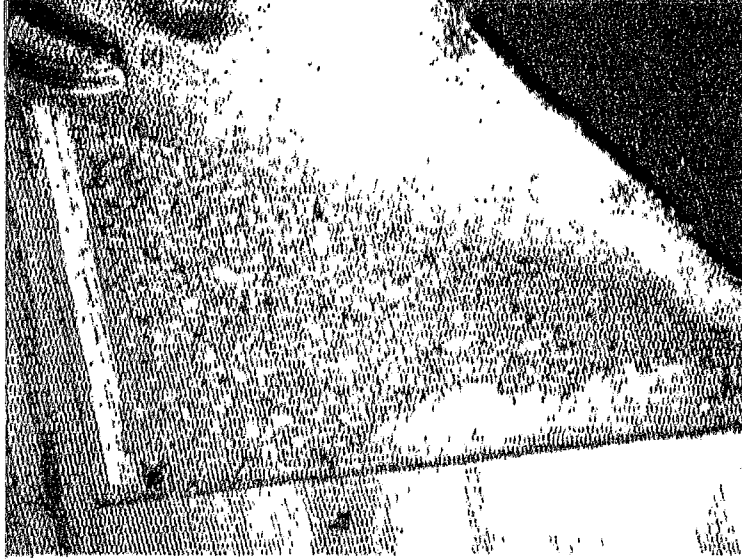
PHOTOGRAPH 3. Carpet over foam in upstairs office

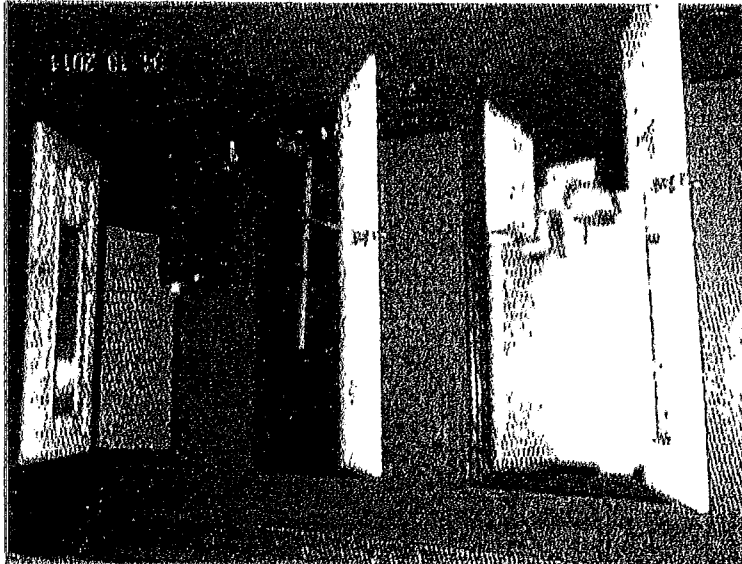
PHOTOGRAPH 1. Restrooms that will not be disturbed during future renovations

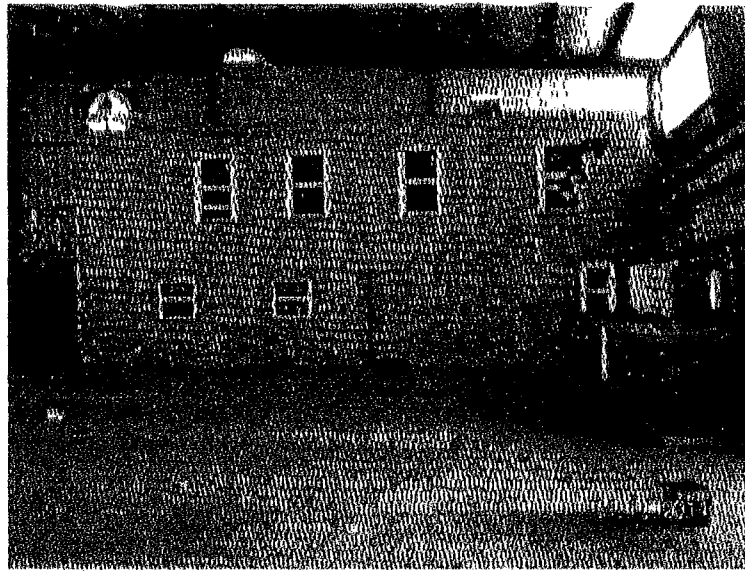
PHOTOGRAPH 4: Offices planning to be demolished inside the warehouse

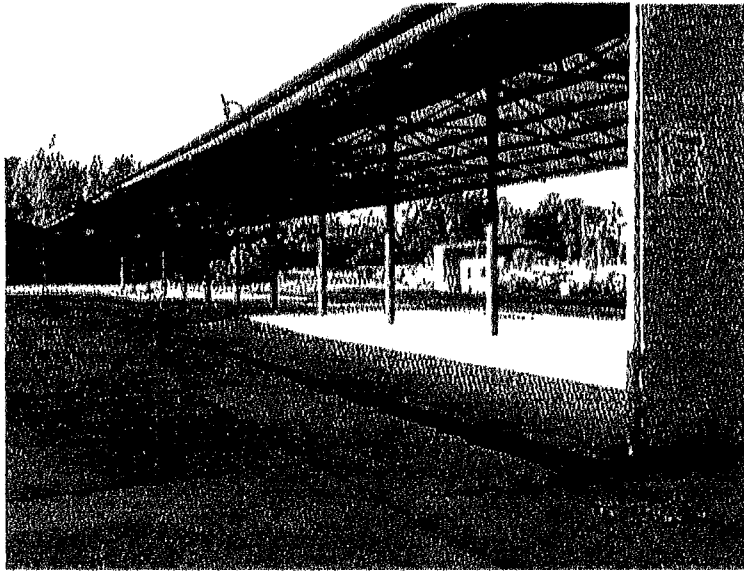
PHOTOGRAPH 7: Storage canopies in the rear of the property

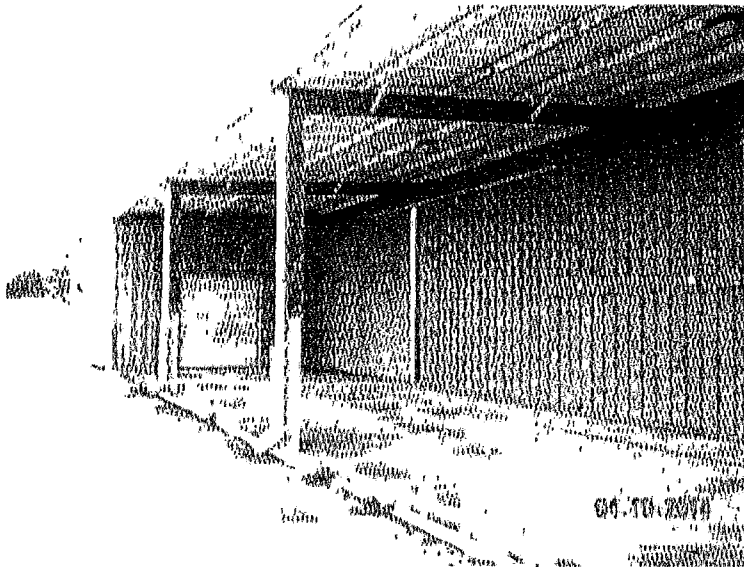
PHOTOGRAPH 8: Side of warehouse

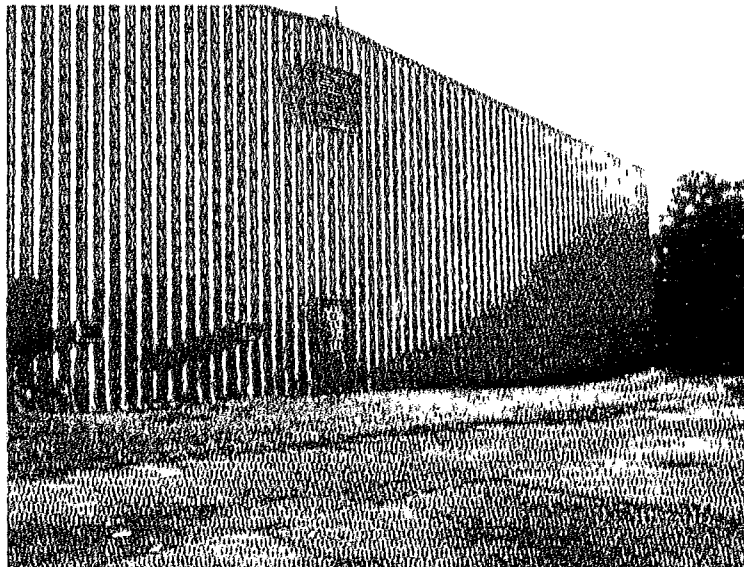
PHOTOGRAPH 9: Rear of warehouse
