Columbia County Building Permit Application

Brown Residence
162 SW Brava Way
Lake City, FL 32024

TECHNICAL SPECIFICATIONS FOR FOUNDATION UNDERPINNING AT THE

Geohazards, Inc. was tasked by State Farm Florida Insurance Company (Claim No. 59-D156-048) to conduct a geotechnical investigation at the above referenced locality. The purpose of the investigation was to determine the probable cause of distress at the subject property.

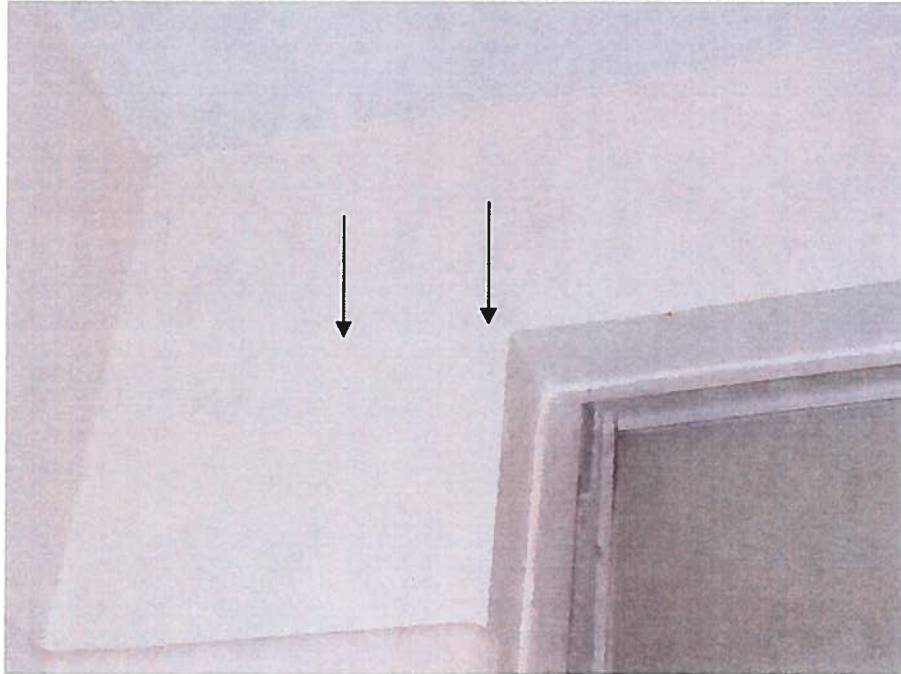
5. Drywall crack from window, south bathroom

An inspection of the interior of the home revealed drywall cracks extending from the windows in both the south bathroom and the kitchen (Photograph #5). Hairline separation cracks were also observed between the tiles below the window in the south bathroom. A drywall crack, up to 1/16" wide extended from the doorframe in the south wall of the kitchen (Photograph #6). A separation crack, approximately 1/16" wide, was also noted between the concrete floor slab and the western brick wall of the utility room (Photograph # 7).

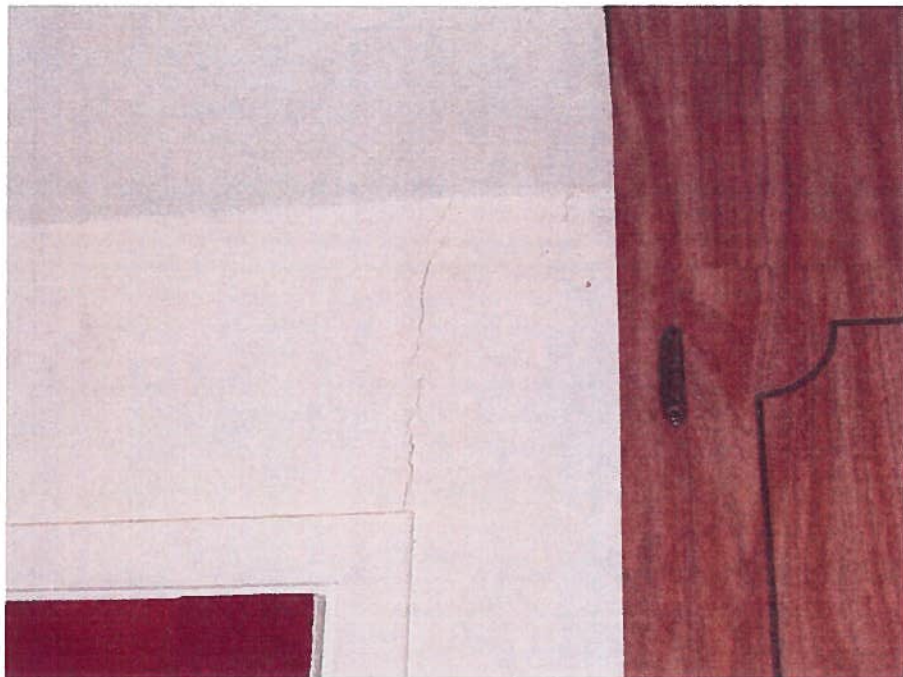
6. Drywall crack from door, south wall of kitchen

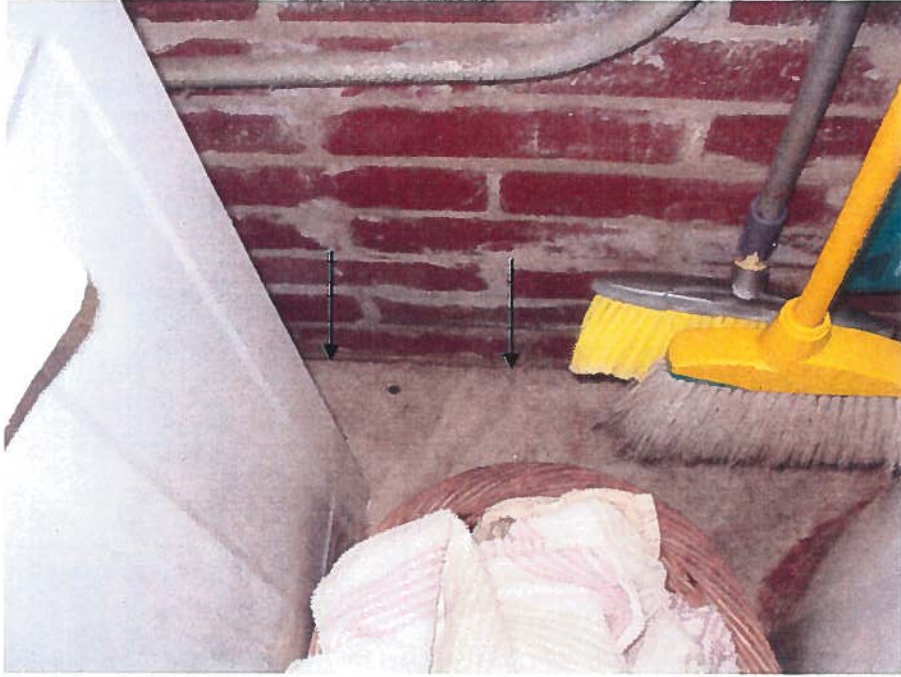
7. Separation crack between floor slab and wall, west side of utility room

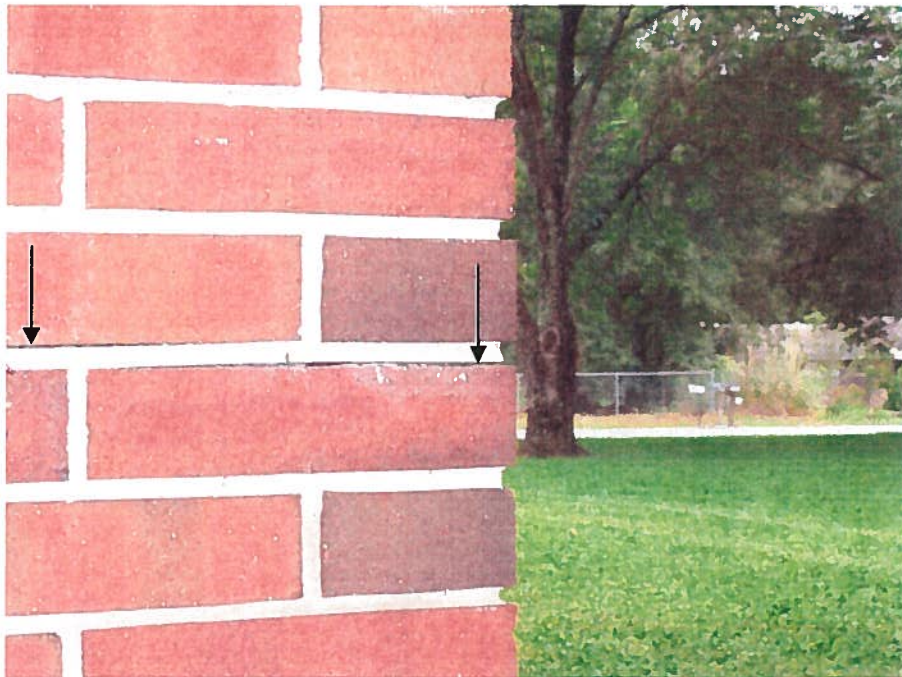
8. Separation crack between bricks, southwest corner of utility room

Evidence of exterior distress included a separation crack (approximately 1/16-inch wide) between the bricks at the southwest corner of the utility room (Photograph #8). Similar but smaller cracks were also observed at the northwest and northeast corners of the residence. Cracks were observed in the concrete slabs of the front porch and the carport. Mr. Brown indicated that the bare spot of grass near the southwest corner of the residence is the location of the depression he filled with soil. This spot is marked as "Former Depression" in the site plan map.

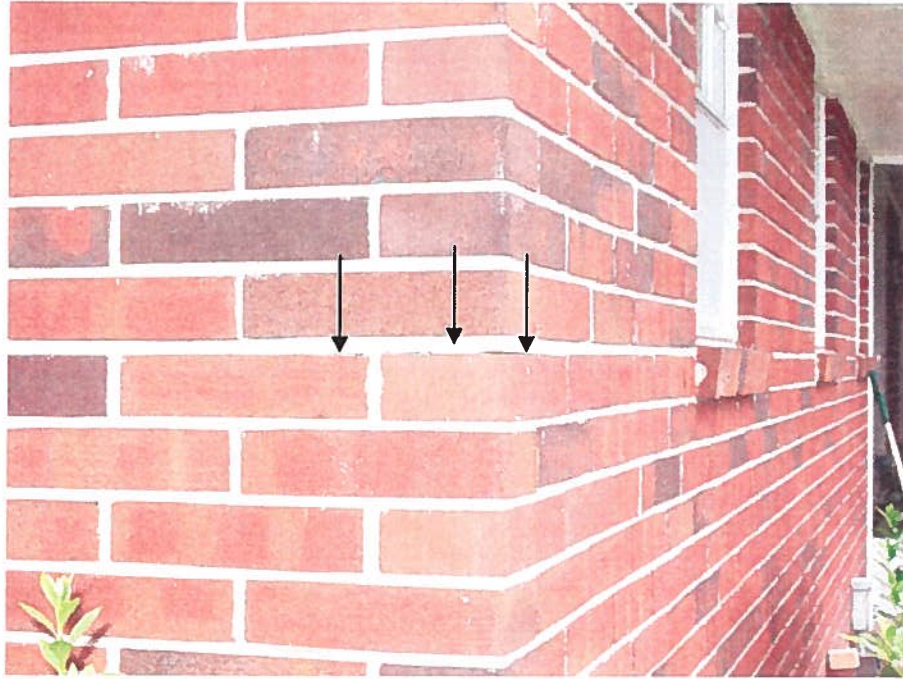
9. Separation crack between bricks, northwest corner of home

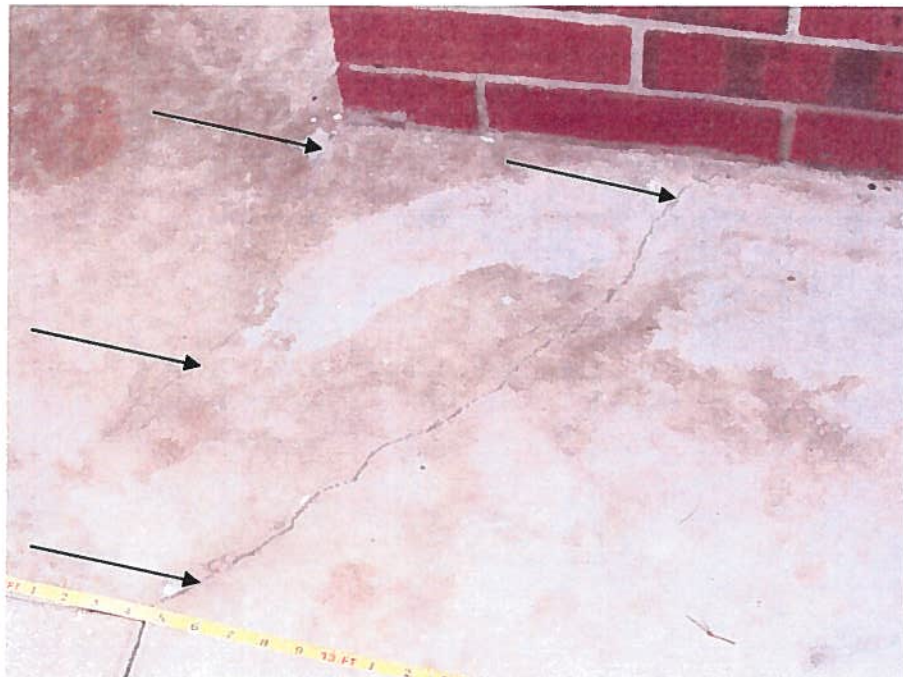
10. Crack in front patio slab, southwest corner

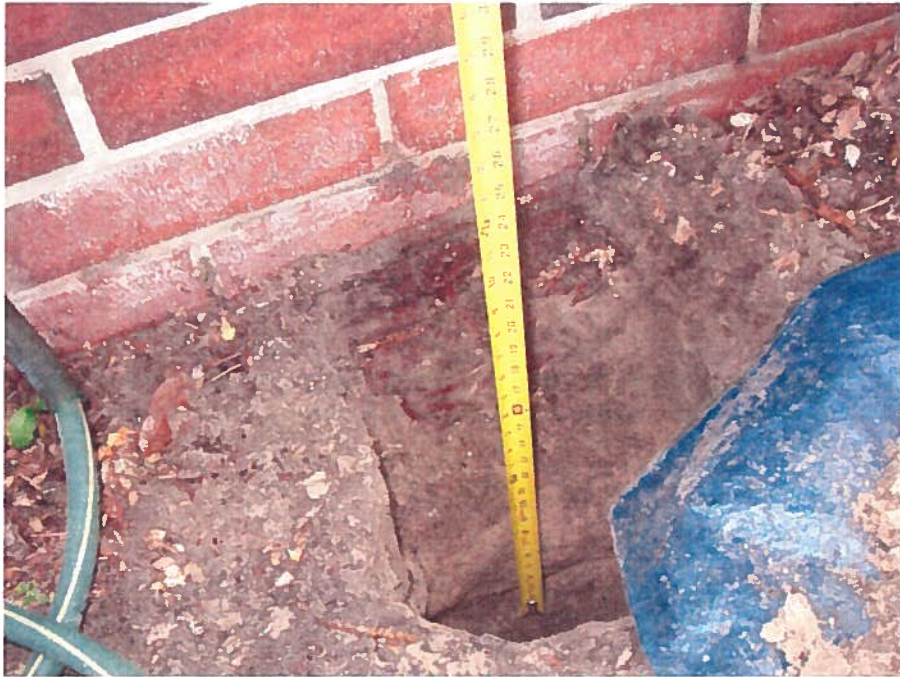
11. Test pit one (TP-1), located near the center of the east wall (see site plan), revealed a foundation embedded approximately 18 inches below ground surface.

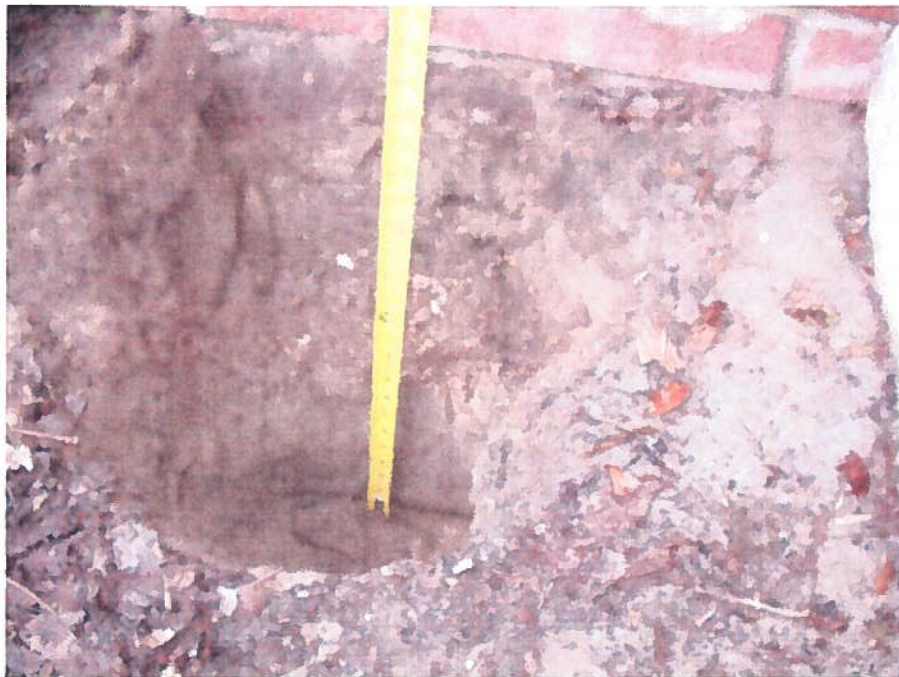
12. Test pit two (TP-2), located near the center of the west wall (see site plan), revealed a foundation embedded approximately 18.5 inches below ground surface.

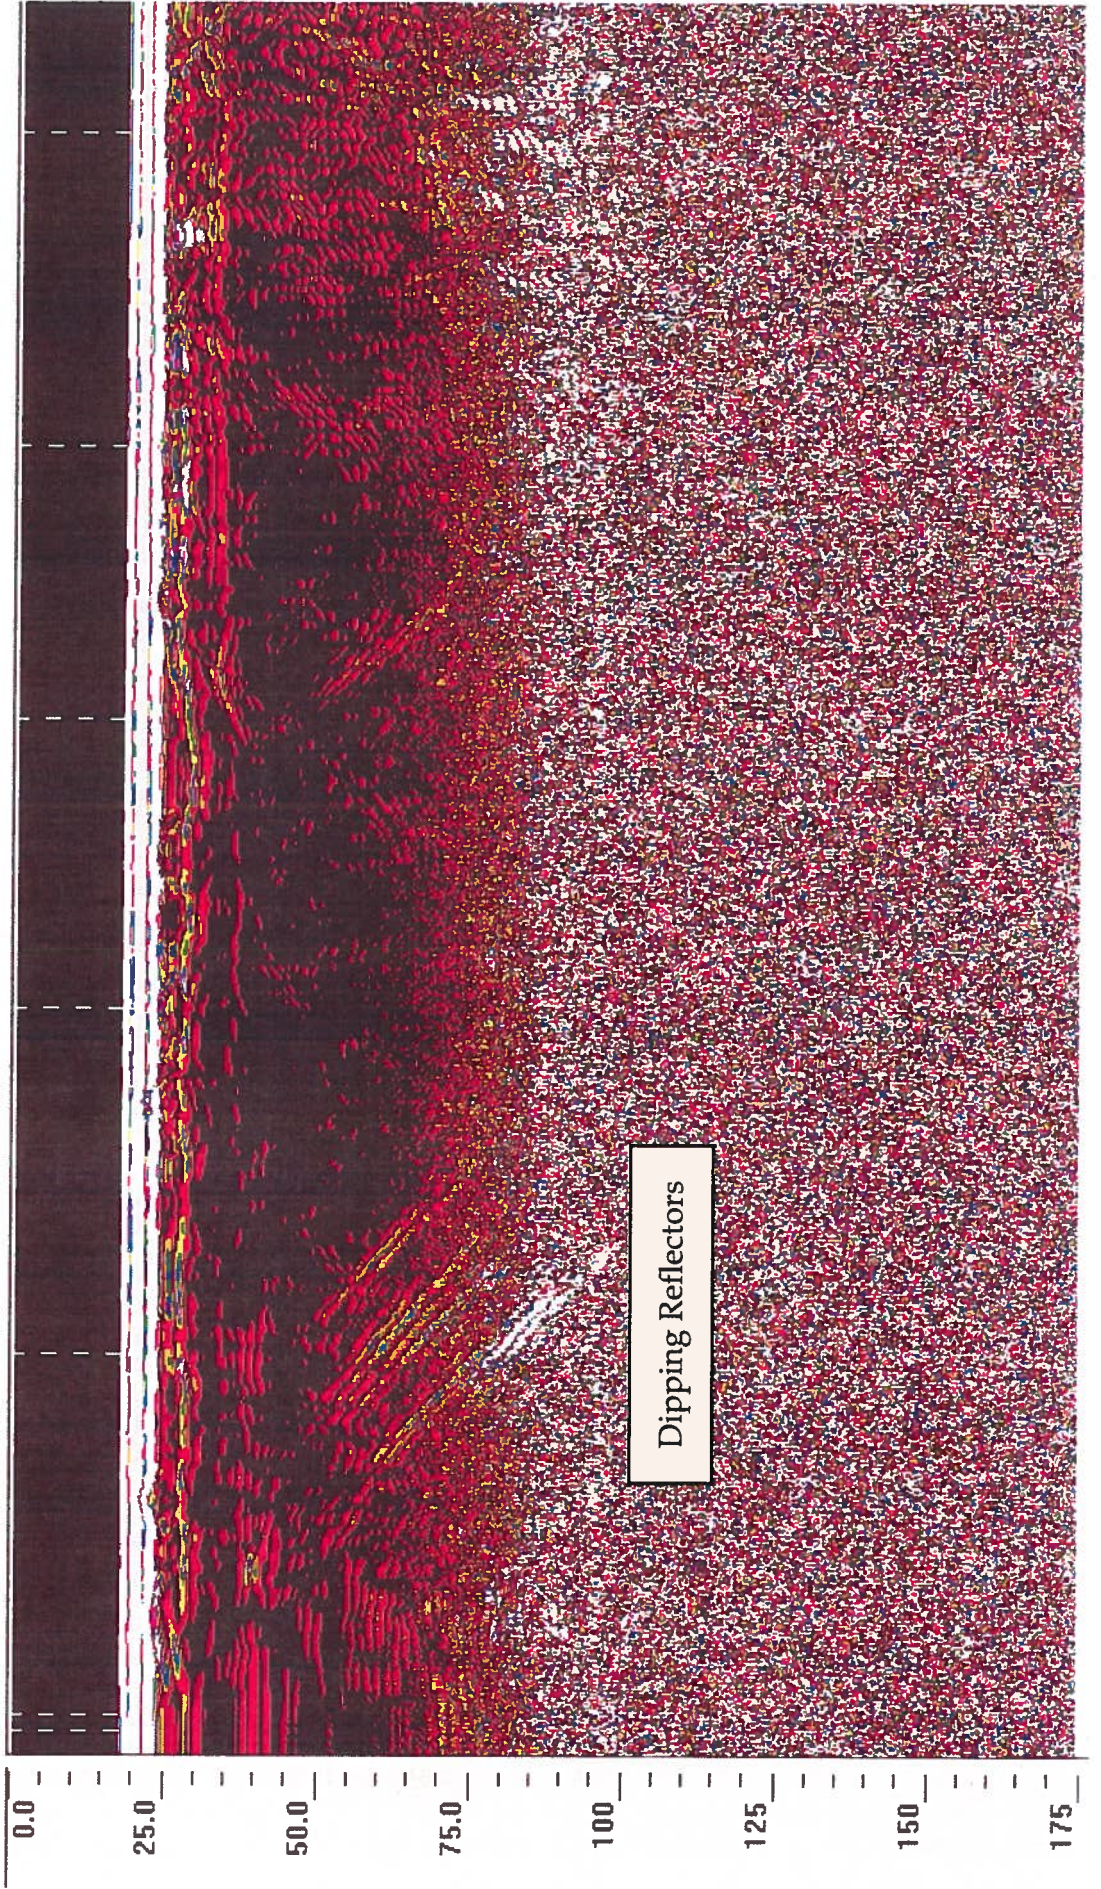
Antenna: 400 MHZ, 150 ns
System: SIR 3000
Description: Disturbed sediments and
dipping reflectors in upper
4-6 feet depth
