## Gill Engineering Services, Inc.

**Senn Residence  
976 NE Blackberry Cir  
Lake City FL 32055  
Beam Inspection – Rear of House**

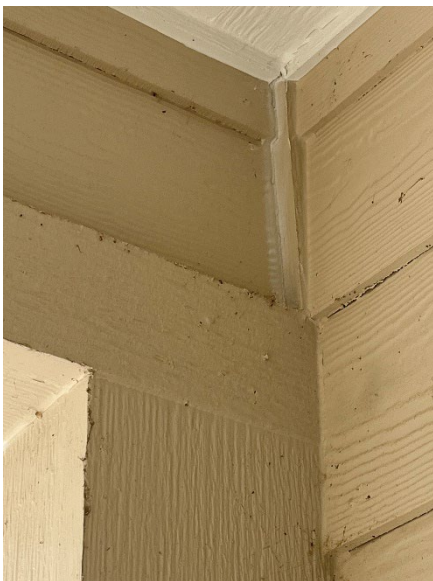
Beam End –Crack Caulked

Based on the visual inspection and previous photographs of girder beam and column support, the crack is not a result of any structural damage, insufficient girder size, or incorrect connections. It is my opinion that the cracking is not structural in nature and most likely the result of some initial shifting or temperature shrinkage.

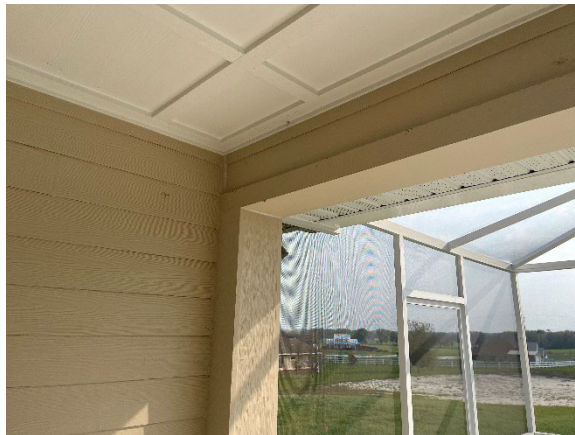
Overall View of Beam

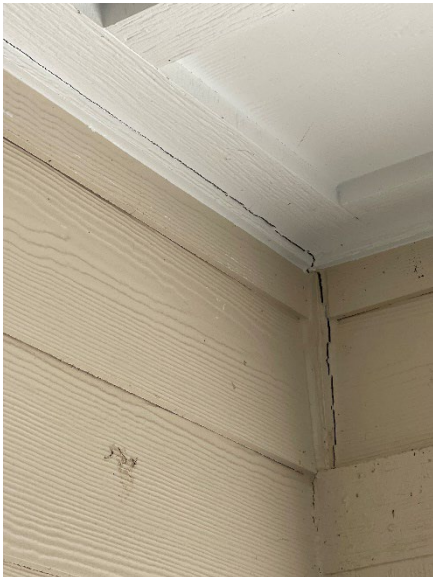
Cracked Hardi Board – Prior to Caulked

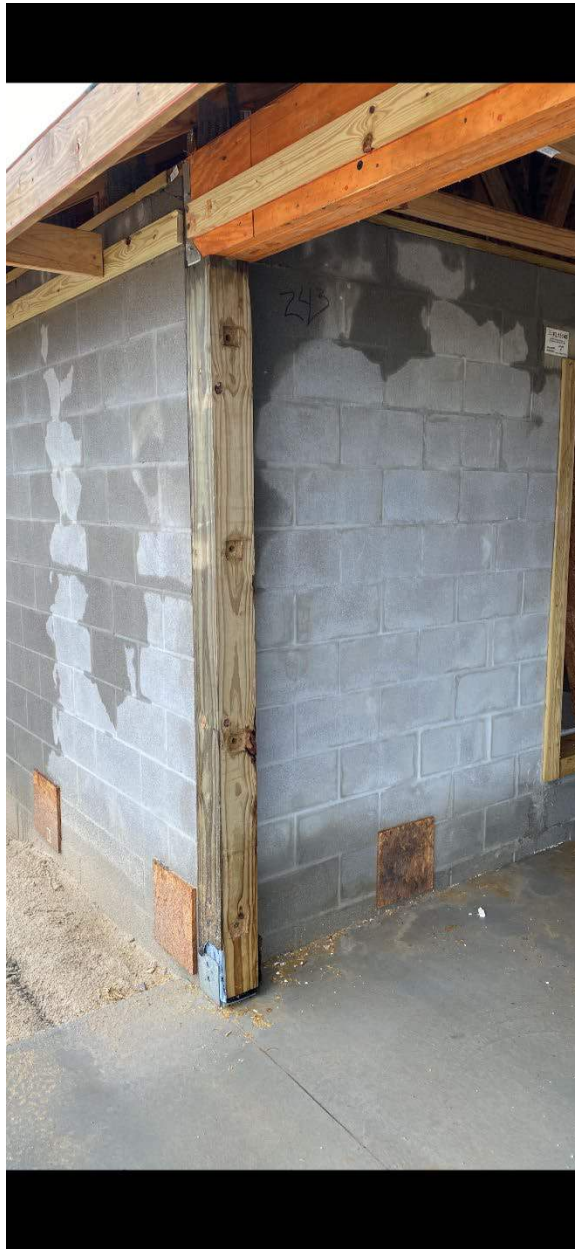
Girder Beam Installation (3 ply LVL)
