# ITW Building Components Group, Inc.

Truss Fabricator: Anderson Truss Company

Job Identification: REPAIR/7-140B

TRUSS REPAIR

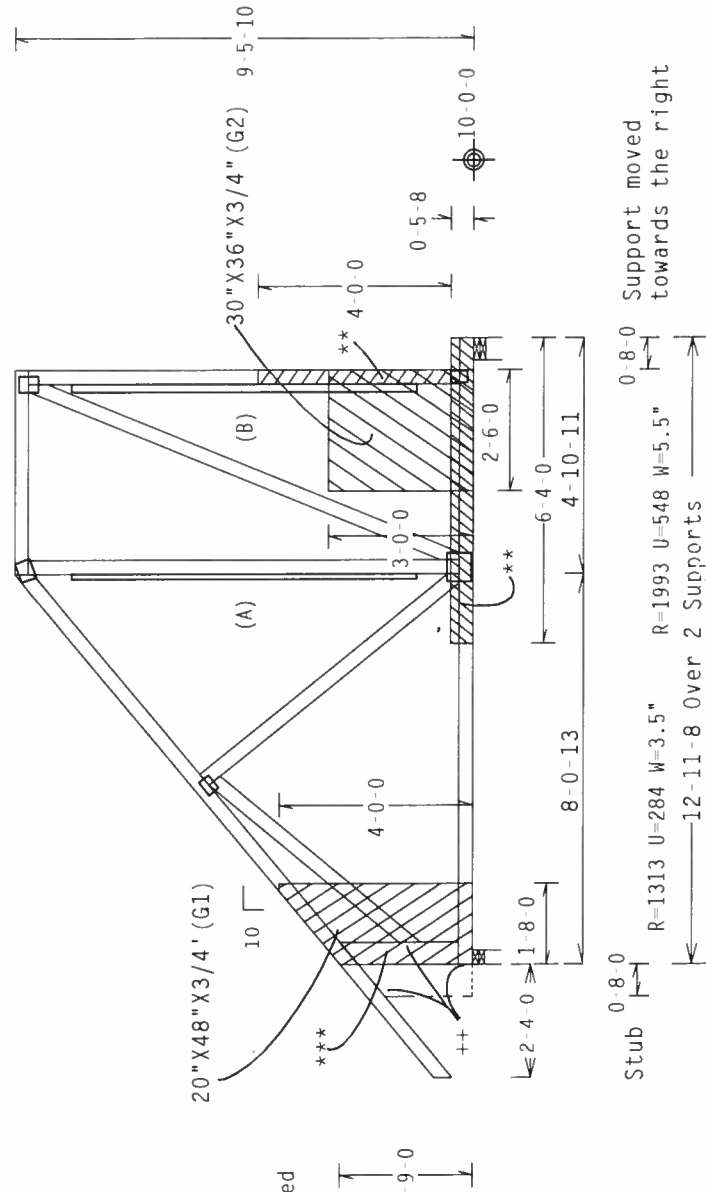
Refer to drawing HCUSR8228 07353141 (C1)

This truss is repaired to extend bottom chord 0-8-0 on the right end and stub truss 0-8-0 on left end as shown.

Shore Truss and any supported spans in proper position as repair is being made.

\*\* Field applied spider jack,

(2) - 2X6X(6-4-0) SP #2 DENSE OR BETTER SCABS.

to each outer face of chord with 1-Row of

10d(0.148"X3.0") COMMON NAILS @ 4.0" O.C.

(2) - 2X4X(4-0-0) SP #2 OR BETTER SCABS.

ATTACH EACH SCAB TO FACE OF THE VERTICAL,

SNUG AND TIGHT AGAINST 2X4 SCAB WITH 1-R

10d(0.148"x3.0") COMMON NAILS @ 4.0" O.C.

(G2) 3/4" Gusset Plates are C-D EXT APA RATED 40/20

**SHEATHING, (Plywood or OSB).** Apply gusset to on top of (\*\*) field scabs with evenly distributed

6d\_common\_or\_gun\_(0.113"x2.0",\_min.)\_nails in 1-row @ 2 0"oc

++ USE A SHARP METAL CUTTING SAW BLADE TO CAREFULLY REMOVE MATERIAL FROM THE TRUSS AS SHOWN. REMAINING PORTIONS OF TRUSS AND ALPINE PLATES MUST BE FREE FROM DAMAGE AND FULLY EMBEDDED INTO TRUSS MEMBERS.

(G1) 3/4" Gusset Plates are C-D EXT APA RATED 40/20

SHEATHING, (Plywood or OSB). Apply gusset to each face of truss and attach with evenly distributed 6d Common or Gun (0.13"x2.0", min.) nails in 1-row @ 2.0" oc throughout chords, webs and new field(\*\*), (\*\*\*) applied members.

\*\*\* (1) - 2X6X(SCRIBE TO CUT FOR TIGHT FIT) SP #2 OR

BETTER FIELD APPLIED MEMBER, in plane with

truss. Note: New (1)-One new 2x6 field applied

vertical web.

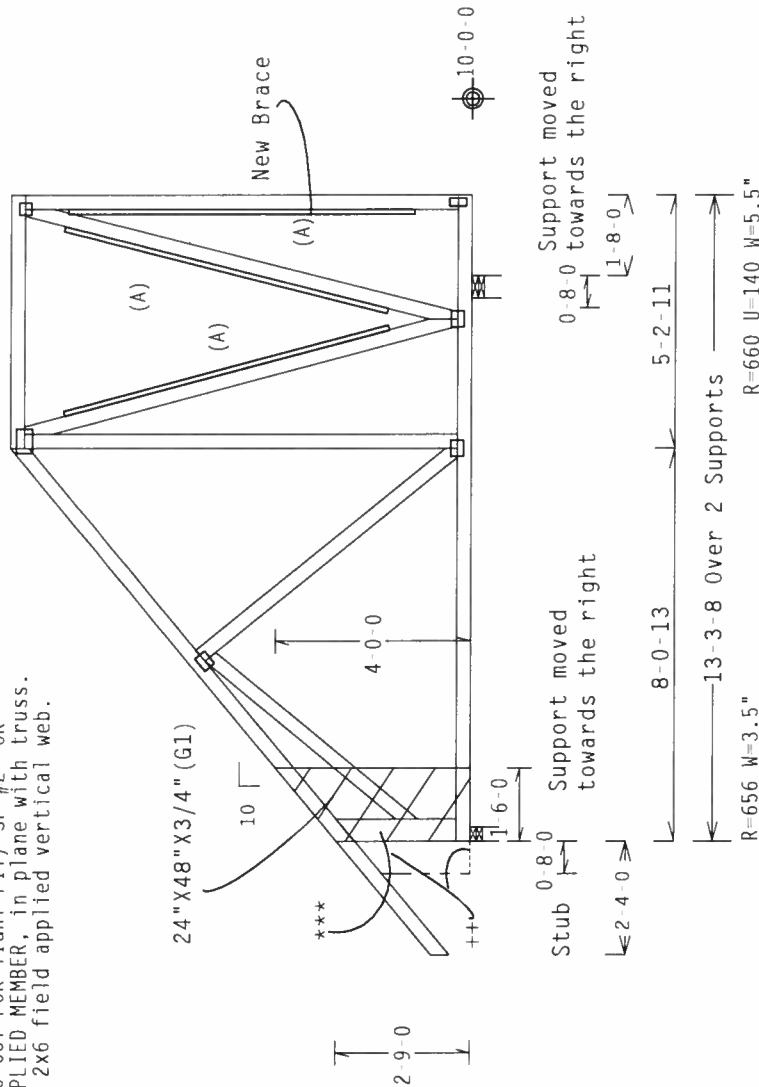
Refer to drawing HCUSR8228 07353178 (C3)

This truss is repaired for right support moving 0-8-0 towards the right and to stub truss 0-8-0 on left end as shown.

Shore Truss and any supported spans in proper position as repair is being made.

++ USE A SHARP METAL CUTTING SAW BLADE TO CAREFULLY REMOVE MATERIAL FROM THE TRUSS AS SHOWN. REMAINING PORTIONS OF TRUSS AND ALPINE PLATES MUST BE FREE FROM DAMAGE AND FULLY EMBEDDED INTO TRUSS MEMBERS.

\*\*\* (1) - 2X6X (SCRIBE TO CUT FOR TIGHT FIT) SP #2 OR BETTER FIELD APPLIED MEMBER, in plane with truss.  
Note: New (1) - One new 2x6 field applied vertical web.

(A) 1x4 #3 or better "T" brace. 80% length of web member. Attach with 8d Box or Gun (0.113"x2.5", min.) nails @ 6" OC.

(G1) 3/4" Gusset Plates are C-D EXT APA RATED 40/20 SHEATHING, (Plywood or OSB). Apply gusset to each face of truss and attach with evenly distributed 6d Common or Gun (0.113"x2.0", min.) nails in 1-row @ 2.0" OC throughout chords, webs and new field (\*\*\*) applied members.

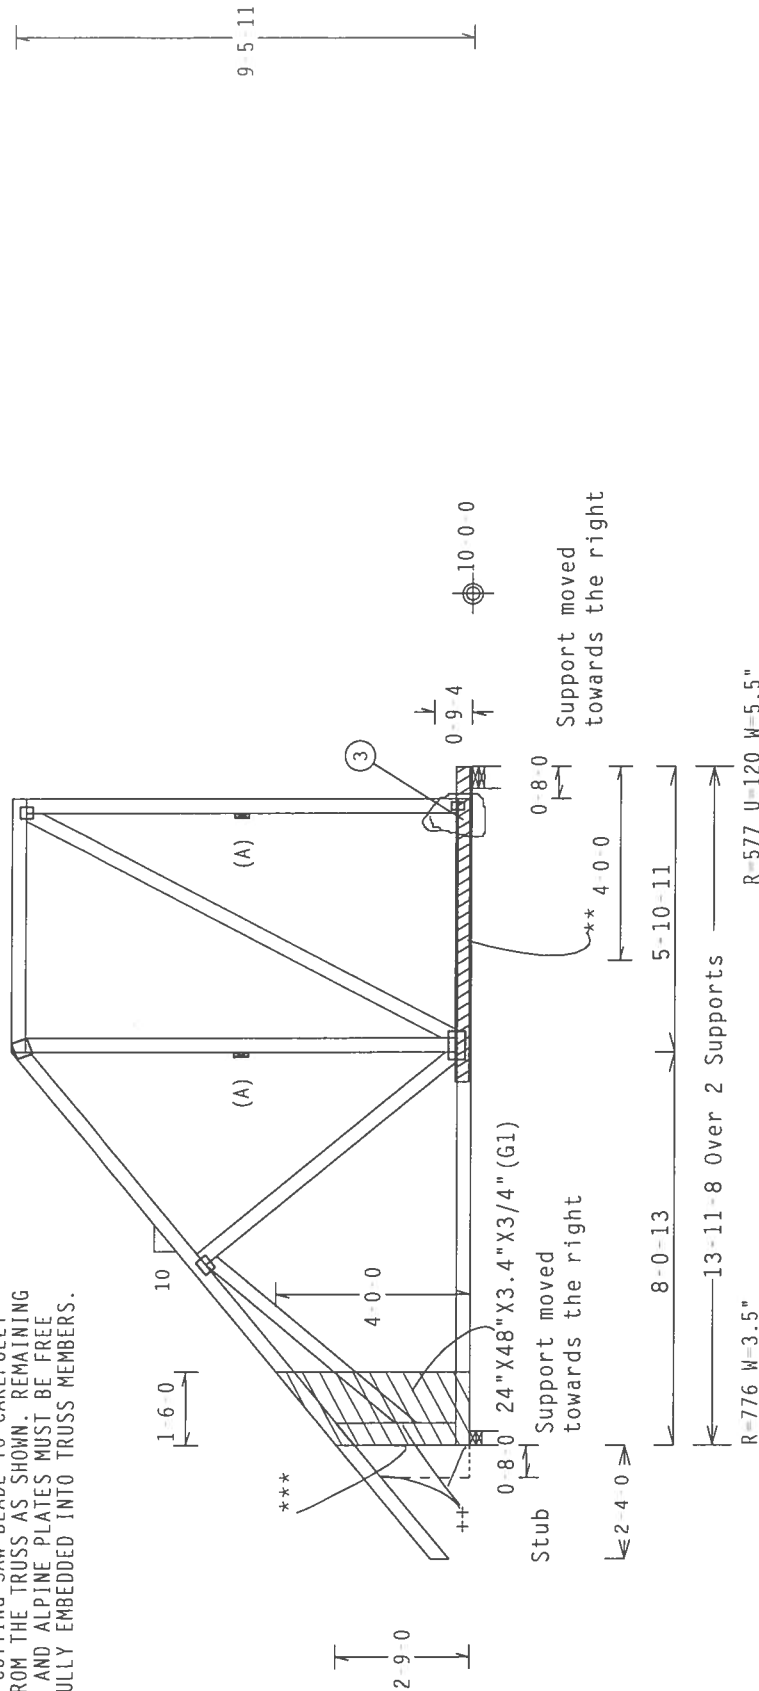
| Refer to drawing | HCUSR8228 | 07353173 | (C4) |

This truss is repaired to extend bottom chord 0-8-0 on the right end and stub truss 0-8-0 on left end as shown.

Shore Truss and any supported spans in proper position as repair is being made.

\*\*\* (1) 2X6X(SCRIBE TO CUT FOR TIGHT FIT) SP #2 OR

BETTER FIELD APPLIED MEMBER, in plane with truss.  
Note: New (1) - One new 2x6 field applied vertical web.

++ USE A SHARP METAL CUTTING SAW BLADE TO CAREFULLY REMOVE MATERIAL FROM THE TRUSS AS SHOWN. REMAINING PORTIONS OF TRUSS AND ALPINE PLATES MUST BE FREE FROM DAMAGE AND FULLY EMBEDDED INTO TRUSS MEMBERS.

(A) Continuous lateral bracing equally spaced on member.

(G1) 3/4" Gusset Plates are C-D EXT APA RATED 40/20

SHEATHING, (Plywood or OSB). Apply gusset to each face of truss and attach with evenly distributed 6d Common or Gun (0.113"x2.0", min.) nails in 1 row @3.0"oc throughout chords, webs and new field (\*\*\*) applied members.

\*\* (2) - 2X4X(6-6-0) SP #2 OR BETTER SCABS.

ATTACH EACH SCAB TO FACE OF THE BOTTOM CHORD, WITH 1-ROW OF 10d(0.128"x3.0") COMMON NAILS @ 4.0" O.C. offset row from opposing faces to prevent splits. In addition, (3) each 10d Box (0.128"x3.0", min.) nails near right as shown circled.

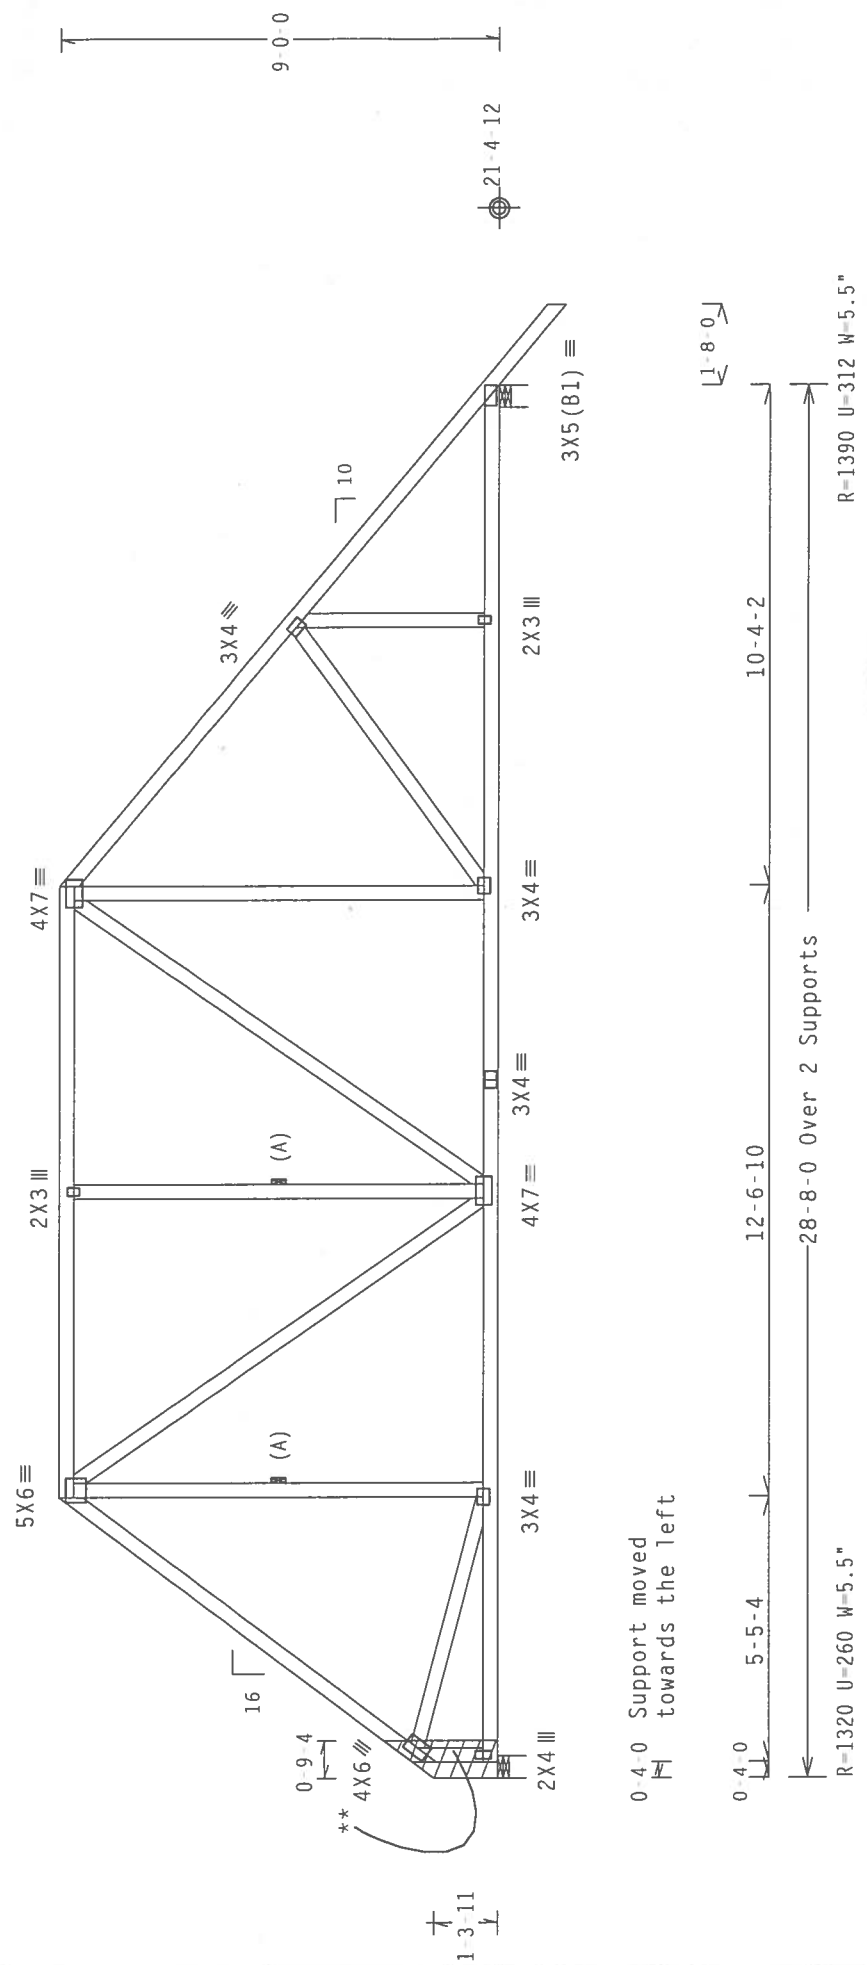
This truss is repaired for left support moving 0-4-0 towards the left as shown.  
Refer to drawing HCUSR8228 07353103 for plates and other data not given here.

Shore Truss and any supported spans in proper position as repair is being made.

(A) Continuous lateral bracing equally spaced on member.

\*\* (2) 2X10X (Profile cut to fit tight) SP #2 OR BETTER SCABS. ATTACH EACH SCAB TO FACE OF THE VERTICAL AND TOP AND BOTTOM CHORD, SNUG AND TIGHT AGAINST SUPPORT WITH 1-ROW OF 10d (0.128"x3.0") COMMON NAILS @ 2.5" O.C.

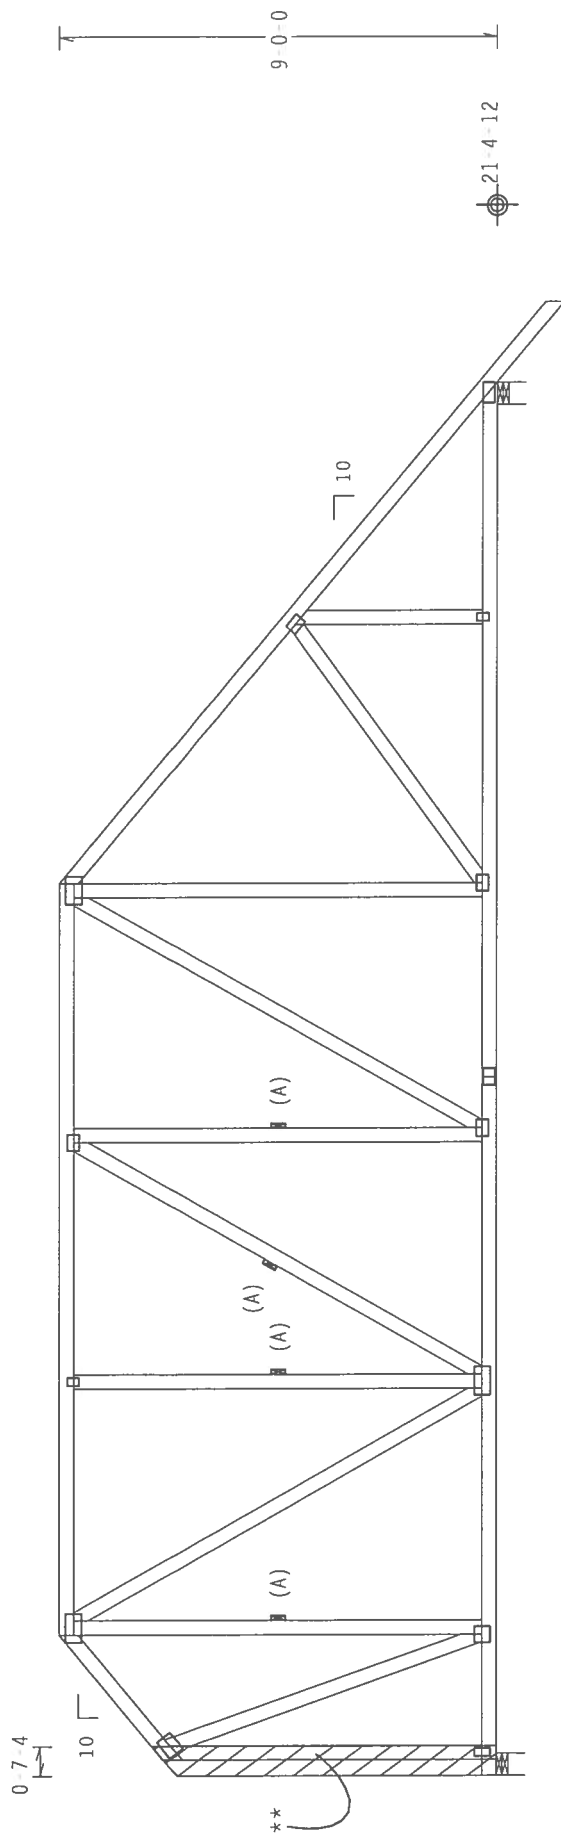
Refer to drawing HCUSR8228 07353093 (B3)

This truss is repaired for extend bottom chord 0-4-0 on the left end of truss as shown.

Shore Truss and any supported spans in proper position as repair is being made.

(A) Continuous lateral bracing equally spaced on member.

2X8X(Profile cut to fit tight) SP #2 OR BETTER SCABS.

ATTACH EACH SCAB TO FACE OF THE VERTICAL  
BOTTOM CHORD, SNUG AND TIGHT AGAINST SUPPORT WITH 1-ROW OF  
10d(0.148"x3.0") COMMON NAILS @ 4.0" O.C.
