December 14, 2019

re: ELEVATION LETTER INSPECTION - 26 | SW DEANNA TERRACE, LAKE CITY, FL

CC Job #FL19080

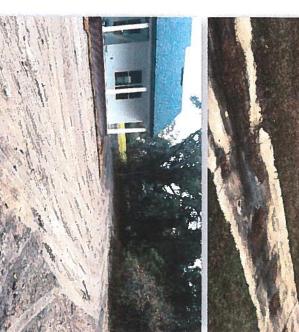
Final grading looking at the northeast corner of the new home
