re: ENGINEER'S REPORT – 23676 S. HWY. 441, HIGH SPRINGS, FL

FIELD OBSERVATIONS

CC Job #FL19074

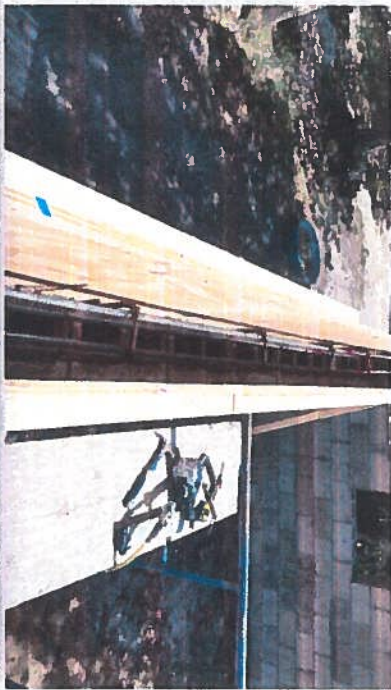
At the time of the inspection, the foundation, walls, floor slab, roof trusses and roof sheathing had been construction. Per photos provided by the owners, the footing was 20" wide and 18" deep with the required reinforcing. Photos 1 and 2. The foundation wall was constructed to a height of 5'. Photos 3 and 4. A cmu bond beam was constructed on the top of the foundation walls. Photo 5.

Photo 4. CMU wall reinforcement.

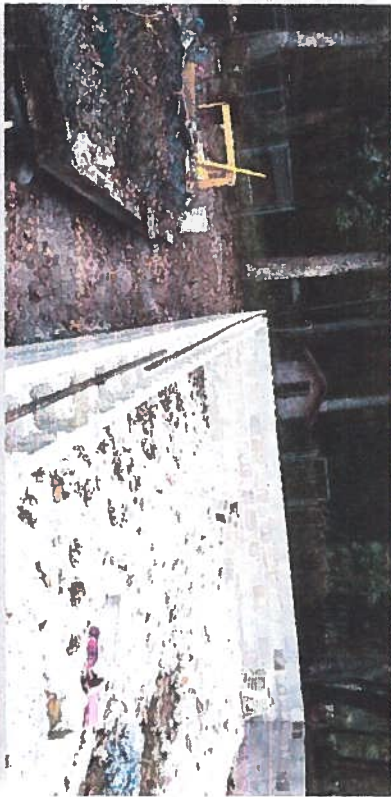
Photo 5. Foundation wall cmu bond beam.

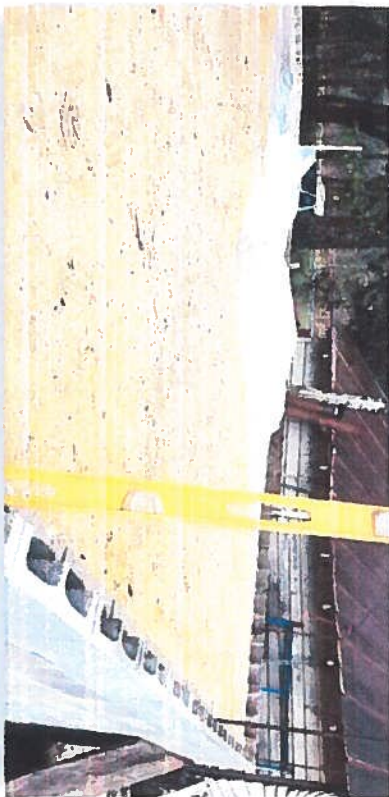
The foundation walls were backfilled, to accommodate the poured concrete floor slab. The plumbing was roughed in prior to backfilling the foundation. The backfill was treated for termites and covered with a vapor barrier. 6" x 6" wire mesh was installed over the vapor barrier. Photos 6, 7 and 8.

Photo 6. Foundation backfill.

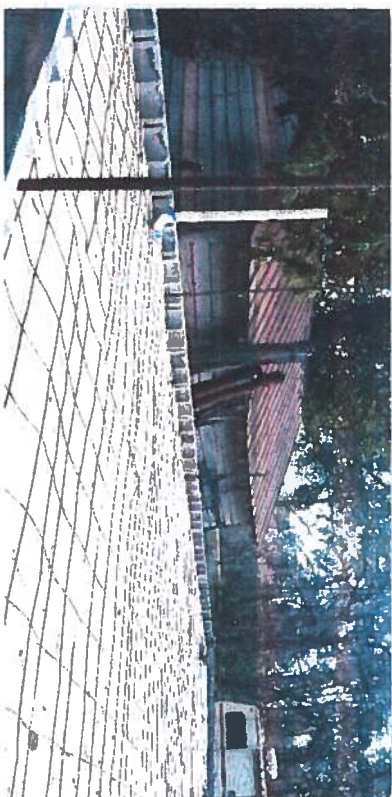
Photo 7. Vapor barrier over foundation backfill and mesh reinforcement for the floor slab.

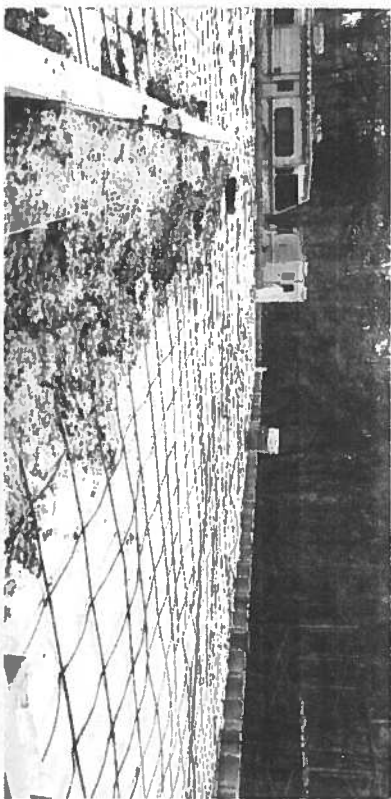
Photo 8. Concrete slab over vapor barrier over foundation backfill and mesh reinforcement.

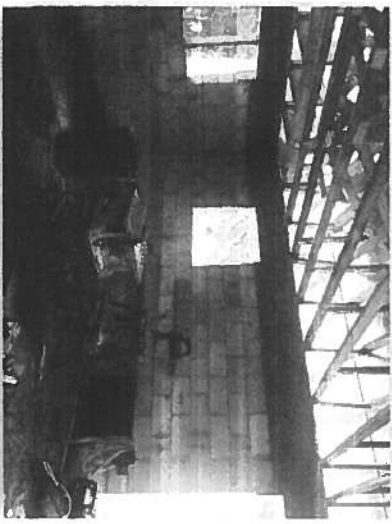
The walls of the structure were constructed with cmu's. Door and window openings were constructed appropriately with a concrete bond beam for headers. Windows are sized correctly for egress. Photos 9 and 10.

Photo 9. Exterior walls with concrete bond beam.

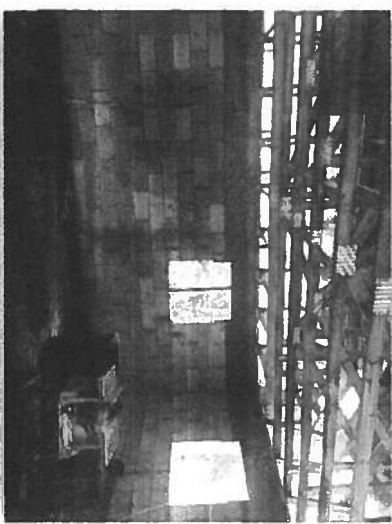
Photo 10. Exterior walls with concrete bond beam.

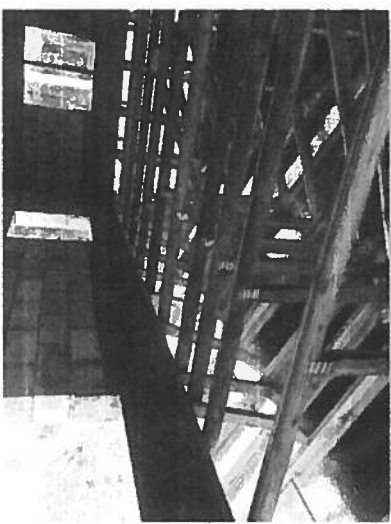
The roof trusses were installed. Additional struts were installed to ensure that the trusses bear upon the cmu wall. Photo 11. Hurricane straps will be installed to prevent uplift at each end of every truss.

Photo 11. Roof trusses with additional struts.
