Reference: Engineering Services
Miscellaneous Design | 14.004
2nd Floor Buildout – Purlin Support Frame – Field Modifications
Belmont Academy
Lake City, Florida

BELMONT ACADEMY
ROOF PURLIN MODIFICATIONS
03/15/2021

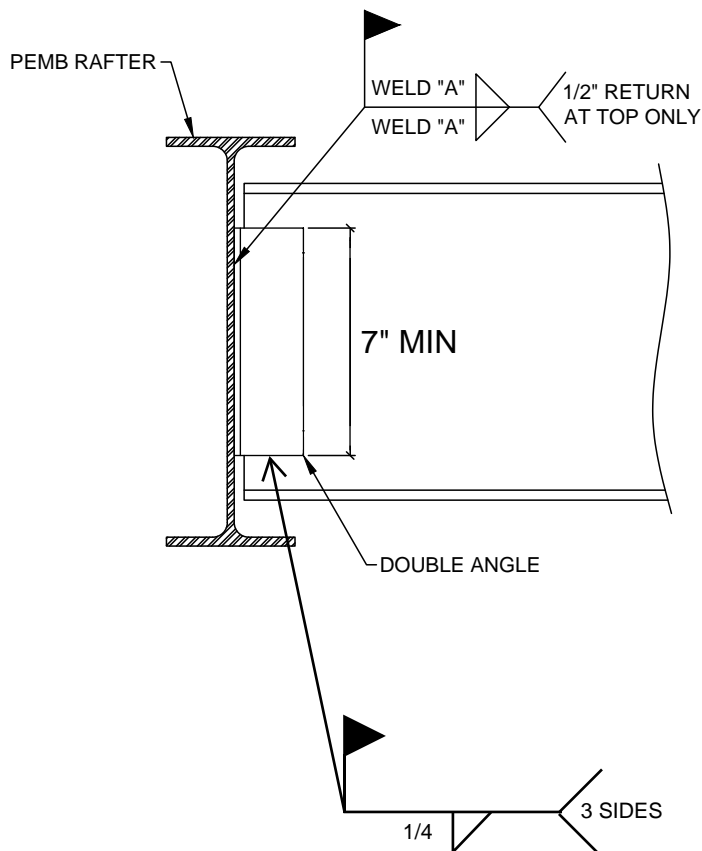
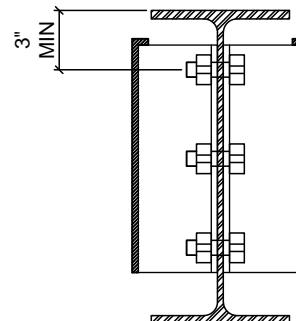
WF BM. TO PEMB RAFTER - FIELD MODIFICATION #1

Modification #1: Double angles were welded, instead of bolted per detail SC-1.

CONNECTION INFORMATION:
 ANGLE THICK. = 5/16" MIN.
 BOLTS = 3/4" DIA. A325N
 V, MIN = 1 1/4"
 WELD "A" = 1/4"

- This modification is acceptable, refer to enclosed detail FM-1.

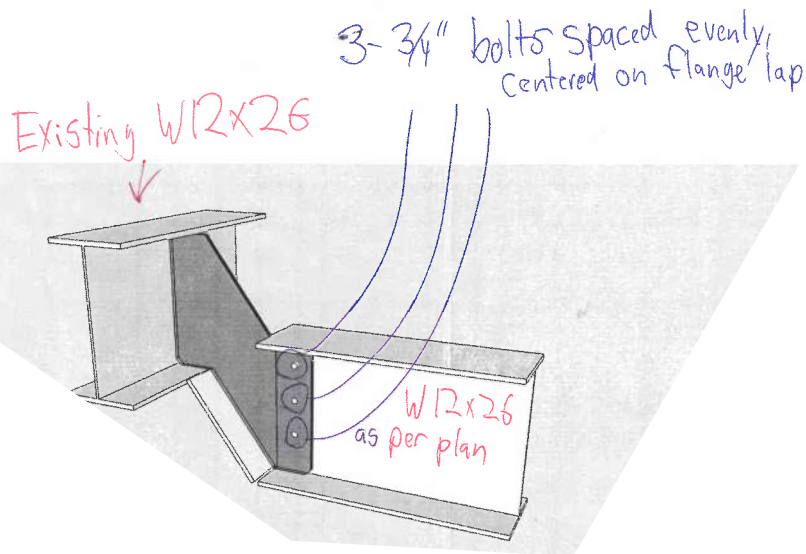
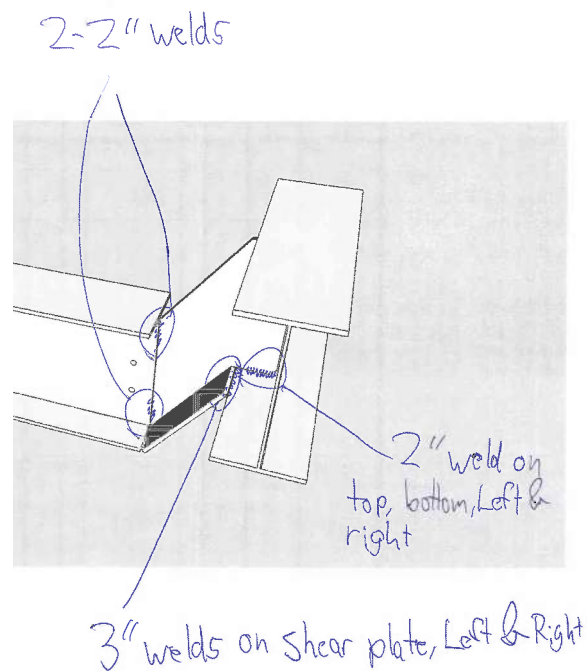
Modification #2: A built-up plate assembly was used in lieu of double angles per detail SC-1.

2" fillet welds in 5 places of contact to the existing I beam, Same Left and right, total of approximately 20" of weld, per bracket-to-beam contact.

- This modification is acceptable, refer to enclosed detail FM-2.

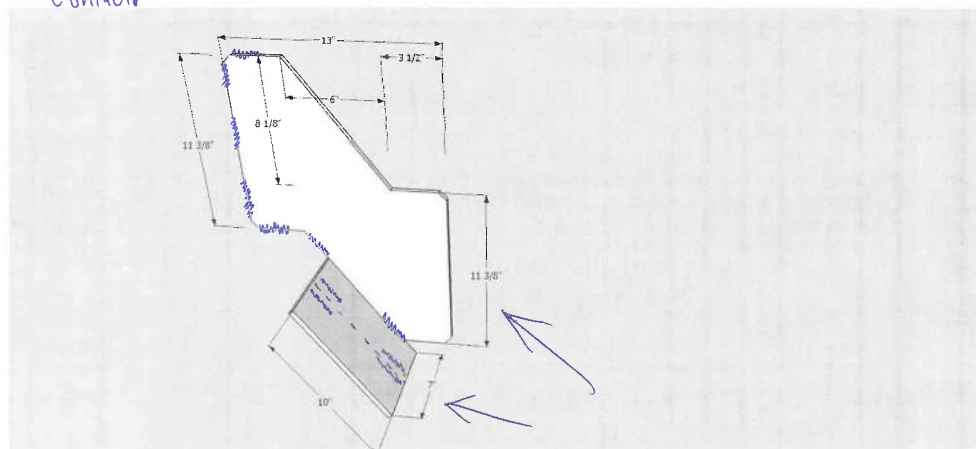
PLATE AND WELD DETAILS

8"-10" of fillet weld on Shear plate-to-bracket contact. All 3/8 thick A36 steel plate
