Columbia County Building Permit

Construction of FOUNDATION STABILIZATION AND/OR REPAIR Total Acreage 0.5 AC Lot Size 0.5 AC

Geohazards, Inc. was tasked by Florida Farm Bureau Insurance Companies (Claim No. 441215) to conduct a geotechnical investigation at the above referenced locality. The purpose of the investigation was to determine the probable cause of distress at the subject property.

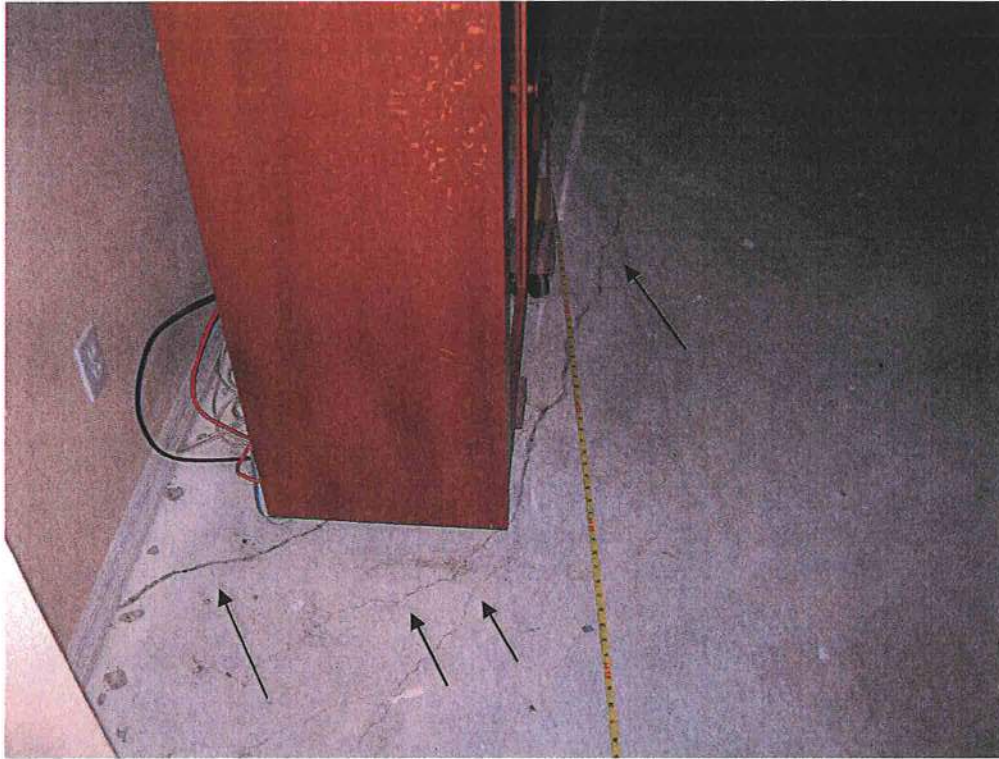
An interior inspection of the structure revealed cracks in the floor slab (up to 1/2 inch) with up to 1/4 inch vertical displacement in the living room and closet containing the air conditioning handler. Loose floor tiles were present in the dining room. Hairline tile cracks were noted in the laundry room, kitchen, master bathroom, and east bathroom. Wall and ceiling cracks (hairline to 1/16 inch) were observed in the kitchen, laundry room, master bedroom, living room, northeast bedroom, and southeast bedroom. An inspection of the garage revealed meandering hairline cracks in the floor slab and a horizontal crack (1/16 inch) below the laundry room entrance.

5. Slab cracks (hairline to $\frac{3}{8}$ inch) in the west portion of the living room.

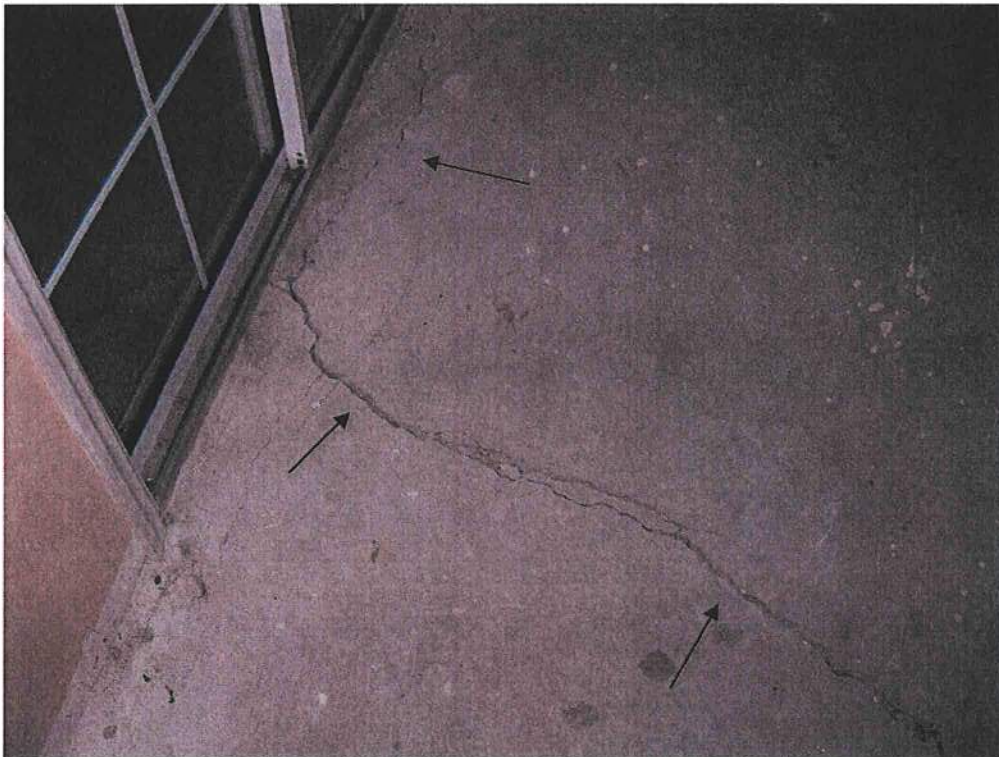
6. Slab cracks (hairline to $\frac{1}{2}$ inch) with up to $\frac{1}{4}$ inch vertical displacement in the north portion of the living room.

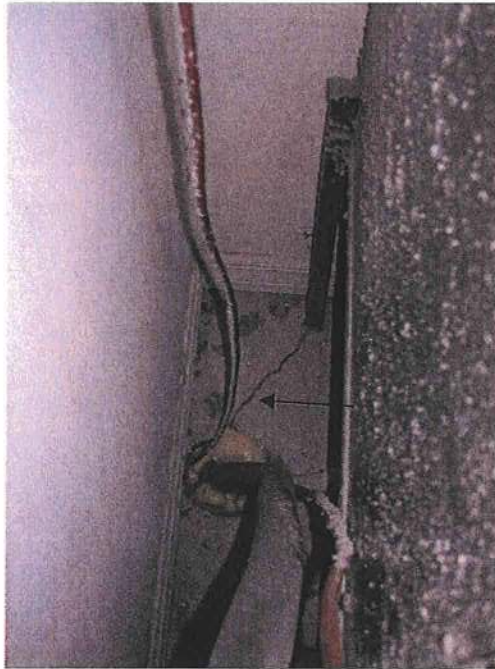
7. Slab crack (1/4 inch) beneath the air conditioner handler.

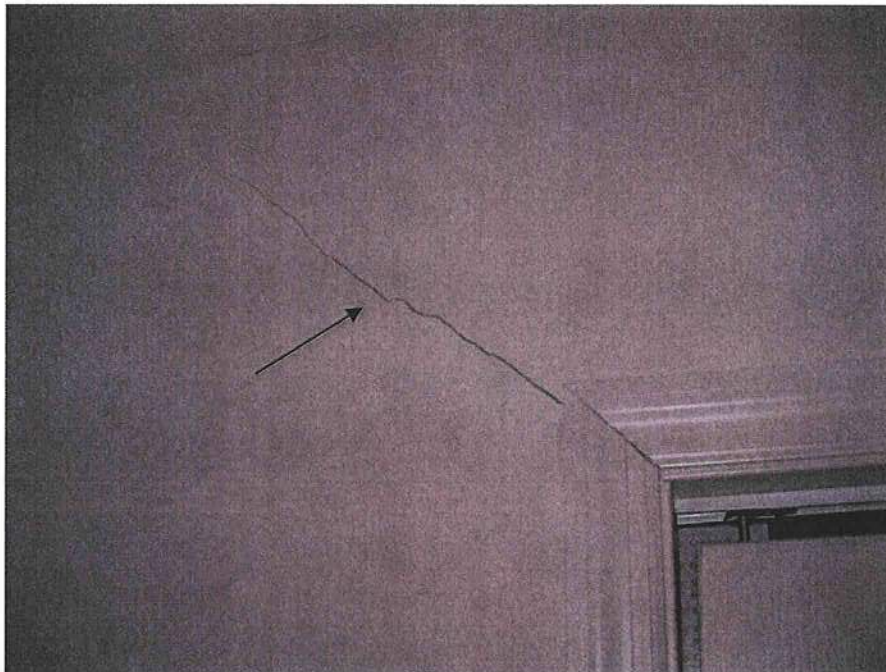
8. Wall crack (1/16 inch) in the west wall of the laundry room.

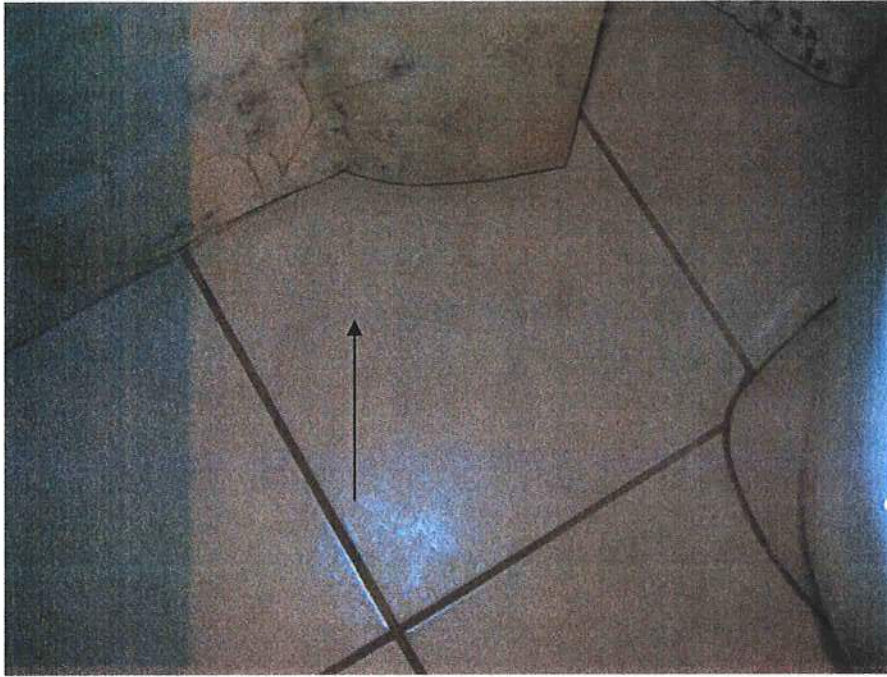
9. Hairline tile crack in the east bathroom.

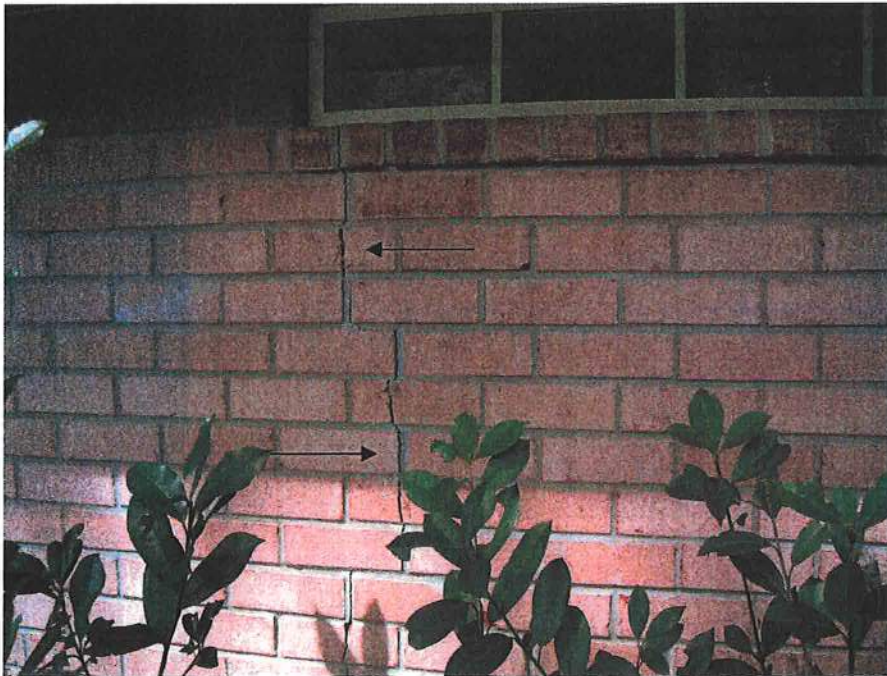
An exterior inspection of the structure revealed stair-step cracks (hairline to 1/8 inch) in the east wall, cracks in the screen porch slab (1/16 to 1/8 inch), cracks in the driveway with 1/8 inch vertical displacement. The pavers located at the northeast corner of the structure appeared to be uneven. Mr. Killin reported that the pavers had shifted from their original, level position. A shallow surface depression was observed at the northeast corner of the driveway and measured approximately 8 by 13 feet at the surface. An additional surface depression was located approximately 40 feet north of the rear patio and measured approximately 4 by 12 feet at the surface. Both depressions were approximately 6 inches deep.

10. Stair-step crack (1/8 inch) in the east exterior wall.

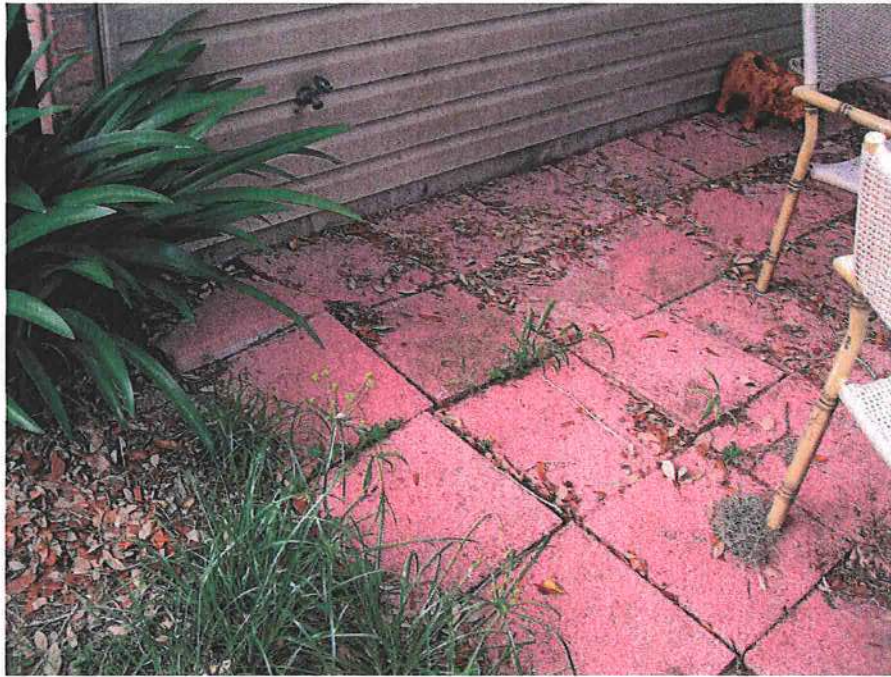
11. Shifted pavers north of the structure.

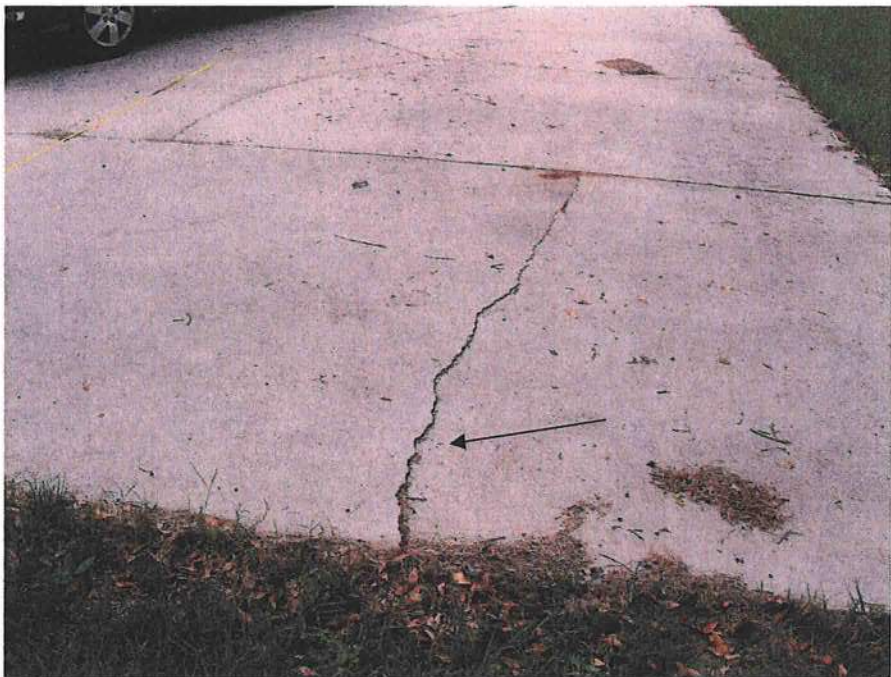
12. Driveway cracks with up to 1/8 inch vertical displacement.

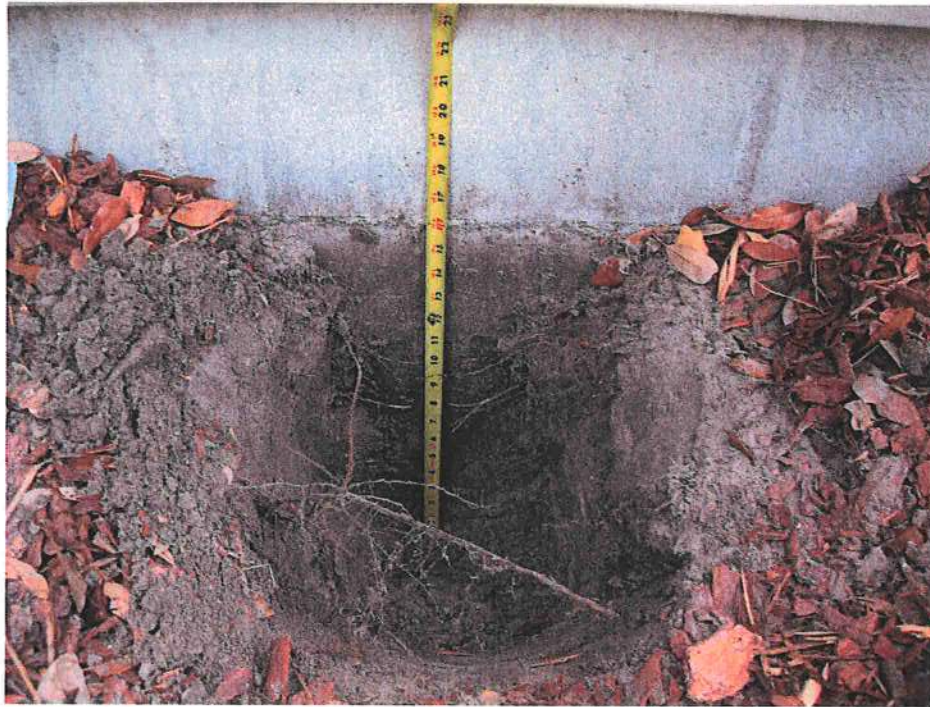
1. Test Pit one (TP-1) was excavated along the north exterior wall of the structure (photograph #13). TP-1 revealed a foundation embedment of at least 16 inches below grade.
2. Test Pit two (TP-2) was excavated along the south exterior wall of the garage (photograph #14). TP-2 revealed a foundation embedment of 16 inches below grade.
3. Current standard construction practices for this area call for a minimum depth of embedment of 12 inches.

13. Test pit one (TP-1), located along the north wall of the structure (shown on site plan map), revealed a total foundation embedment of at least 16 inches below grade.

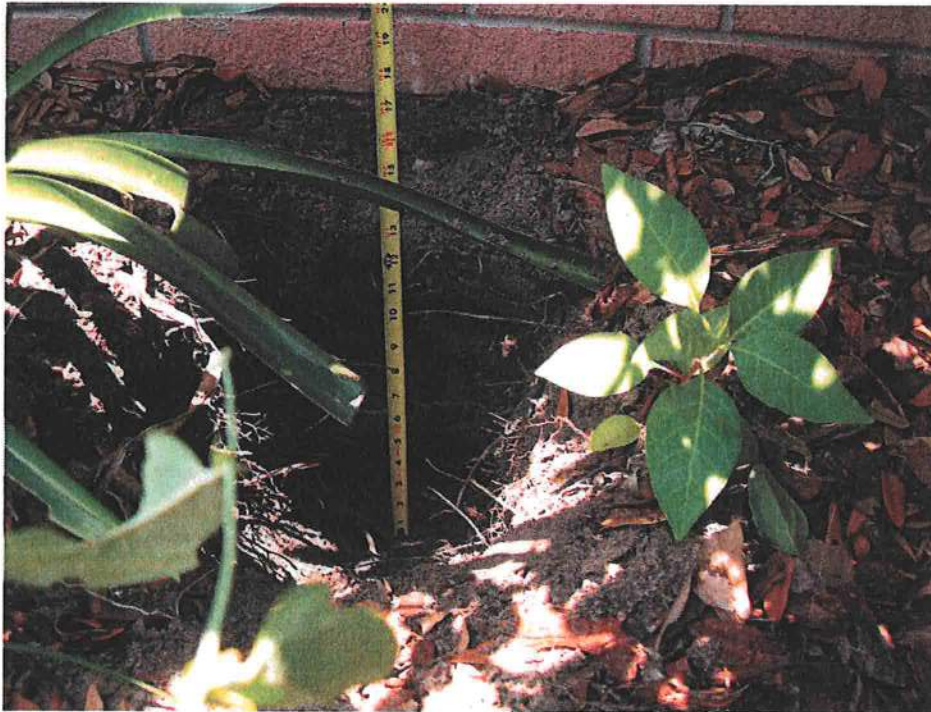
14. Test pit two (TP-2), located along the south wall of the garage (shown on site plan map), revealed a total foundation embedment of approximately 16 inches below grade.
