# Green Building Design

## Foundation Stabilization 410 SW Merciful Place Fort White, FL 32038

November 18, 2021

## Photos – 410 SW Merciful Place, Fort White, FL 32038

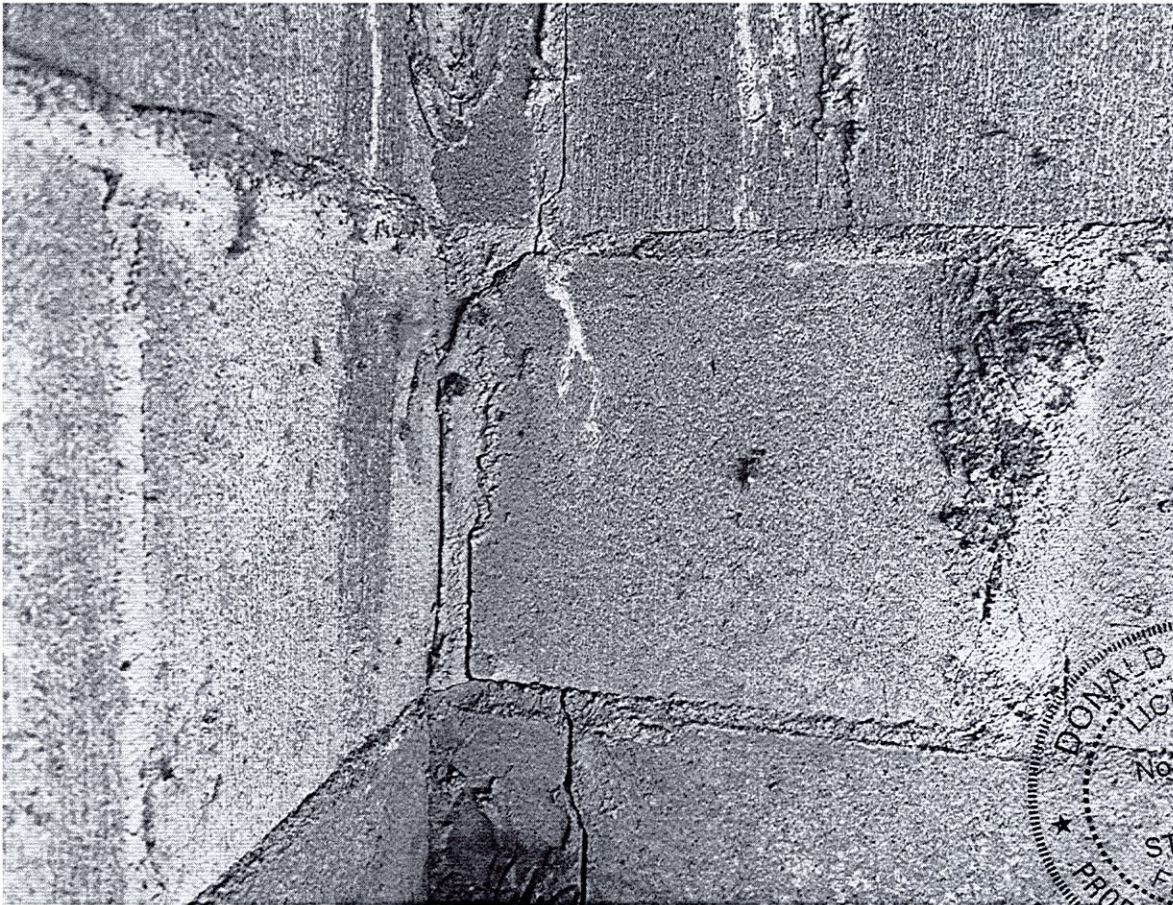
7. There are stairstep cracks in the concrete block stem wall, along the northeast corner of the home, due to settlement. (see photos)
8. Due to a recent kitchen remodel, an additional support beam was added running east/west under the kitchen approximately six feet from the north wall.

11. The cause of the settlement is unknown, but most likely due to a combination of soil erosion and decomposing organics in the supporting soil.

Stairstep cracks in concrete block stem wall as seen in crawl space, due to settlement.

12. Soil borings were not taken.
13. It is likely that the settlement will continue to occur unless the foundation is stabilized.
14. To stabilize the foundation, we recommend installing 1 three inch helical pier at the east end of the north wall, and 6 three inch helical piers along the north end of the east wall, for a total of 7 three inch helical piers. See attached sketch.
15. Each helical pier shall be up to 14 feet long using standard brackets and spaced a maximum of 7.0 feet as shown on the attached sketch.
16. Pier spacing may exceed 7.0 feet to avoid placement directly under a door or window or to avoid interference with an HVAC unit.
17. To reinforce the beam that was added to support the kitchen floor, we recommend using 2 SmartJacks as shown on the attached sketch.
18. The design is based on the Florida Building (Residential) Code, 7<sup>th</sup> Edition (2020).

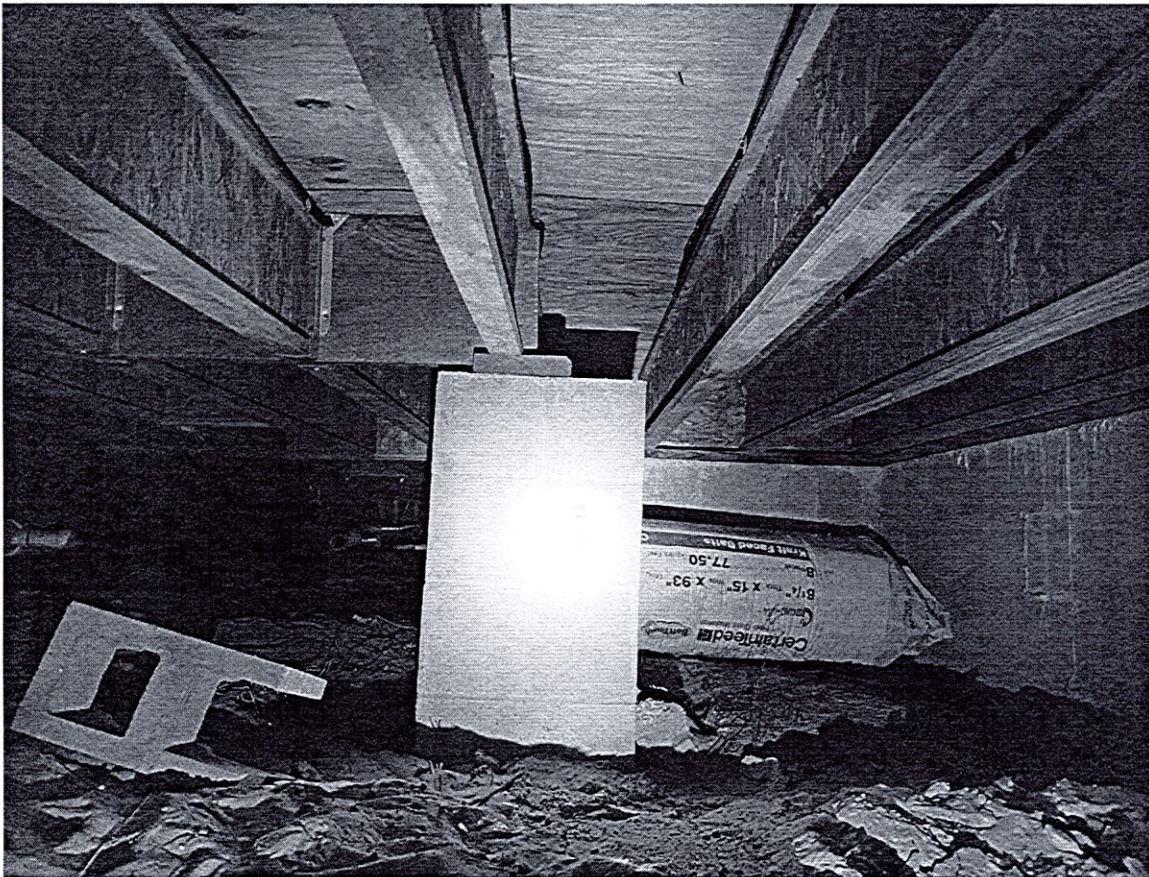
9. The concrete block piers supporting the new wood floor beam is inadequate (see photos) and must have additional support by using SmartJacks.
10. Measurements taken along the east wall of the home indicates settlement as much as 1.3 inches below the original finished floor.

Previously added support beam under kitchen used inappropriate concrete block piers.
