# Property Inspection Report Builders Trust Construction Co./Ameristar Home Inspections 11620 Hartman Road

# POOF CERTIFICATION

ROOF CERTIFICATION	
05/16/23	
Montavious Bryant	
LOCATION:	
4761 SW US C Lake City, Flor	ounty Road 242 ida
I have inspected the roof at the ab	ove referenced location and have found the following
General Roof Conditions	
Drainage	Good drainage
Physical Damage Attic Condition	none Good
Structural Deformation	none
Age of roof	2018
Sloped Roof	
<b>Location:</b> Item	<b>Garage Section of house</b> Remarks
Roof Material	25 year 3 tab shingles
Condition of Surface	Good
Deformed edges	None
Sloped Roof Continued	
Item	Remarks
Shingles Buckled	none

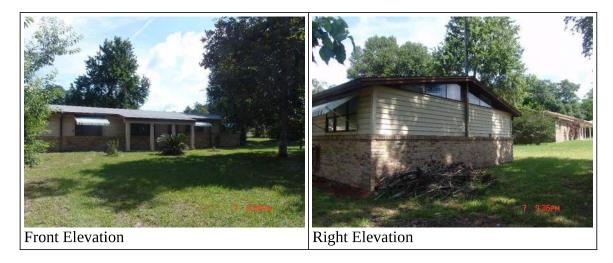
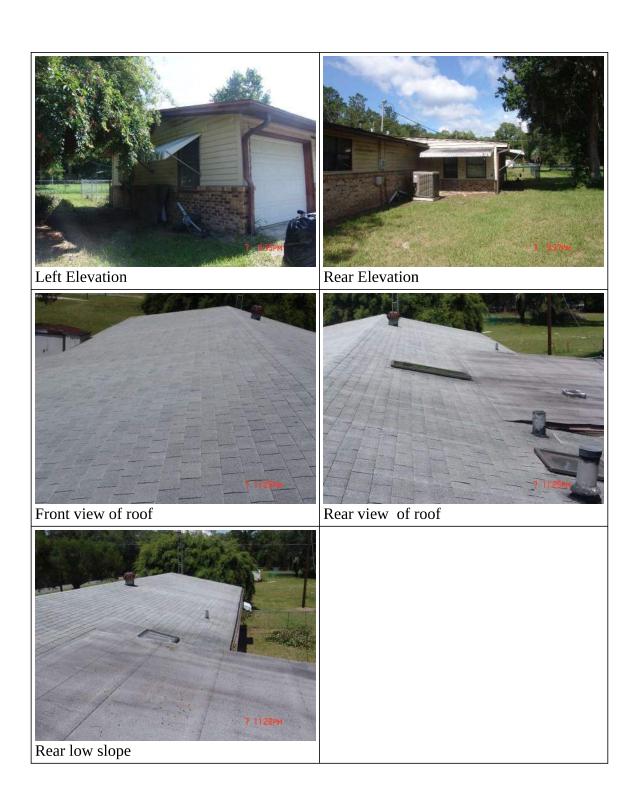
# Photos of roof:

The roof was installed in 2018. This was determined by reviewing the dates all of the other roofs in the neighborhood was completed. By looking at the roofs that are similar condition as this roof, I determined that this roof was completed in or near 2018. This will place the roof being replaced the same time the roofing companies were replacing the neighborhoods roofs. This is not an uncommon practice. The roof is in good sound condition with over 17+ years left.
