Truss Fabricator: Anderson Truss Company
Job Identification: REPAIR / 8-203 - ISAAC CONSTR
Truss Count: 6
Model Code: Florida Building Code 2004 and 2006 Supplement
Truss Criteria: FBC CODE/TPI-2002(STD)
Engineering Software: Alpine Software, Version 7.36.
Structural Engineer of Record: The identity of the structural EOR did not exist as of
Address: the seal date per section 61G15-31.003(5a) of the FAC
Minimum Design Loads: Roof - 40.0 PSF @ 1.25 Duration
Floor - N/A
Wind - 110 MPH ASCE 7-02 - Closed

#	Ref	Description	Drawing#	Date
1	19151--H7B	REPAIR	09076054	03/17/09
2	19151--H9B	REPAIR	09076055	03/17/09
3	19151--H11B	REPAIR	09077001	03/18/09
4	19151--H17B	REPAIR	09077004	03/18/09
5	19151--H13B	REPAIR	09077002	03/18/09
6	19151--H15B	REPAIR	09077003	03/18/09

TRUSS REPAIR

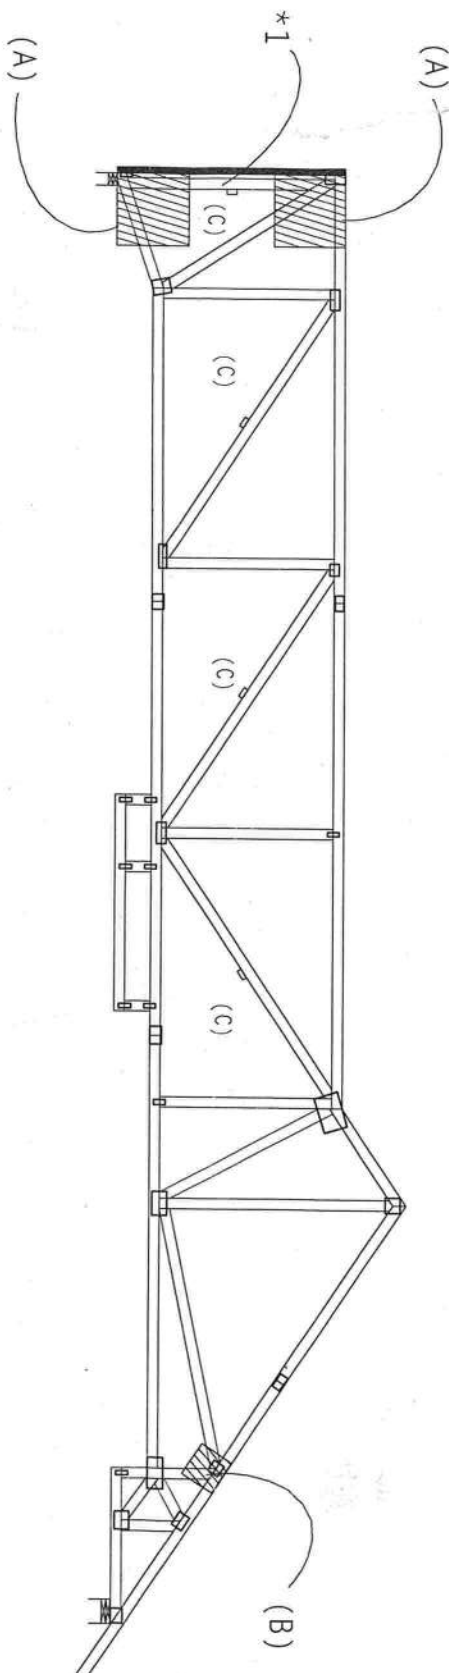
This truss is repaired stub 2" off left end of truss as shown.

++ 2" CUT OFF LEFT END

++USE A SHARP METAL CUTTING SAW BLADE TO CAREFULLY REMOVE MATERIAL FROM THE TRUSS AS SHOWN. REMAINING PORTIONS OF TRUSS AND ALPINE PLATES MUST BE FREE FROM DAMAGE AND FULLY EMBEDDED INTO TRUSS MEMBERS.

*1 (1) 2x4 SP #2 OR BETTER CUT TO FIT FIELD- INSTALLED MEMBER TO BE ADDED AS SHOWN INTO PLANE OF TRUSS. TOTAL OF (1) MEMBER(S) TO BE ADDED IN PLANE.

(2) 3/4" (NOM.) x (SIZE BELOW) APA 48/24 RATED SHEATHING (PLYWOOD OR OSB) GUSSETS REQUIRED. APPLY ONE GUSSET TO EACH FACE LOCATED AS SHOWN. AND ATTACH WITH (2) ROWS 0.093x2.0" (6d BOX) NAILS @ 3" OC, STAGGERED 1-1/2" WITHOUT SPLITTING LUMBER.

GUSSET
SIZE
(A) 2-0-0 x 2-0-0
(B) 1-0-0 x 1-0-0

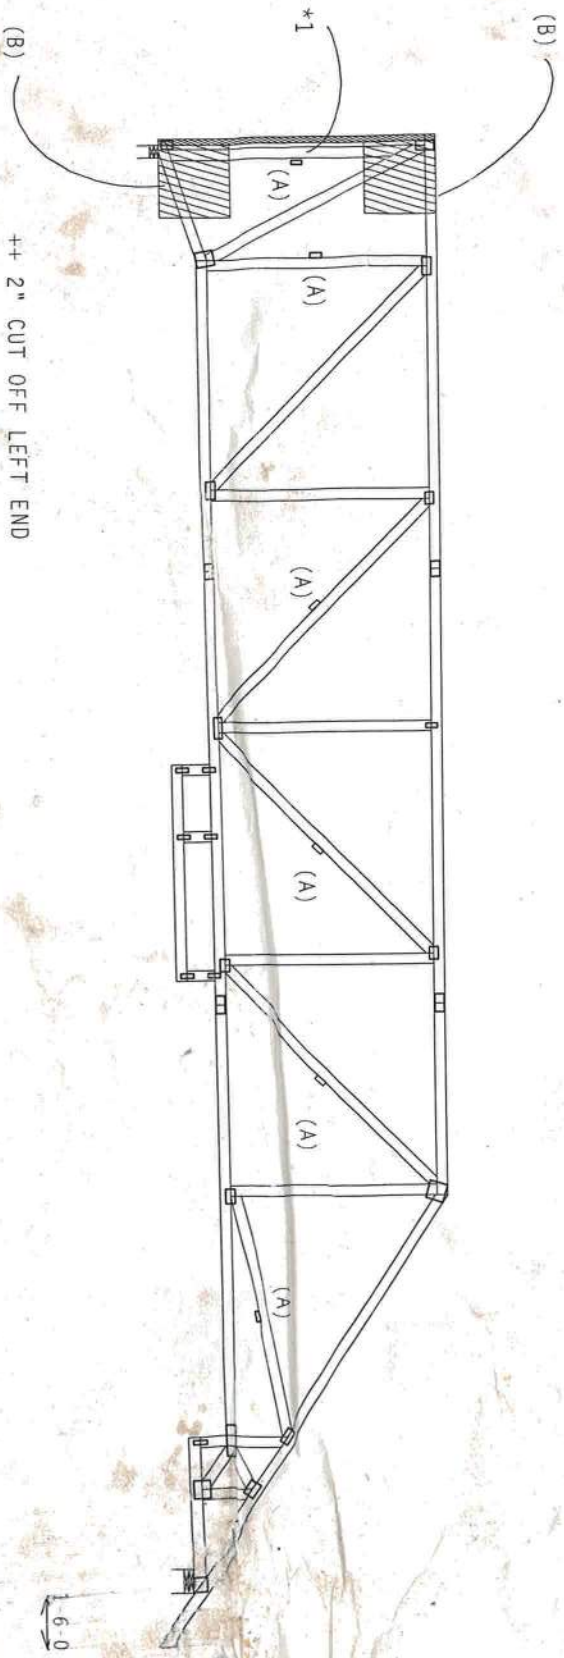
(8-203 - Isaac Construction Suresh Patel - ** H11B)
 This truss is repaired stub 2" off left end of truss as shown.

USE A SHARP METAL CUTTING SAW BLADE TO CAREFULLY REMOVE MATERIAL FROM THE TRUSS AS SHOWN. REMAINING PORTIONS OF TRUSS AND ALPINE PLATES MUST BE FREE FROM DAMAGE AND FULLY EMBEDDED INTO TRUSS MEMBERS.

*1 (1) 2x4 SP #2 OR BETTER CUT-TO-FIT FIELD-INSTALLED MEMBER TO BE ADDED AS SHOWN INTO PLANE OF TRUSS TOTAL OF (1) MEMBER(S) TO BE ADDED IN PLA

(B) (2) 3/4" (NOM.) x2-0-0 x2-0-0 APA 48/24 DIED SHEATHING (PLYWOOD OR OSB) GUSSETS REQUIRED. APPLY ONE GUSSET TO EACH FACE LOCATED AS SHOWN, AND ATTACH WITH (2) ROWS 0.099x2.0" (6d 80X) NAILS AT 3" O.C. STAGGERED 1-1/2" AND STAGGER ROWS OF NAILS 1" FROM FACE TO FACE WITHOUT SPLITTING LUMBER NOTE: GUSSET MAY BE TRIMMED TO FIT TRUSS PROFILE.

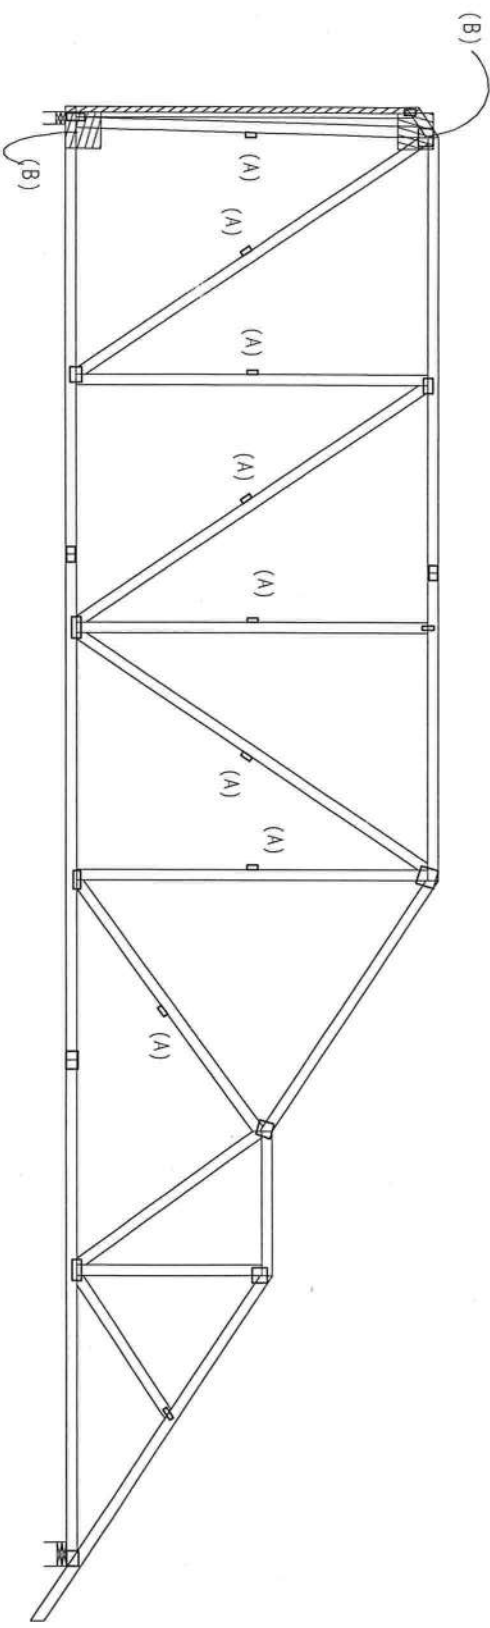
This truss is repaired stub 2" off left end of truss as shown.

0-2'-0" ++ 2" CUT OFF LEFT END

++USE A SHARP METAL CUTTING SAW BLADE TO CAREFULLY REMOVE MATERIAL FROM THE TRUSS AS SHOWN. REMAINING PORTIONS OF TRUSS AND ALPINE PLATES MUST BE FREE FROM DAMAGE AND FULLY EMBEDDED INTO TRUSS MEMBERS.

(B) (2) 1/2" (NOM.) x 1-0-0 x 1-0-0 APA 2415 RATED SHEATHING (PLYWOOD OR OSB) GUSSETS REQUIRED ONE GUSSET TO EACH FACE LOCATED AS SHOWN, AND ATTACH WITH 0.099x2.0" (6d BOX) NAILS AT 2" O.C. STAGGERED THROUGHOUT AND STAGGER ROWS OF NAILS 1" FROM FACE TO FACE WITHOUT SPLITTING LUMBER. NOTE: GUSSET MAY BE TRIMMED TO FIT TRUSS PROFILE.

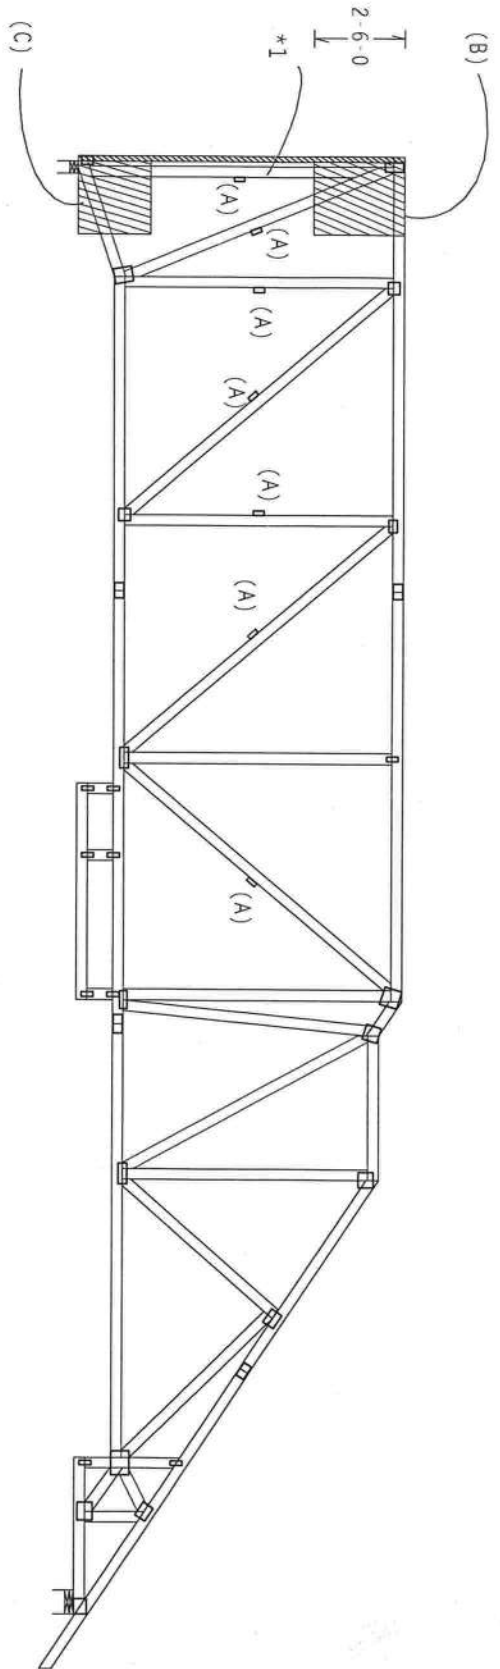
This truss is repaired stub 2" off left end of truss as shown.

++ 2" CUT OFF LEFT END

++USE A SHARP METAL CUTTING SAW BLADE TO CAREFULLY REMOVE MATERIAL FROM THE TRUSS AS SHOWN. REMAINING PORTIONS OF TRUSS AND ALPINE PLATES MUST BE FREE FROM DAMAGE AND FULLY EMBEDDED INTO TRUSS MEMBERS.

*1 (1)2x4 SP #2 OR BETTER CUT-TO-FIT FIELD-INSTALLED MEMBER TO BE ADDED AS SHOWN INTO PLANE OF TRUSS. TOTAL OF (1) MEMBER(S) TO BE ADDED IN PLANE.

(2) 1/2" (NOM.) X (SIZE BELOW) APA 32/16 RATED SHEATHING (PLYWOOD OR OSB) GUSSETS REQUIRED. APPLY ONE GUSSET TO EACH FACE LOCATED AS SHOWN, AND ATTACH WITH (2) ROWS 0.099x2.0" (6d BOX) NAILS @ 3" OC, STAGGERED 1-1/2" WITHOUT SPLITTING LUMBER.

GUSSET SIZE
(B) 2-0-0 X 2-6-0
(C) 2-0-0 X 2-0-0

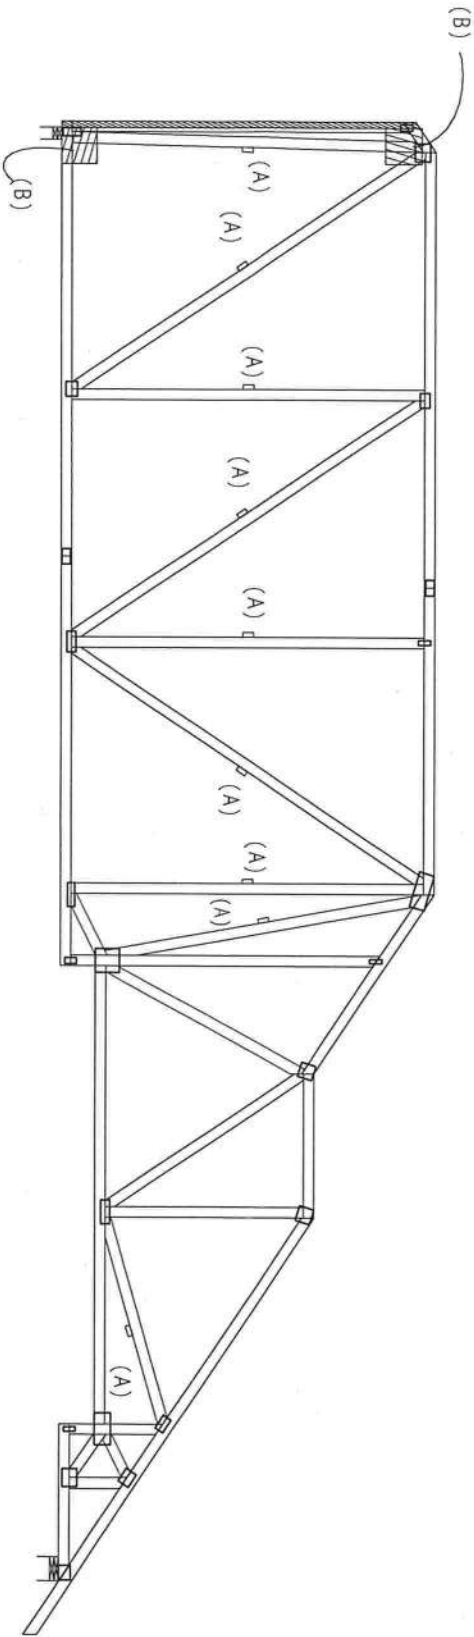
This truss is repaired stud 2" off left end of truss as shown.

++ 2" CUT OFF LEFT END

++USE A SHARP METAL CUTTING SAW BLADE TO CAREFULLY REMOVE MATERIAL FROM THE TRUSS AS SHOWN. REMAINING PORTIONS OF TRUSS AND ALPINE PLATES MUST BE FREE FROM DAMAGE AND FULLY EMBEDDED INTO TRUSS MEMBERS.

(B) (2) 1/2" (NOM.) x1-0-0 x1-0-0 APA 32/16 RATED SHEATHING (PLYWOOD OR OSB) GUSSETS REQUIRED. APPLY ONE GUSSET TO EACH FACE LOCATED AS SHOWN, AND ATTACH WITH 0.099x2-0" (6d BOX) NAILS AT 2" O.C. STAGGERED THROUGHOUT AND STAGGER ROWS OF NAILS 1" FROM FACE TO FACE WITHOUT SPLITTING LUMBER
NOTE: GUSSET MAY BE TRIMMED TO FIT TRUSS PROFILE.
