WELDTEST SERVICES

United States Cold Storage

Report No.: 260-23

Type of Inspection:

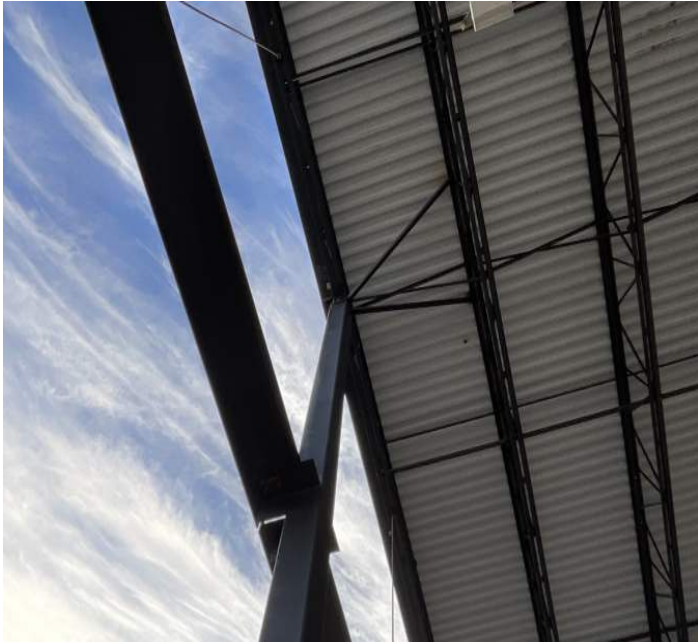
Girder stabilizer plates were welded where required at the braced frame connections. The welded opposed to bolted slip connection at 23/K5 has been repaired and installed in accordance with the drawing requirements. Several anchor bolts are still not tightened. Areas where plate washers were installed were completed in all locations. Loose base plate connections only exist in locations where standard washers are installed.

**Slip connection completed at
23/K5**

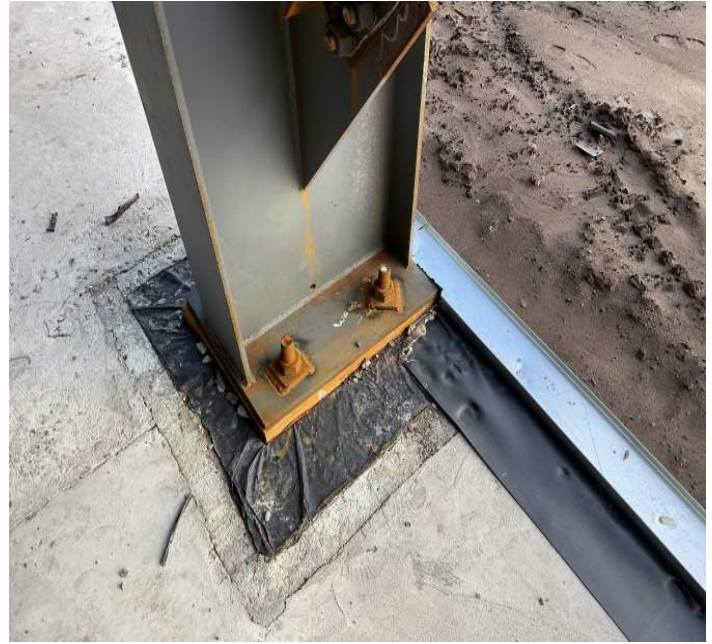
**Missing plate washer weld completed
along Line 23**

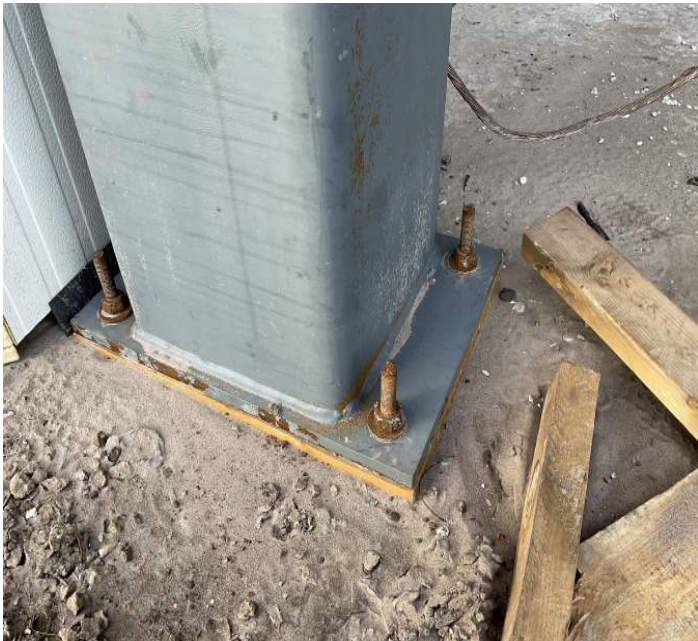
**Loose washers in several locations
at column base plates**

- Tighten column base plate anchors. These are loose in several locations
- Marr threads on Sag Rods per Detail2/E301A
- Completion of the entrance structure at 23.1/H.8
- TC bolts at braced frame connections behind the South Catwalk

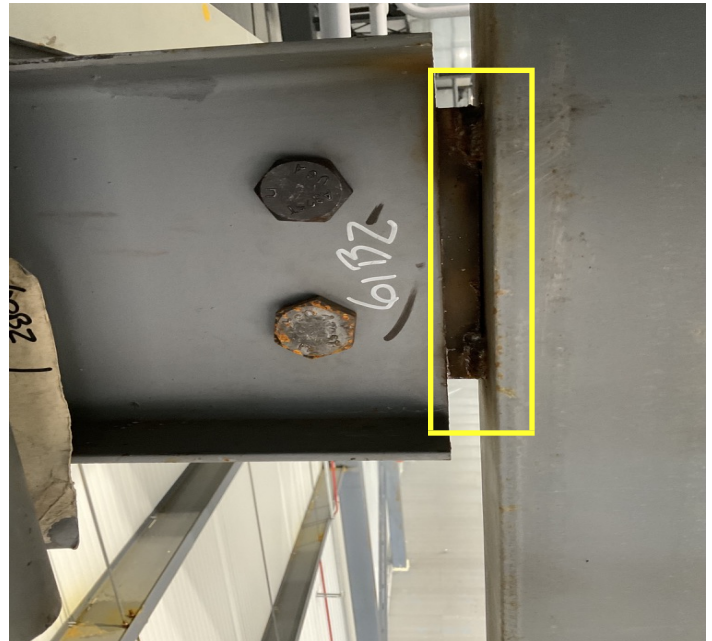
Follow up inspection of previously noted deficiencies was performed on 12/22/23 as well as in process inspection of the North and South Catwalks. The North and South Catwalks were not fully completed at time of inspection. Several locations were only tack welded. Primarily at the South Catwalk. Note: TC bolts at the braced frame connection behind the South Catwalk were not completed.

Connections at cat walk supports only tacked

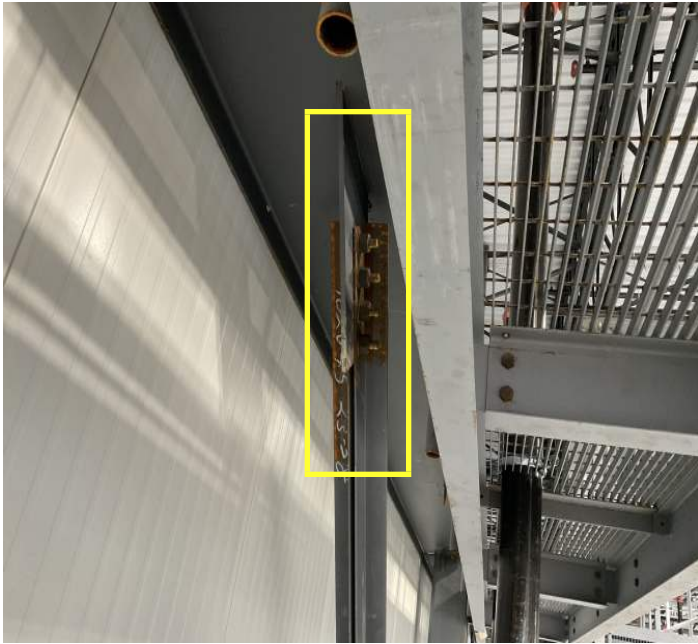
TC Bolts behind cat walk at braced frames along Line H.8 not completed

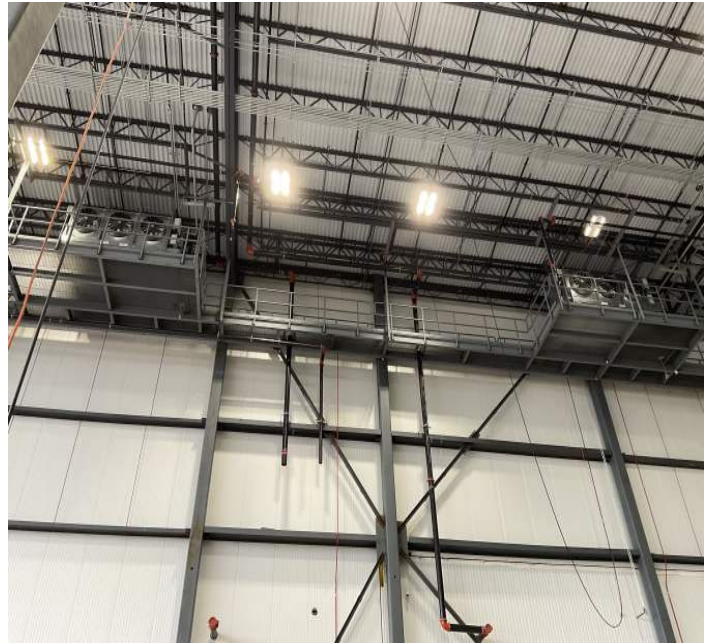
Several missing welds along South cat walk

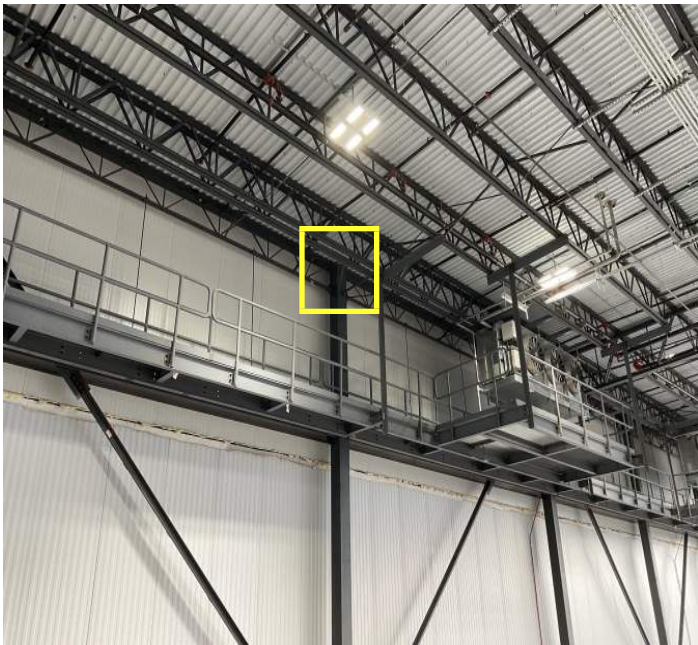
Girder bottom chords welded where required
