TRUSS REPAIRED TO REMOVE SECTION OF WEBS

REFER TO DRAWING HCUSR9114 12354180 FOR ORIGINAL DESIGN FOR LUMBER, PLATES, AND OTHER DATA NOT LISTED HERE.

TRUSS REPAIR

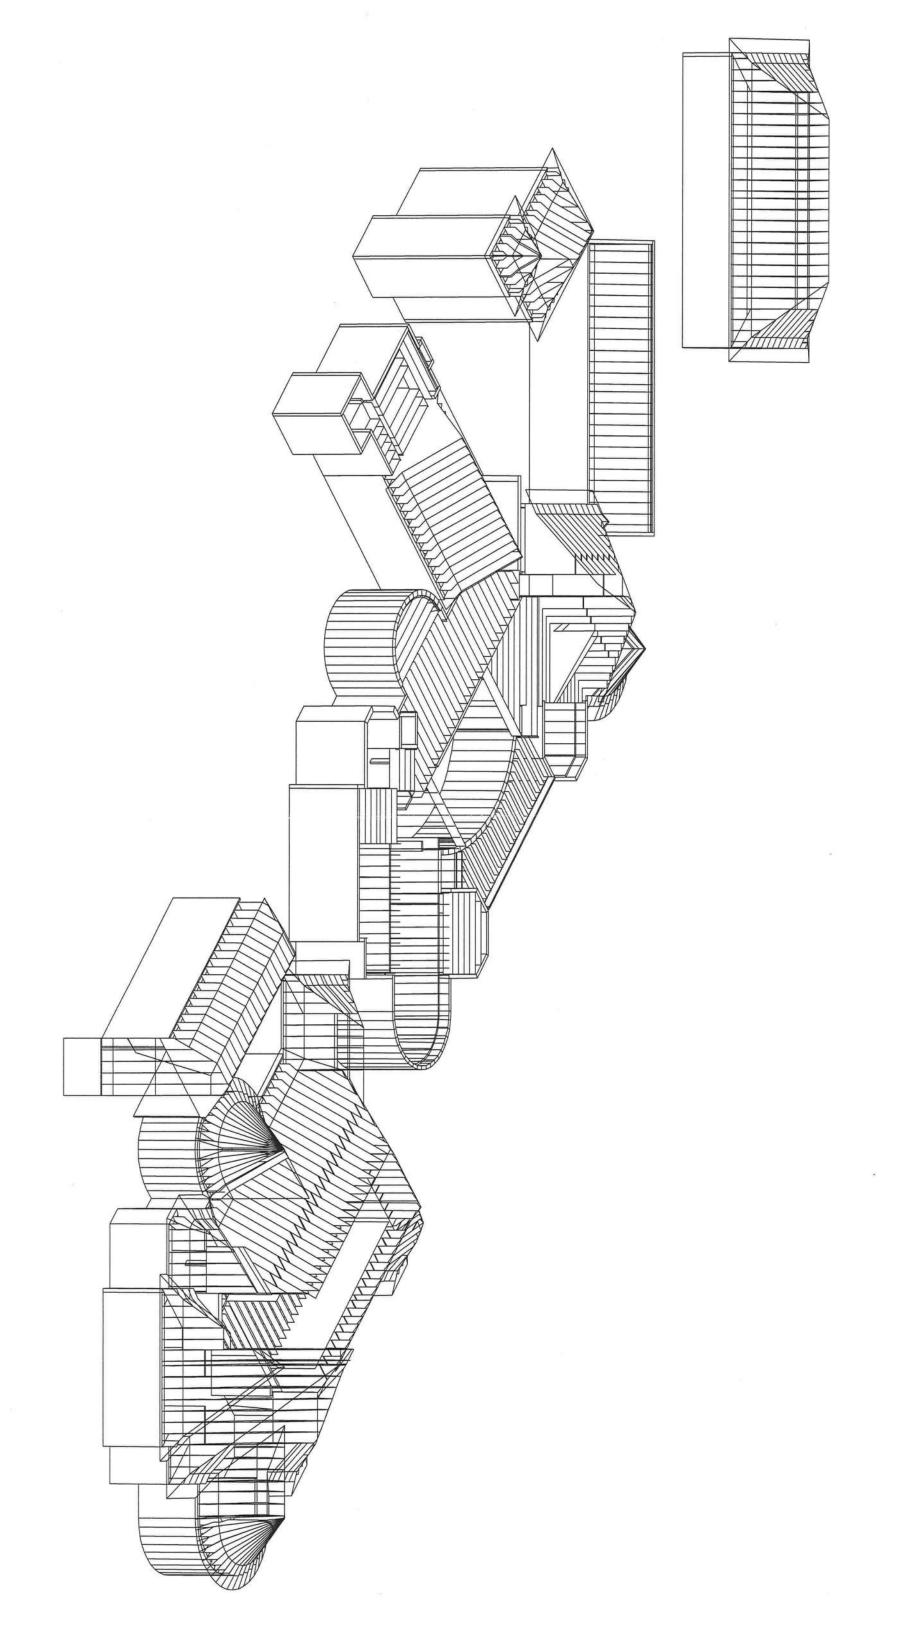
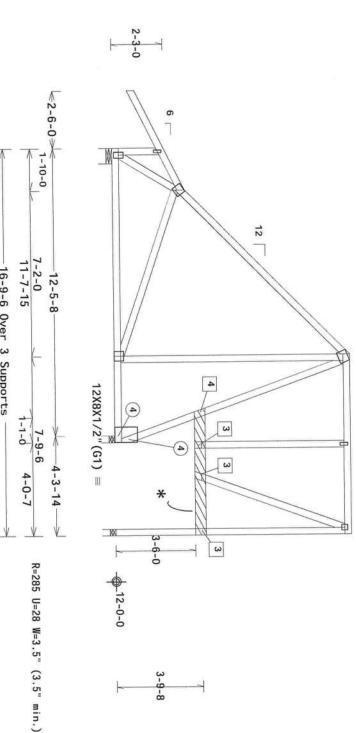
REPORTED BY THE TRUSS MANUFACTURER TO HAVE BEEN DAMAGED. A QUALIFIED THIRD PARTY INSPECTOR SHALL CHECK TRUSSES TO DETERMINE THE EXTENT OF ANY FURTHER DAMAGE. IF ANY. AND VERIFY THAT REPAIRS HAVE BEEN PERFORMED AS INDICATED ON THIS DRAWING. REPAIR WORK SHOWN ON THIS DRAWING APPLIES ONLY TO THOSE SECTIONS OF THE TRUSS

(1) 2x6x(CUT TO FIT) SP #2 OR OR BETTER SCAB. ATTACH ONE SCAB TO ONE FACE OF TRUSS WITH CLUSTERS OF 0.131"X3" GUN NAILS AS SHOWN BY 'SQUARED' NUMBER.

Minimum Nail/Screw Spacing Requirements Based on ANSI/AF&PA NDS-2001:
End Distance 1-3/4"
Edge Distance 5/8"
Spacing Between Rows 5/8"
Spacing in a Row 1-3/4" (G1) Gusset Plates are 1/2" APA STRUCTURAL I RATED SHEATHING, 32/16, EXP 1. Apply gusset to each face of truss and attach with evenly distributed 0.113"x2.0" Nails specified in circles. Hatched lines Spacing Between Rows 5/8" Spacing in a Row 1-3/4" Maximum Number of Rows for Member Size:
