Green Building Design

Foundation Stabilization 410 SW Merciful Place Fort White, FL 32038

November 18, 2021

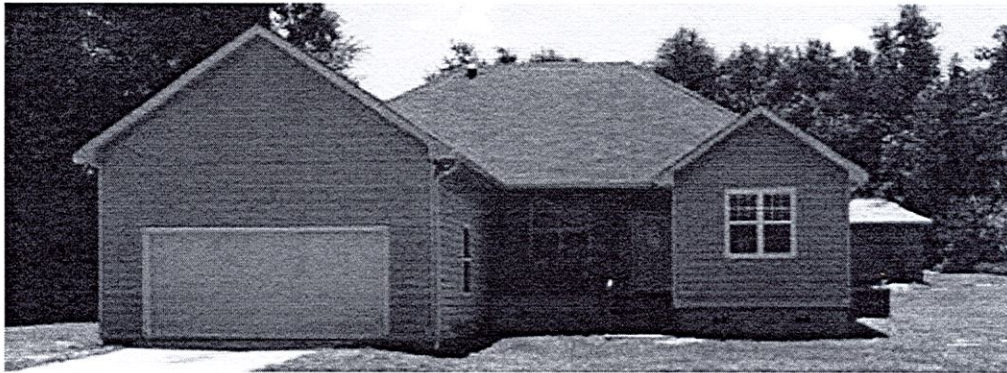
Front of house looking south.
