WELDTEST SERVICES

United States Cold Storage

Report No.: 233-23

Type of Inspection:

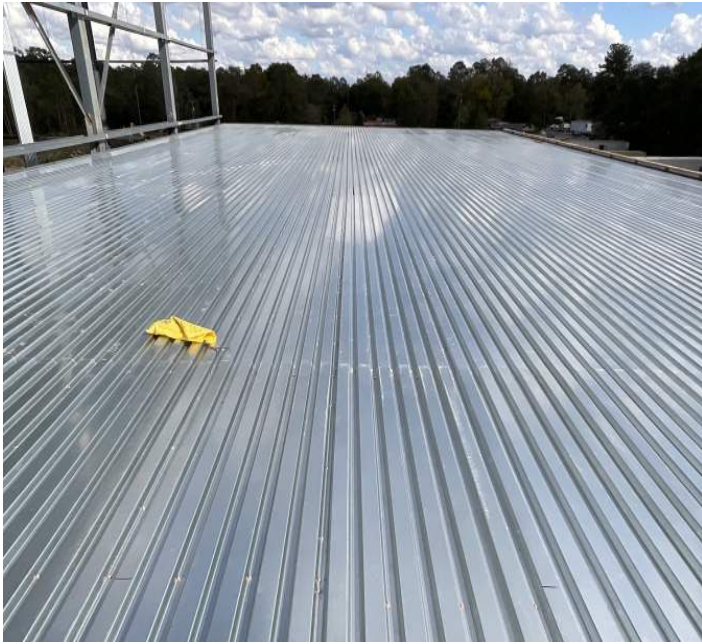
Low roof completed

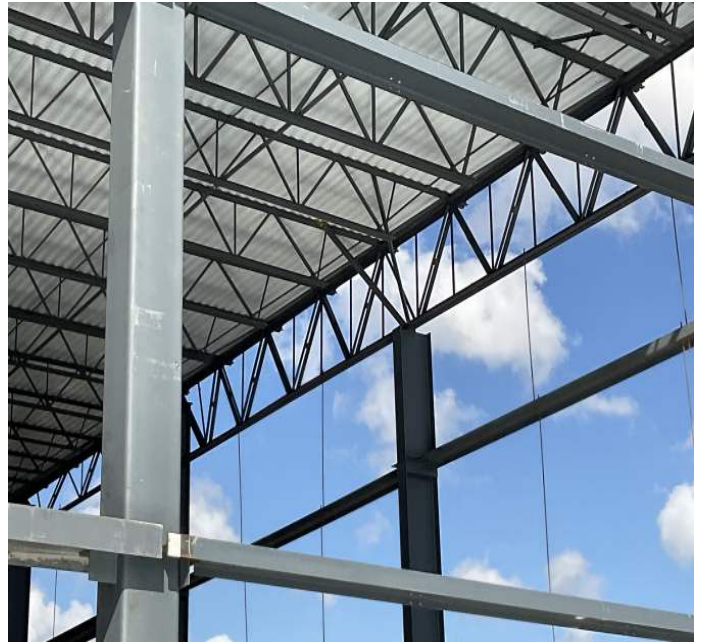
Angle kickers in process

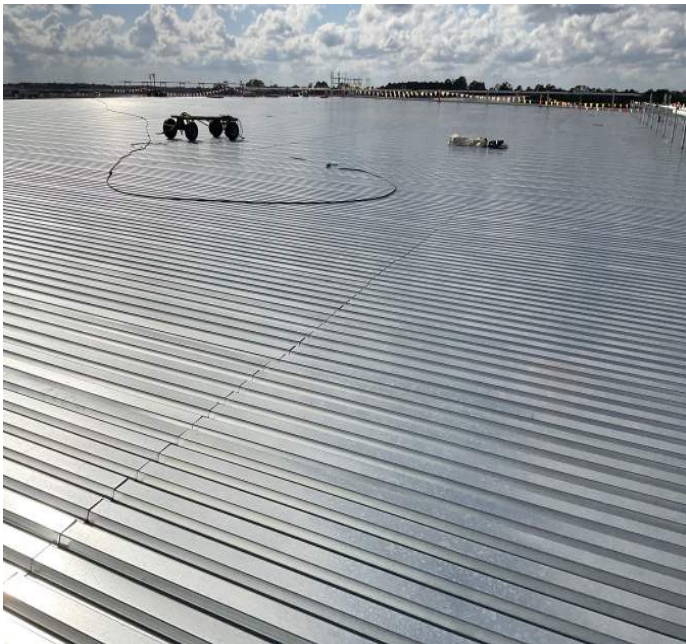
Missing pins and side lap fasteners completed at the roof level

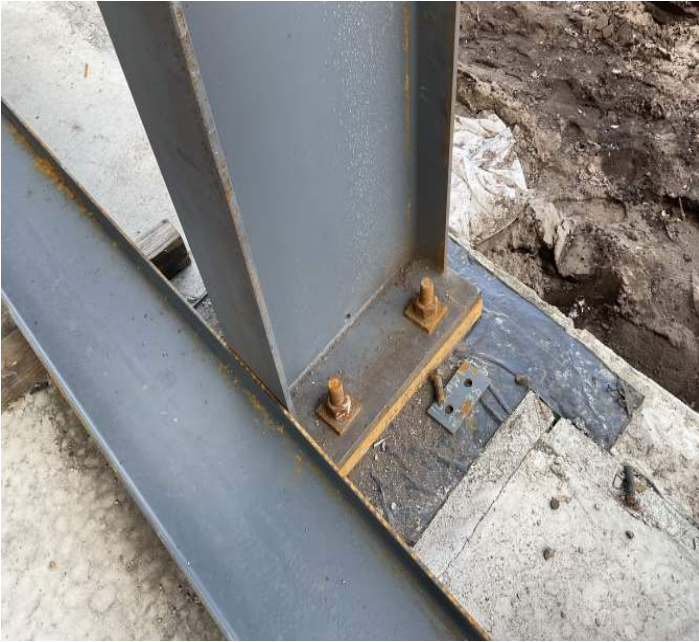
Plate washers not welded along Line 23

- Tighten column base plate anchors. These are loose in several locations
- Weld plate washers at braced frame locations along Line 23
- Completion of TC bolts at braced frame connections
- Weld girder stabilizer plates at braced frames
- Mar threads on Sag Rods per Detail 2/E301A
- RFI for welded connection opposed to slotted connection at 23/K5

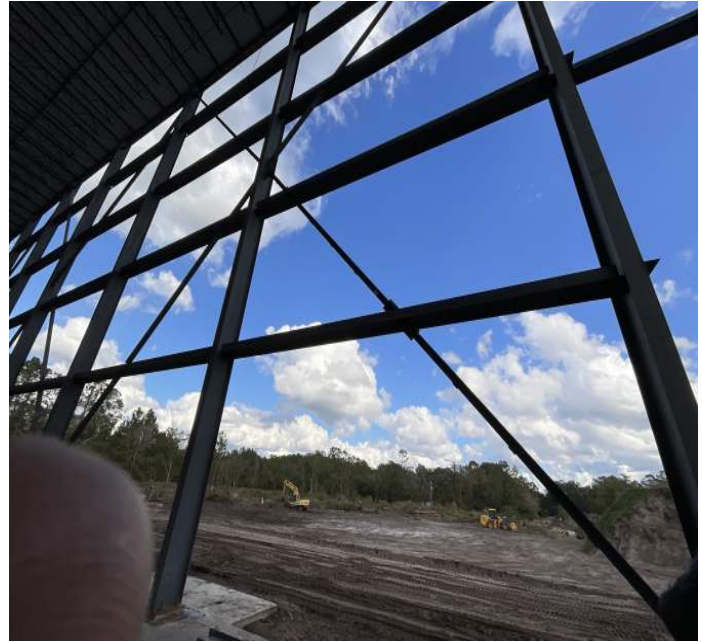
TC bolt splines not severed at braced frame connections

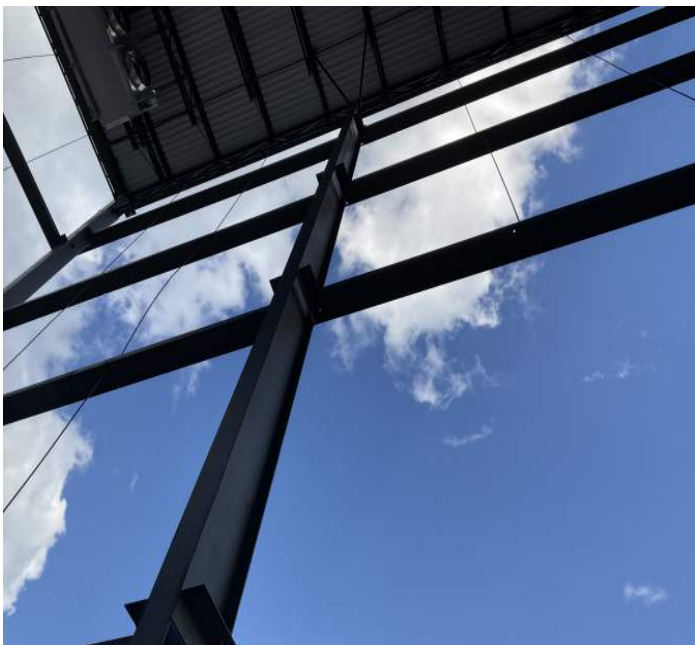
Completed perimeter wind beams along Line 23

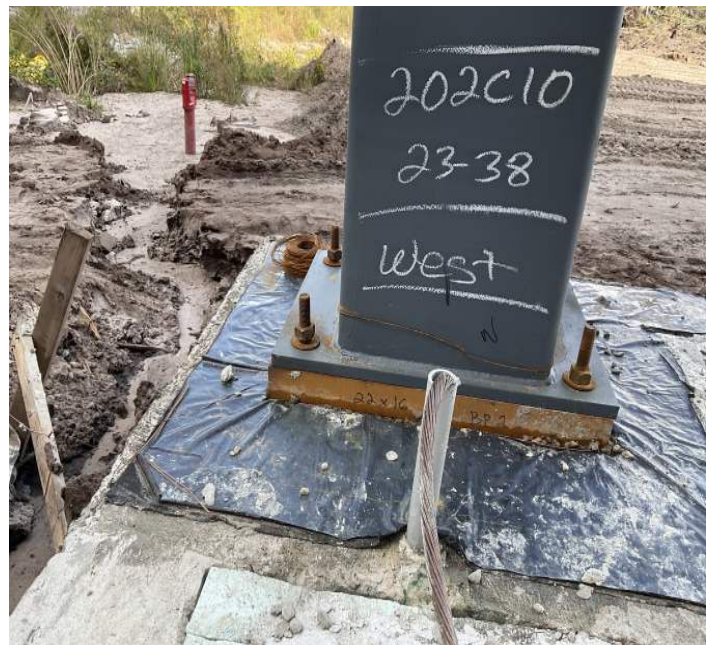
Loose bolts at column base plates
