THIS REPAIR IS APPLICABLE TO DRG. # T06080472-A1.

Robbins Engineering, Inc./Online Plus™

Job	Mark	Quan	Type	Span	P1-H1	Left OH	Right OH	Single Drawing
SAACC-CATO	A1-FXUG	1	SP	481100	8	0	1 - 6 - 0	T06080472

ATTACHED IS THE REPAIR FOR THE CATO JOB. I WILL SEND THE FINGER SCAB FOR THE A1 TRUSS OVER TO THE JOB SITE ON MONDAY. THE A3 TRUSS DOES NOT REQUIRE A REPAIR. THE RAISED SEALS FOR THIS REPAIR SHOULD BE DELIVERED TO ME ON MONDAY OR TUESDAY. IF YOU HAVE ANY QUESTIONS, CALL ME.

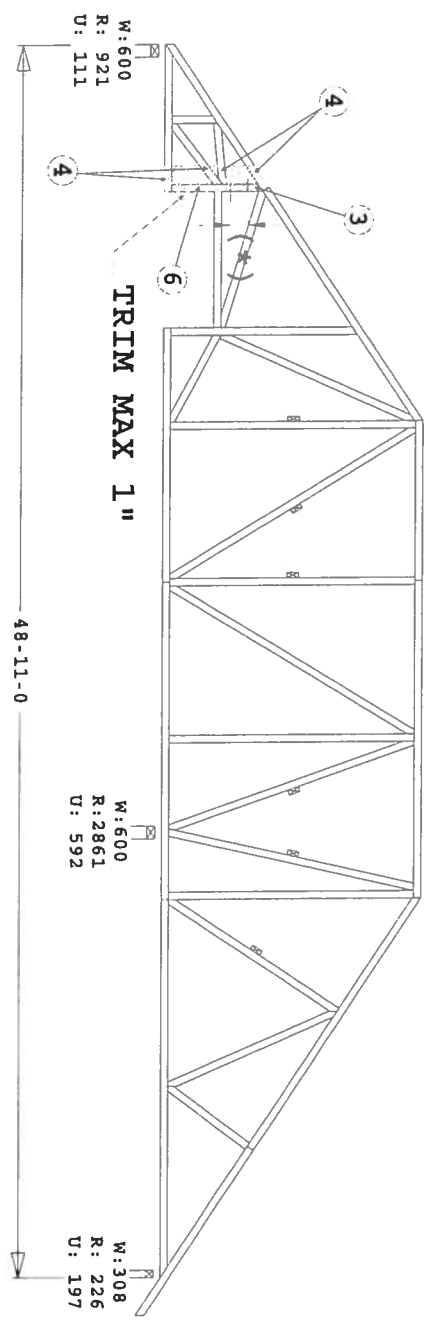
REPAIR PROBLEM:

PORTION OF VERTICAL MEMBER BROKEN OUT WHERE SHOWN (*).

NEED TO TRIM THE VERTICAL MEMBER 1" OFF WHERE SHOWN DASHED.

REPAIR SOLUTION:

APPLY ALL FASTENERS SO AS TO AVOID DAMAGING OF LUMBER AND LOOSENING OF PLATES AT JOINTS.

ATTACH 2X12 SP#2 SCAB (SHADED), TO ONE FACE OF TRUSS USING CLUSTERS OF 10d COMMON NAILS.

TO UNDAMAGED PORTION OF TRUSS WHERE SHOWN CIRCLED.

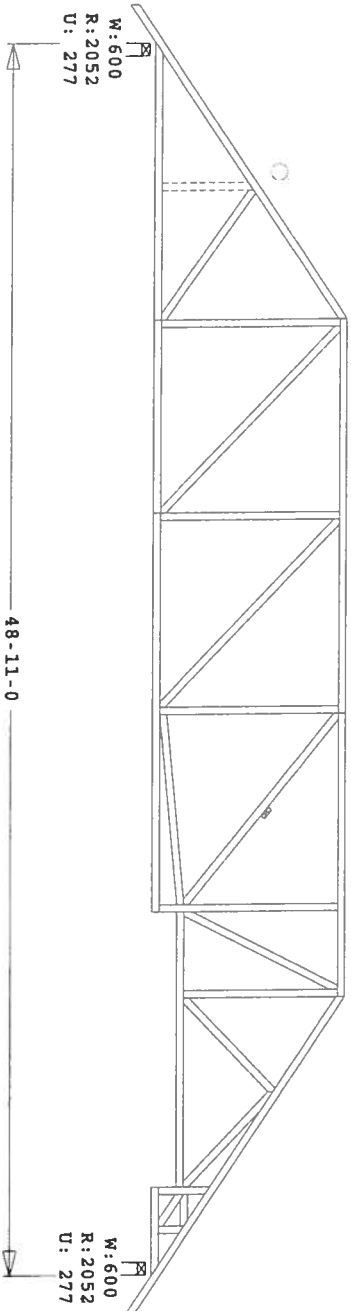
REPAIR PROBLEM: CRITICAL MEMBER BROKEN OUT WHERE SHOWN DASHED.

TOP CHORD PLATE IS INTACT AND FULLY EMBEDDED INTO DIAGONAL WEB.

NO REPAIR IS NEEDED.

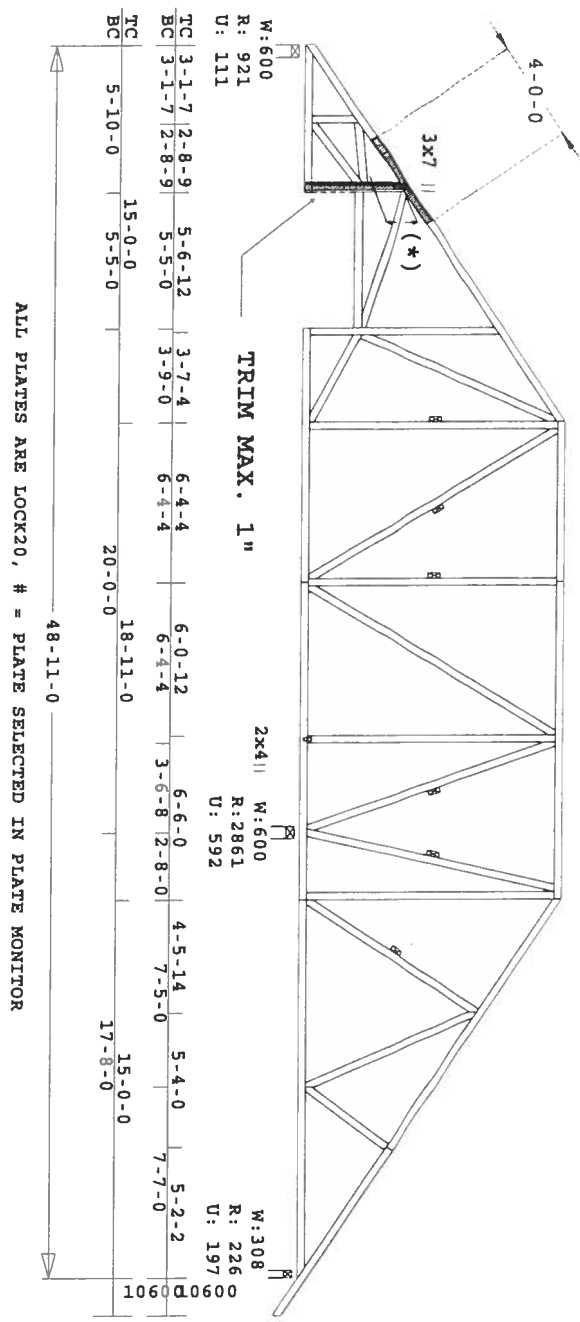
REPAIR PROBLEM:
 PORTION OF VERTICAL MEMBER BROKEN OUT WHERE SHOWN (*).
 NEED TO TRIM THE VERTICAL MEMBER 1" OFF SHOWN DASHED.

REPAIR SOLUTION:
 APPLY ALL FASTENERS SO AS TO AVOID DAMAGING OF LUMBER AND LOOSENING OF PLATES AT JOINTS.
 FABRICATE FINGER-SCAB (SHADED) USING LUMBER AND PLATES SPECIFIED AND ATTACH TO ONE FACE OF
 TRUSSES USING 2 ROWS OF 10d COMMON NAILS AT 3" ON CENTER EACH ROW AND STAGGERED INTO UNDAIMAGED
 LUMBER.

NGER SCAB MEMBERS:
 CP 2x4 SP#2
 EB 2x4 SP#2
