For Office Use Only Applica	ition # 0907-15 Date Received	7-10-09 By 4 Permit # 27947
Zoning Official 61	Date 4-07.09 Flood Zone	Land Use RES In Devzoning RSF-2
FEMA Map # AVIA_ Eleva	tionMA MFEVA RiverV	Plans Examiner Date 7 (3/04
Comments Dwater Signat	use on Application	
NOC EH Deed or PA	Site Plan State Road of Parent P	arcel #
Dev Permit #	In Floodway / Letter of Auth. fro	om Contractor AF W Comp. letter
IMPACT FEES: EMS	FireCorr	Road/Code
School	= TOTAL

CLAIM No. 59-D215-335 HENDRICKSON RESIDENCE LAKE CITY, COLUMBIA COUNTY, FLORIDA GSE PROJECT No. 10314

Completion Report of Underpinning Remediation Hendrickson Residence – Lake City, Florida Claim No. 59-D215-335 SDII Project No. 3020180B

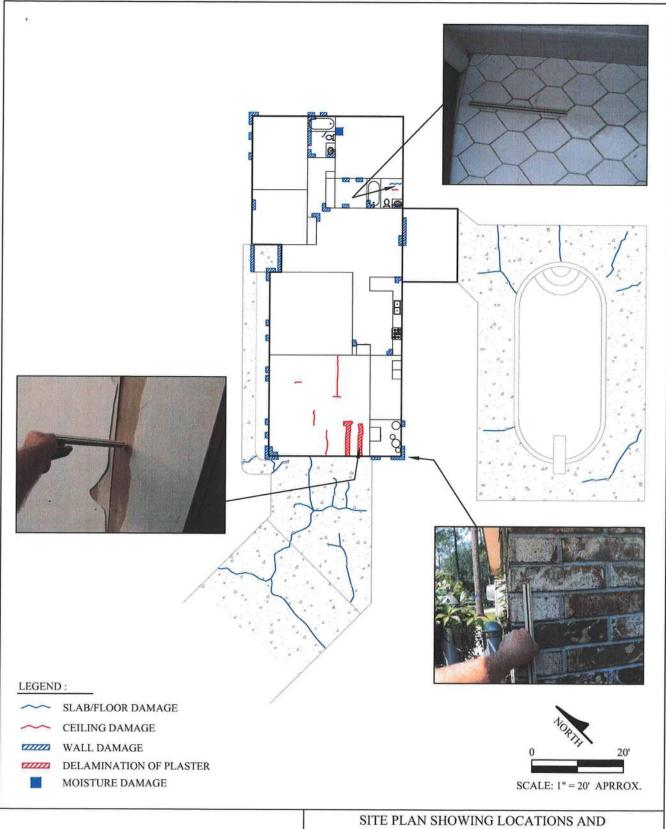
REPRESENTATIVE PHOTOGRAPHS OF DAMAGE

Cracking damage was noted on both the interior and exterior of the home. Figure 2 illustrates the overall layout and observed representative damage to the interior and exterior of the home.

between walls and adjoining sinks, bathtubs, and cabinets, and separations between the ceiling and wall joints. These cracks and separations are generally hairline to less than 1/16-inch wide. Along with the cracking damage within the interior of home, some of the doors and windows appeared out-of-square and were difficult to open.

Cracking damage to the exterior of the residence generally consists of cracks in the exterior walls through the bricks and mortar ranging from hairline to less than 1/16-inch wide. Some of these cracks have a stair-step type pattern.

Damage on the exterior of the home also consisted of cracks in the concrete pool deck, driveway, and walkway. The widths of the cracks ranged from approximately 1/16-inch to less than 1/8inch.

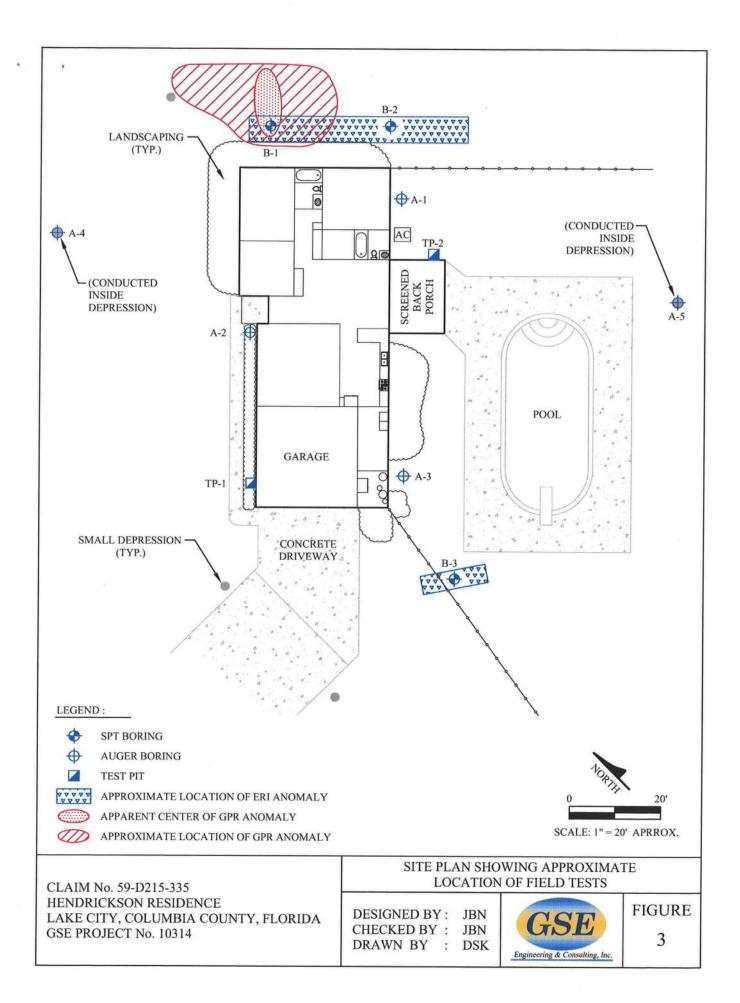
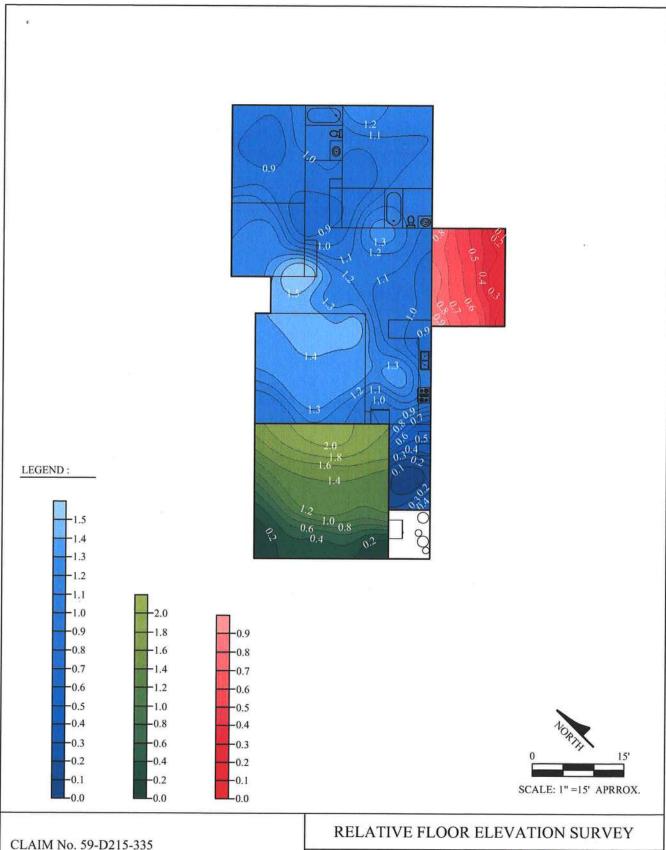
Two test pits were manually excavated at the residence in order to observe the foundation type, measure its dimensions and confirm the embedment depth. The location of the test pits are indicated on Figure 3.

In addition, the GPR data identified a linear feature within the GPR anomaly area at a depth range of 2 to 3 ft (Figure 3). This linear feature is most likely associated with buried debris (i.e. buried tree/root). No near-surface soil disturbances were observed directly below any of the small surface depressions located throughout the survey area.

Two test pits were excavated at the site to determine the foundation type and embedment depth. Figure 3 indicates the test pit locations.

TP-1 indicates the foundation of the home consists of a stem wall placed on a continuous shallow foundation. The top of the foundation was encountered 8.5 inches bls. The foundation extended out from the stem wall 3 inches with a thickness of 7.5 inches. The test pit indicates the foundation consists of a 7.5 inch thick continuous foundation embedded about 16 inches, with an overall width of 14 inches.

TP-2 was performed at the rear porch and the foundation was determined to be a monolithic thickened edge foundation. The top of the slab was approximately one inch below the ground surface and the foundation thickness was approximately 5.5 inches, indicating an embedment depth of 6.5 inches.

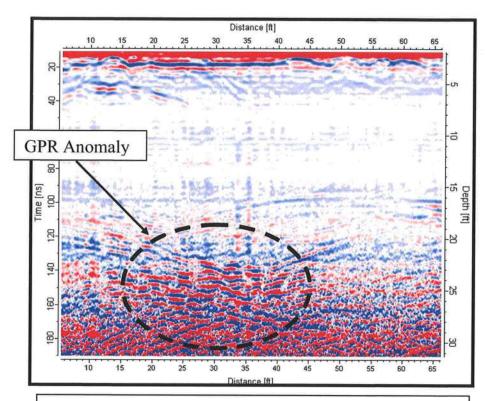
GPR Transect 3 Showing Example of GPR Anomaly

One GPR anomaly area was identified north of the residence. The anomaly is semi-elliptical in shape with a total area of approximately 540 square ft. The apparent vertical relief of the upper portion of the anomaly area is 4 to 5 ft as characterized by the observed downwarping of the lower GPR reflector set. The apparent center of the feature is characterized as the area of maximum downwarping of the previously referenced GPR reflectors. It is noted that no disruption to the sediments overlying the downwarped GPR reflector was observed. This suggests that the GPR anomaly is likely associated with relic depositional or erosion activity, rather than possible karst activity.

An ERI anomaly was identified in the area of the GPR Anomaly, but no GPR anomaly was identified within the southern ERI anomaly. Accordingly, the area with two corresponding geophysical anomalies has the greatest probability for being associated with karst activity, rather than being a result of the modeling process of suspect ERI data. However, the lack of any indications of downwarping or other observed soil disturbances in the GPR data overlying these anomaly areas suggests that these anomalies are more likely relic depositional features, rather than possible karst activity.
