WELDTEST SERVICES

United States Cold Storage

Report No.: 247-23

Visual Inspection (VT) of welded joints per AWS D1.1-2020 Structural Welding Code - Steel, Clause 8, Table 8.1 and Drawings supplied by Stellar Construction.

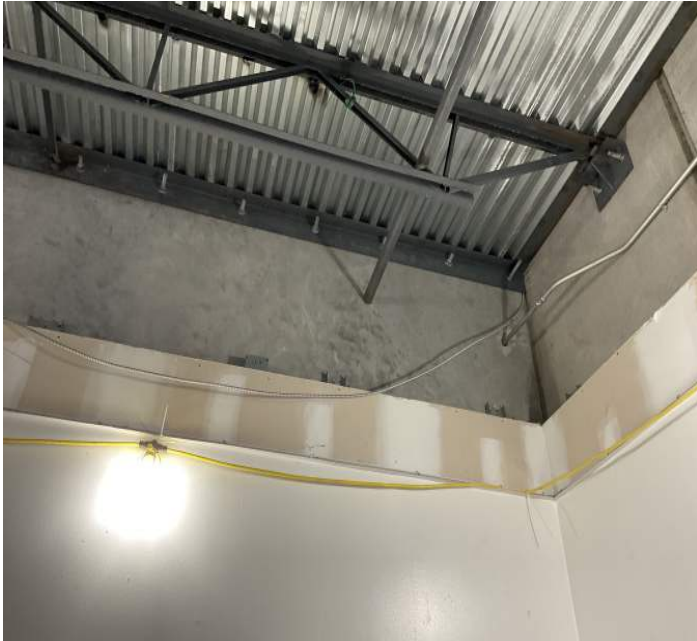
Follow up inspection of previously noted deficiencies was performed on 12/8/23. The Mezzanine Deck of the Break Room was inspected as well. Note: Bridging terminations were not attached to the end walls.

**Bridging not anchored
in Breakroom Area**

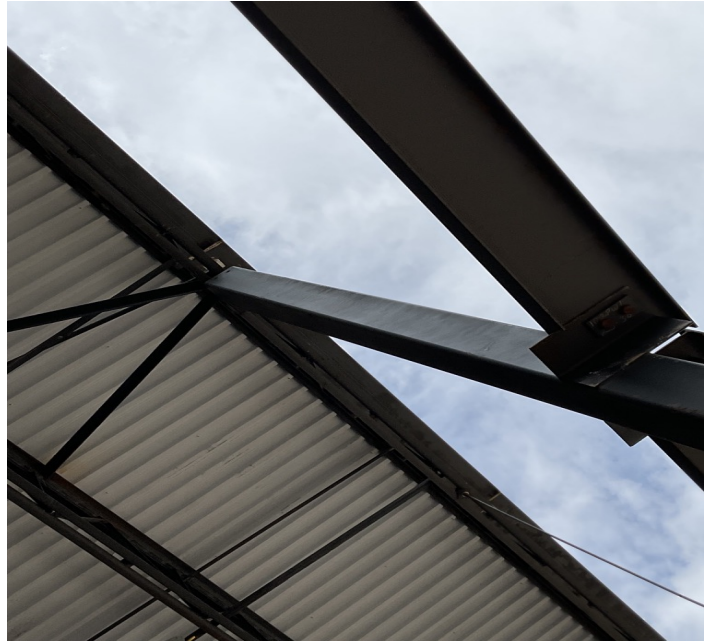
Threads of the Sag Rods have not been "marred" as required as of 12/8/23 inspection. The slip connection at location 23/K5 at the roof level is welded. Detail 5/E301B requires this connection to allow for movement by tack welding the nuts to the bolts inside slotted connections. An RFI will be required to determine if the welded connection is acceptable or if repair is necessary. This RFI has not yet been submitted. Nuts are not tack welded to the bolts in the other locations of the building where slotted connections are required. See list of remaining deficiencies below.

**Slip connection at 23/K5
not completed**

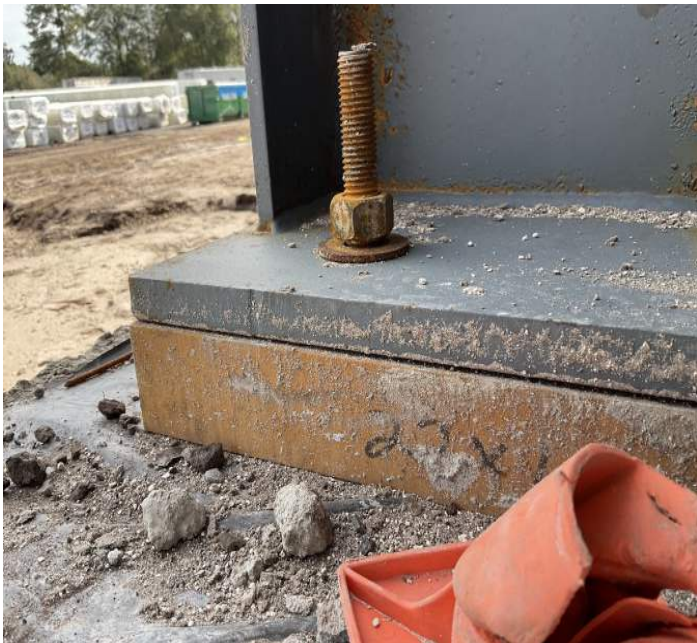
**Loose anchors found in several
locations along Line 23**

- Tighten column base plate anchors. These are loose in several locations
- Weld (1) plate washer at braced frame locations along Line 23
- Tack nuts to threaded rod at slip connections
- Weld girder stabilizer plates at braced frames
- Marr threads on Sag Rods per Detail2/E301A
- RFI for welded connection opposed to slotted connection at 23/K5
- Completion of the entrance structure at 23.1/H.8

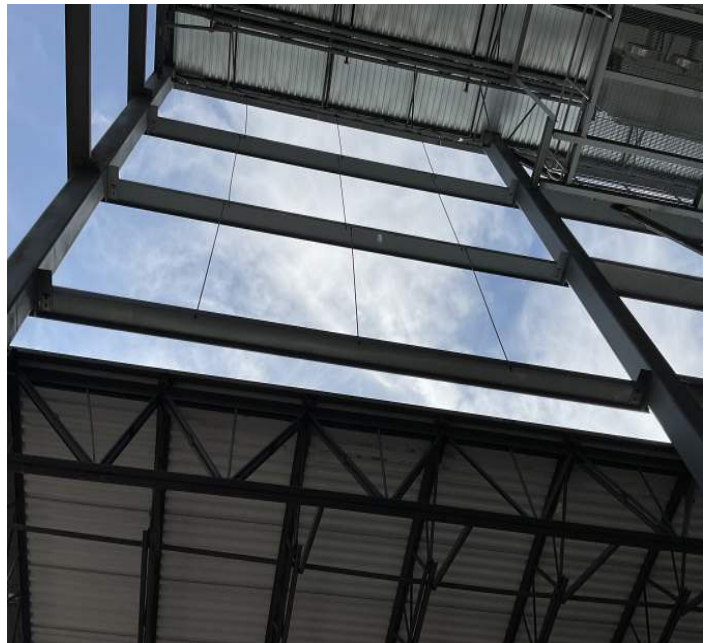
**Threads on sag rods not marred
as required**

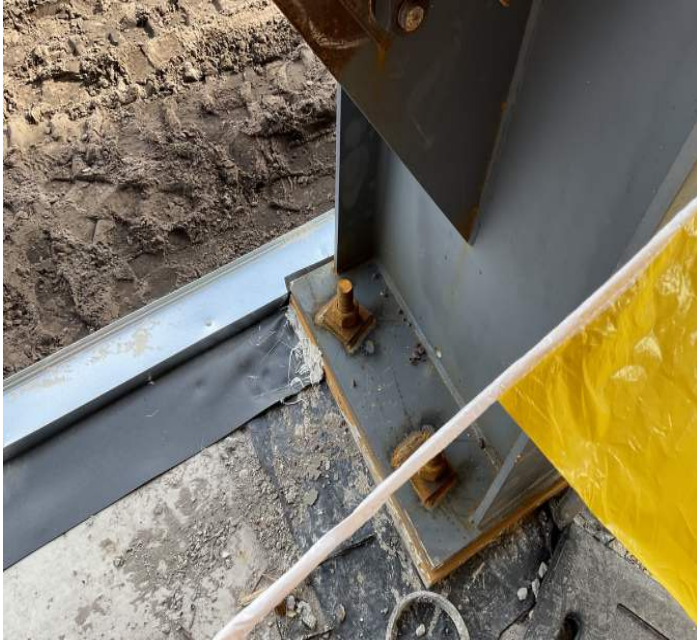
**Previously missing plate washer
welds completed**

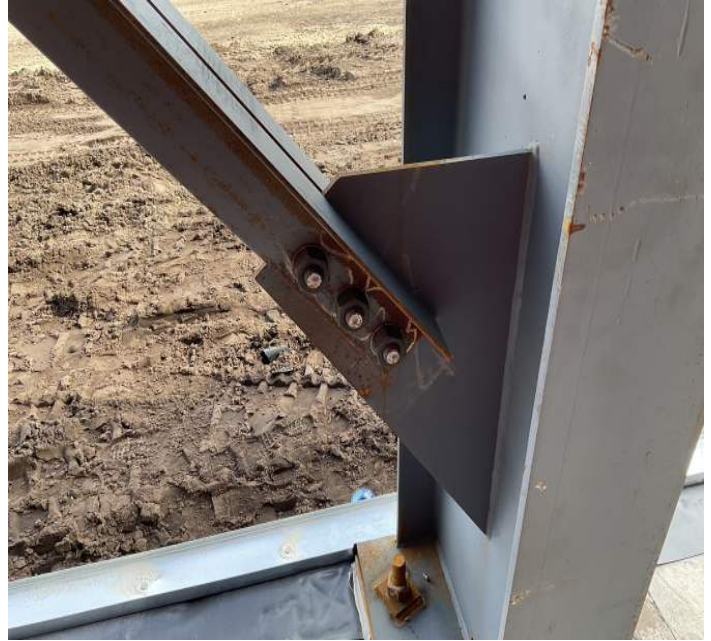
TC bolted connections at the braced frames were completed and found to be acceptable. No other deficiencies were completed at time of inspection.

TC bolts at braced frames completed

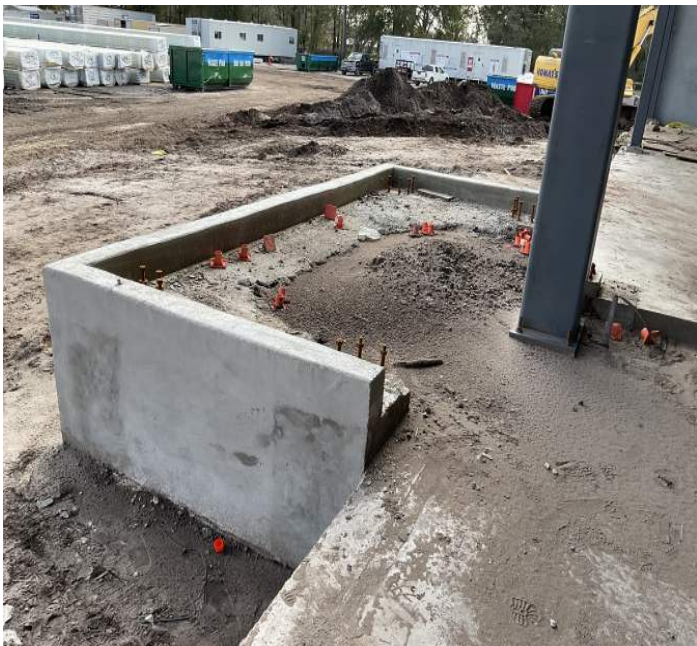
Structure not completed at 23.1/H.8

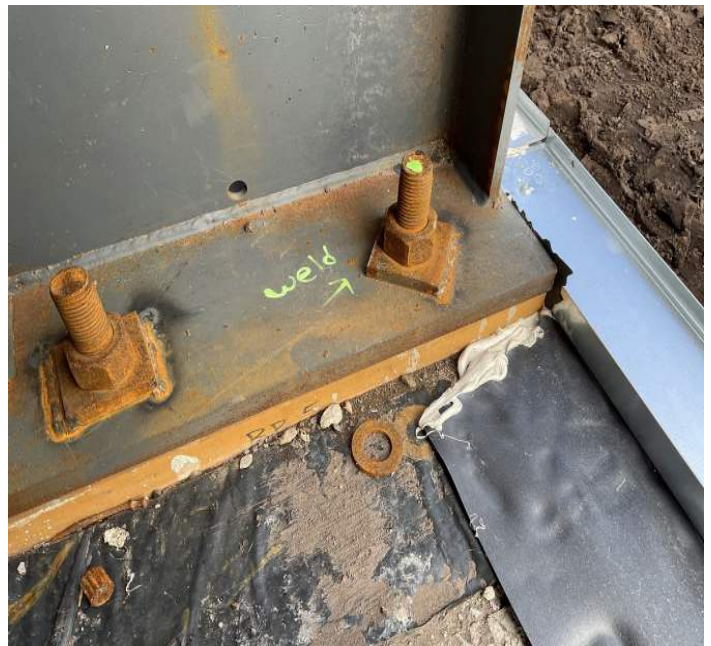
23/E.2 weld missing at plate washer

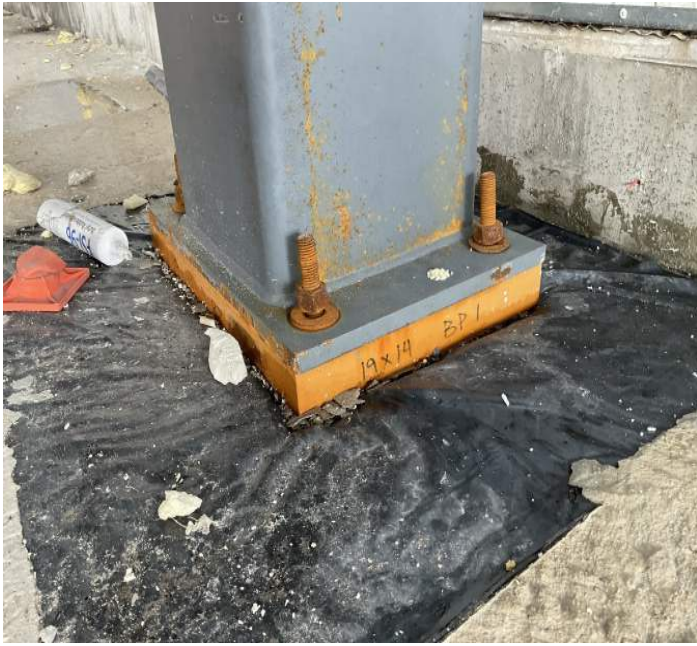
Loose anchor bolts along Line A.8

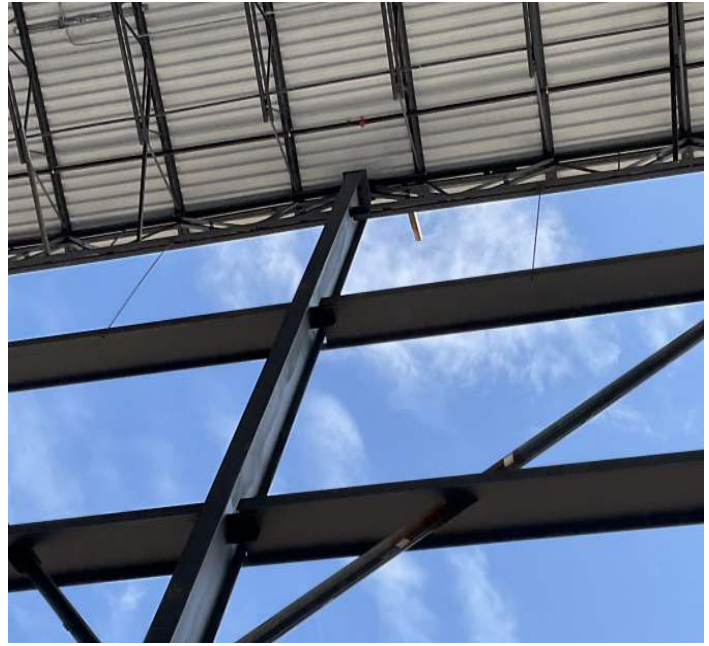
Bottom chords of joists not welded to stabilizer plates per Detail 8/301D
