Columbia County Building Permit

2. General description of Improvement: Pressure Grouting and Foundation
Underpinning For Ground Stabilization

SUBSIDENCE INVESTIGATION

MILLER RESIDENCE
 FORT WHITE, FLORIDA

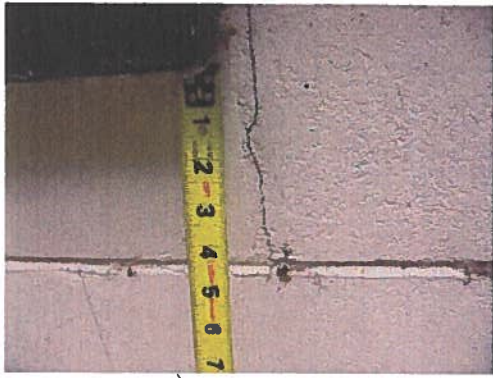
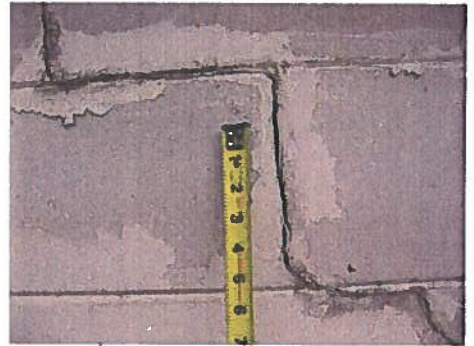
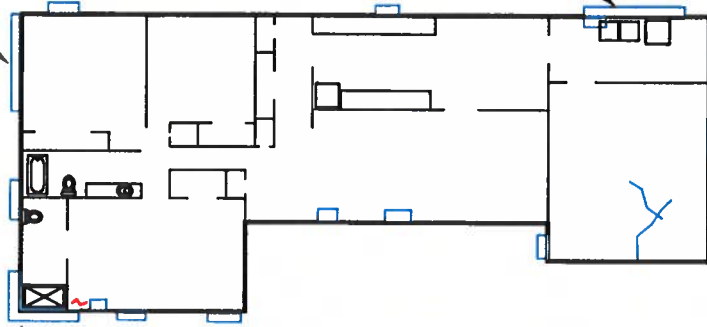
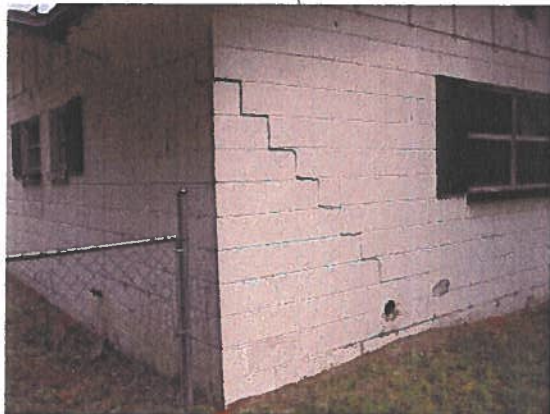
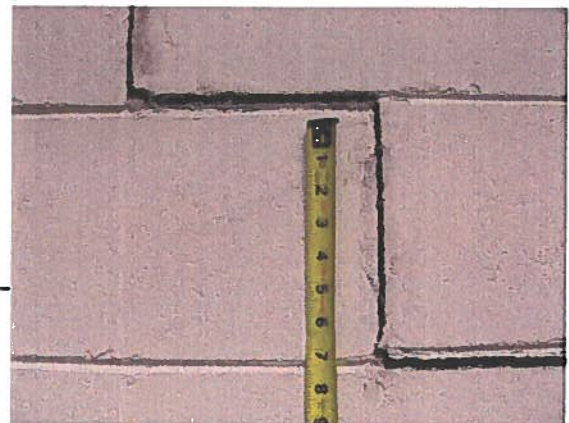
SITE PLAN SHOWING APPROXIMATE LOCATION
 AND EXAMPLES OF OBSERVED DAMAGE

The following paragraphs summarize the damage noted during the investigation. Approximate locations and photographs representative of the damage are illustrated in Figure 2.

Physical examination of the interior revealed that in the master bedroom located along the south elevation of the structure had hairline to 1/8-inch wide ceiling and wall cracks. The window located along the south elevation of the master bedroom was out of plumb. The living room located along the south elevation of the structure had hairline to 1/8-inch wide wall cracks near the window frame. The laundry room located at the northeast corner of the structure had hairline to 1/8-inch wide wall cracks. The garage located at the southeast corner of the structure had hairline to 1/8-inch wide slab cracks.

Physical examination of the exterior revealed that on the south elevation of the structure there were multiple hairline to 1/4-inch wide vertical, horizontal and stair step pattern wall cracks. The east elevation of the structure had hairline to 1/16-inch wide horizontal, vertical and stair step pattern wall cracks. The north elevation of the structure had hairline to 1/8-inch wide horizontal,

vertical and stair step pattern wall cracks. The west elevation of the structure had hairline to 1/8-inch wide horizontal, vertical and stair step pattern wall cracks.

The observed damage on the exterior and interior of the residence is consistent with either the direct result or the collateral effect of differential movement of the foundation. The direct result of differential movement of the foundation occurs when a portion of the structure is damaged directly due to a loss of support of underlying soils. The collateral effect occurs when stresses resulting from uneven foundation settlement are redistributed through the structure. Differential movement results in the cracking of concrete, masonry and drywall, and in some cases results in the sloping of the floor slab. See Section 2.0 "Geologic and Geotechnical Evaluation" for further discussion of deleterious soil conditions encountered at the site that may have initiated the differential movement of the foundation.

The geologic and geotechnical investigations concluded that sinkhole activity is occurring at the site. It is our recommendation that the subsurface soils be stabilized to minimize further subsidence damage. Stabilization should be accomplished through grout injection to compact and

Following the grout injection it is our recommendation that the foundation of the residence be stabilized through the installation of underpinning piles around the perimeter of the structure. The intent of the underpinning is to resupport the foundation/slab on piles bearing on competent material at depth. The installation of the underpinning piles will lift and support the structure and span the loose soils that exist at the site. The underpinning pile assembly, including mounting bracket, is to have a minimum load capacity of 30 kips. The contractor is to submit the proposed pin pile system to SDII for approval.

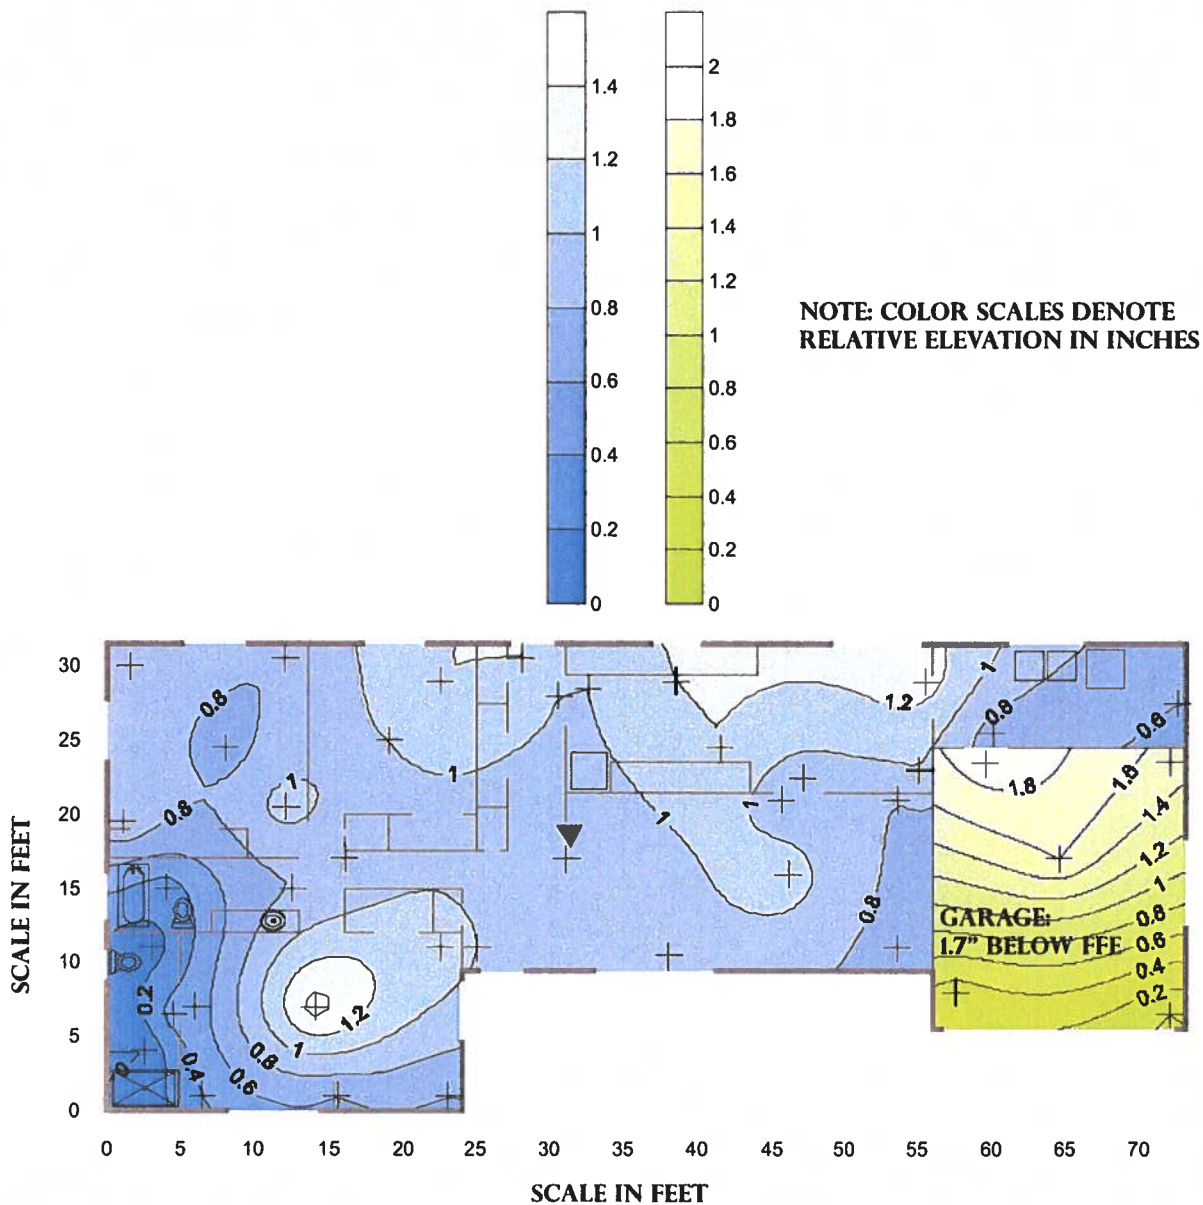
The floor elevation map indicated that there was a total elevation difference of approximately 1.4 inches across the floor slab of the main living area of the residence. There was a mild slope of approximately 1.2 inches over a span of 15 feet recorded descending toward the southwest portion of the structure. It is important to note that this slope corresponds to the substantial cracking at the western portion of the residence. This correlation indicates that differential settlement has occurred at this portion of the structure.
