# ROOF SYSTEM REPAIR NOTES:

MCKINZEY REMODEL

EXISTING & REMODEL  
 PLANS

SHEET NO.  
 1

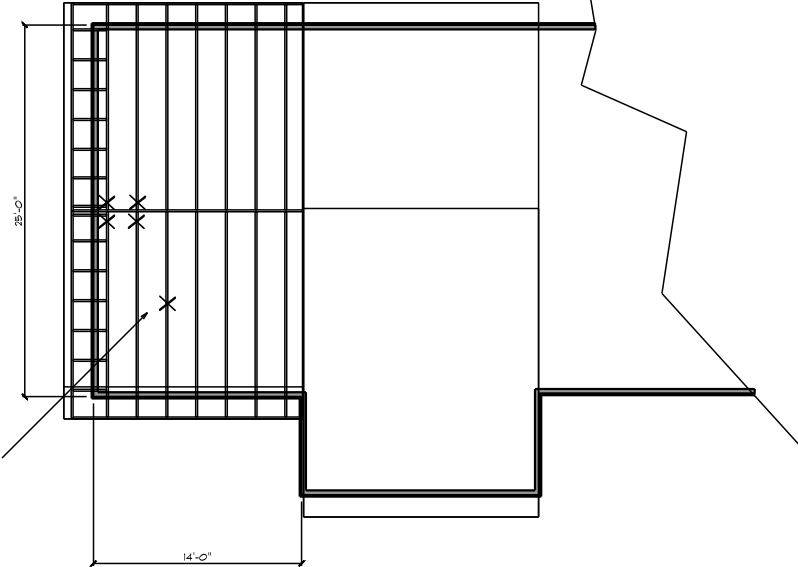
DETAIL 1

RAFTERS TO BE REPAIRED MARKED WITH (X) AT DAMAGED OR BROKEN AREA

THIS RAFTER WILL HAVE A CONTINUOUS REPAIR TO BOTH SIDES DUE TO LOCATION OF BREAK.

1. REPLACE RIDGE BEAM
2. REPAIR BROKEN RAFTER. (SEE DETAIL 1.)
3. INSTALL NEW COLLAR TIES.
4. INSTALL 1/2" PLYWOOD AS NEEDED NAILED 4" O.C. ALONG EDGES AND 8" O.C. IN THE FIELD
5. INSTALL NEW METAL ROOFING OVER TITANIUM UNDERLAYMENT

ADD 2X6 S.Y.P. MINIMUM OF 8' TO BOTH SIDES OF DAMAGED RAFTERS (5)  
 NAIL WITH 12 PENNY NAILS 2 ROWS 6" O.C.  
 RE NAIL ROOF WITH 8D .131 NAILS 4" ALONG EDGES AND 8" IN FIELD
