# WELDTEST SERVICES

United States Cold Storage  
23-297  
Location:  
211 NE McCloskey Ave  
Lake City, FL

Report No.: 205-23

Visual Inspection (VT) of welded joints per AWS D1.1-2020 Structural Welding Code - Steel, Clause 8, Table 8.1 and Drawings supplied by Stellar Construction.

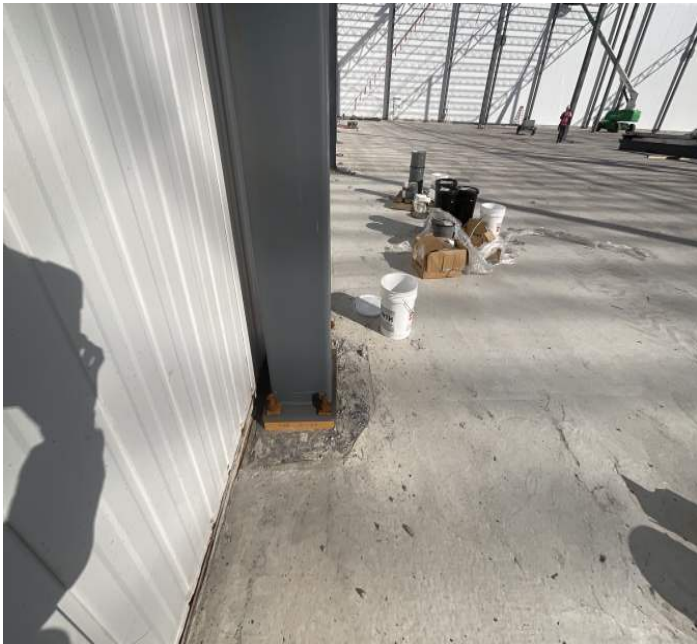
**14x14 columns along Line 17.2 as detailed**

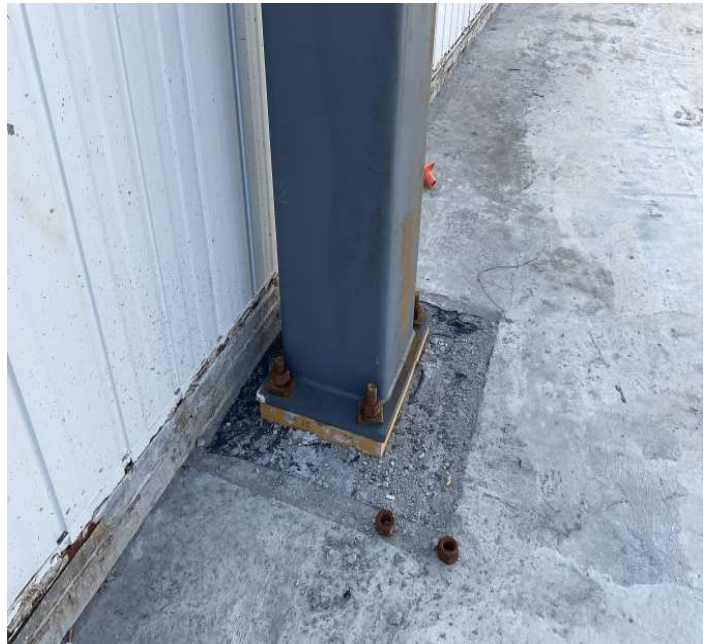
Tie plates and angles were missing in all locations at time of inspection. These locations and details were reviewed with Emory, foreman of R & D Erectors. Anchors bolts at the base plates were not tightened throughout the building. Columns were still being plumbed during inspection.

**Base of column connections not tightened at time of inspection.**

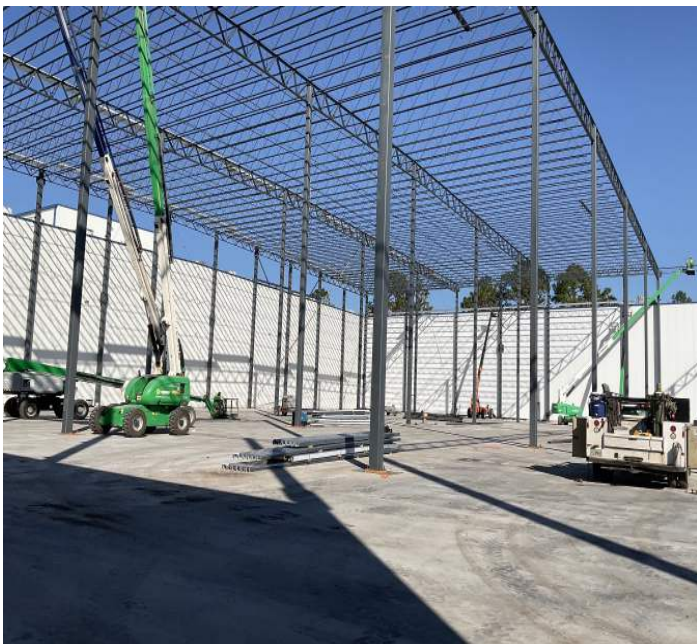
**Structural framing of Sequence 2 in process**

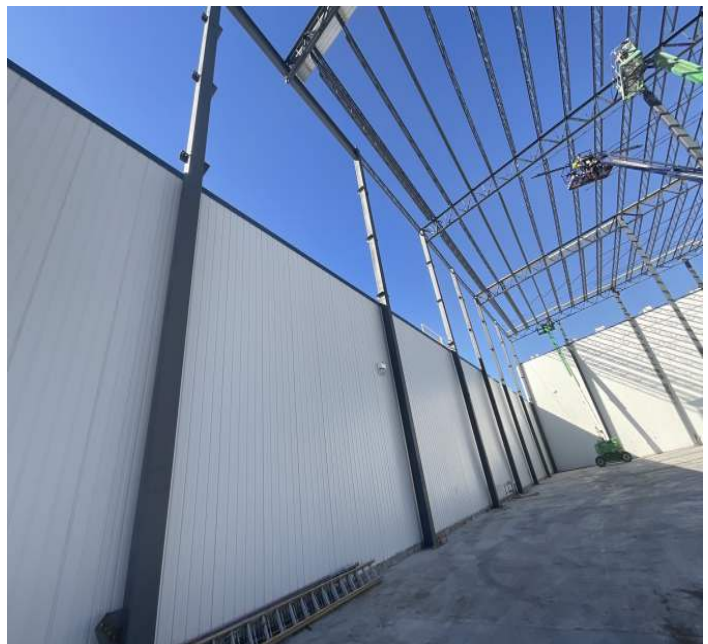
X bracing, joist reinforcements, RTU frames, perimeter I Beams, uplift braces per Detail 1/E301B, and bent plate were not installed at time of inspection. Note: Tie plates at the joists were not installed per Detail 9/E301C at Line 18.5. Detail 9/E301C also requires the joists to be welded to the stabilizer plates at this Line.

**X bracing between columns and lower flange bracing not completed at time of inspection**

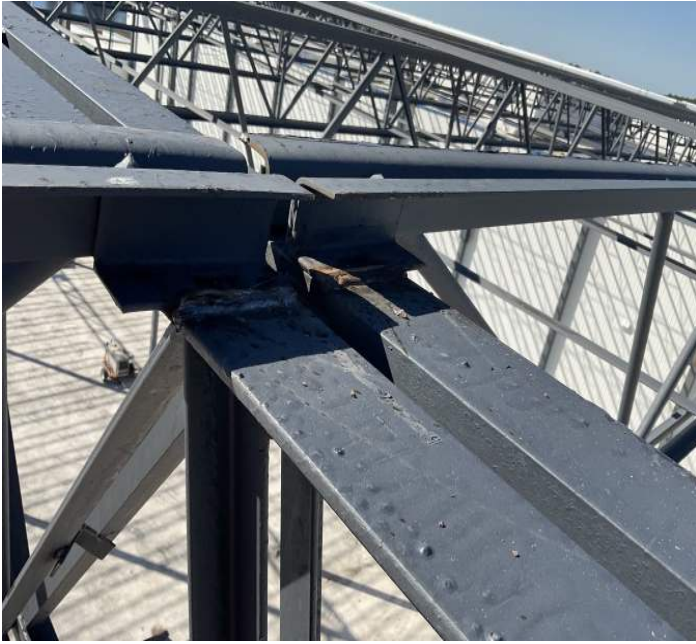
**Typical joist welds**

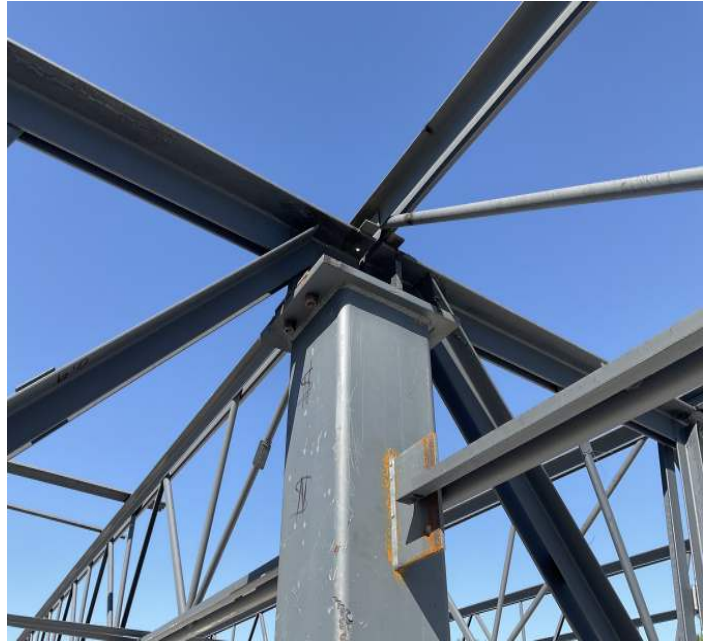
**Tie plates not installed**
