**FOUNDATION CERTIFICATION REPORT  
SOSA RESIDENCE  
152 SW NIGHTSHADE DRIVE  
LAKE CITY, FLORIDA 32024**

**MAY 21, 2014  
FOUNDATION CERTIFICATION REPORT  
JOB #14-3258**

Subject: Report of Settlement Investigation  
Existing One Story Masonry Block House  
Sosa Residence, 152 SW Nightshade Drive  
Lake City, Columbia County, Florida

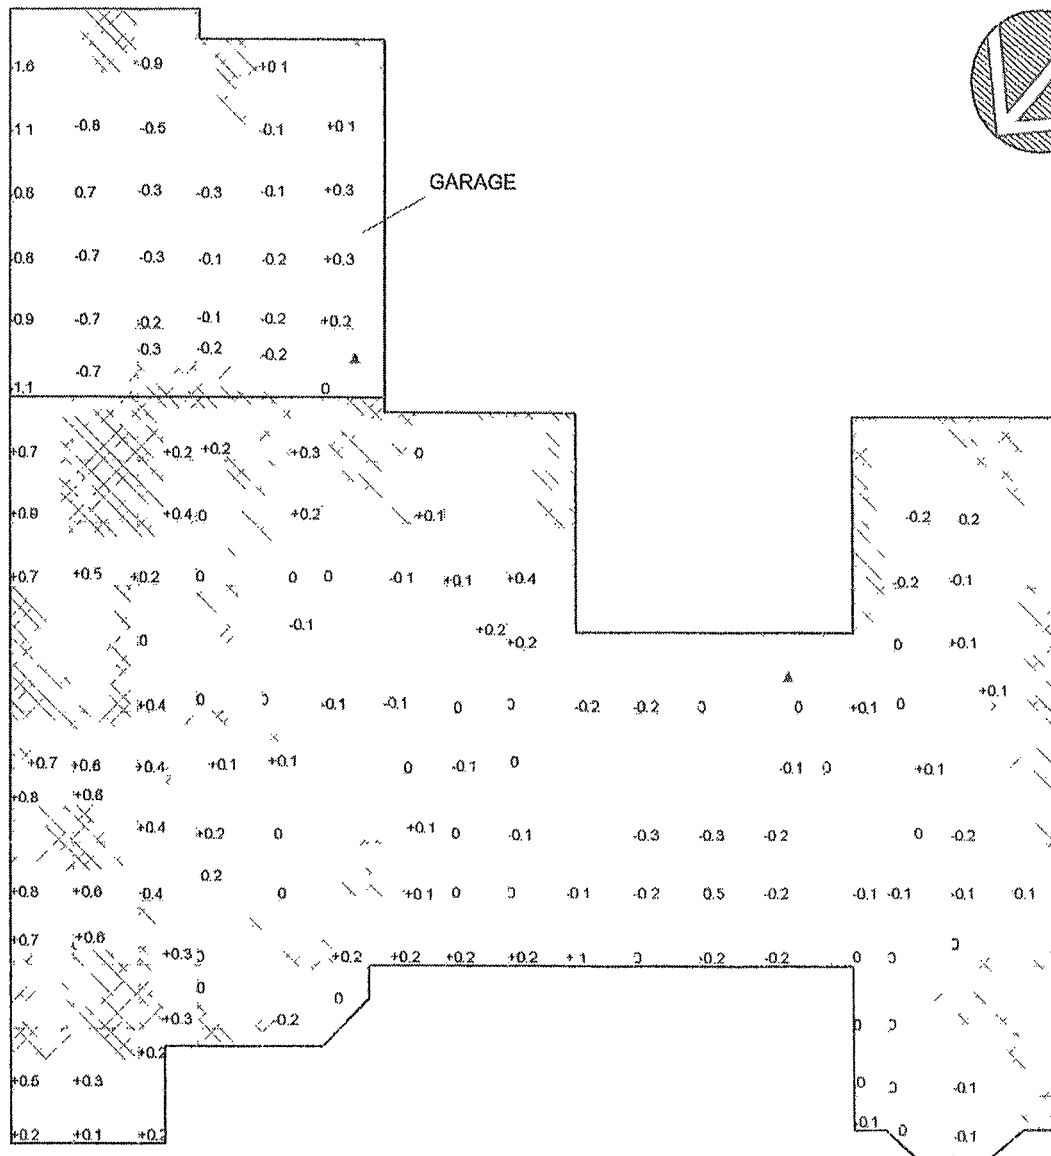
**FLOOR SURVEY**  
SOSA RESIDENCE  
152 SW NIGHTSHADE DRIVE  
LAKE CITY, FLORIDA

A survey of relative floor elevations was performed and is presented with this report. With reference to the survey performed within the main residence, a maximum variation of approximately 1.3± inches was observed. The highest elevation was observed in the east center portion, while the lowest elevations were observed in the northwest portion of the house.

It is my professional opinion that the floor slab has undergone overall differential settlement of up to 1.3± inches, and more than 1/2 inch over 10 feet horizontal distance, (excessive elevation gradient) and multiple anomalous areas and will need remediation. As pressure grouting is not intended to correct floor slab elevation difference, it is recommended that the sinkhole remediation must include both cement grouting and underpinning.

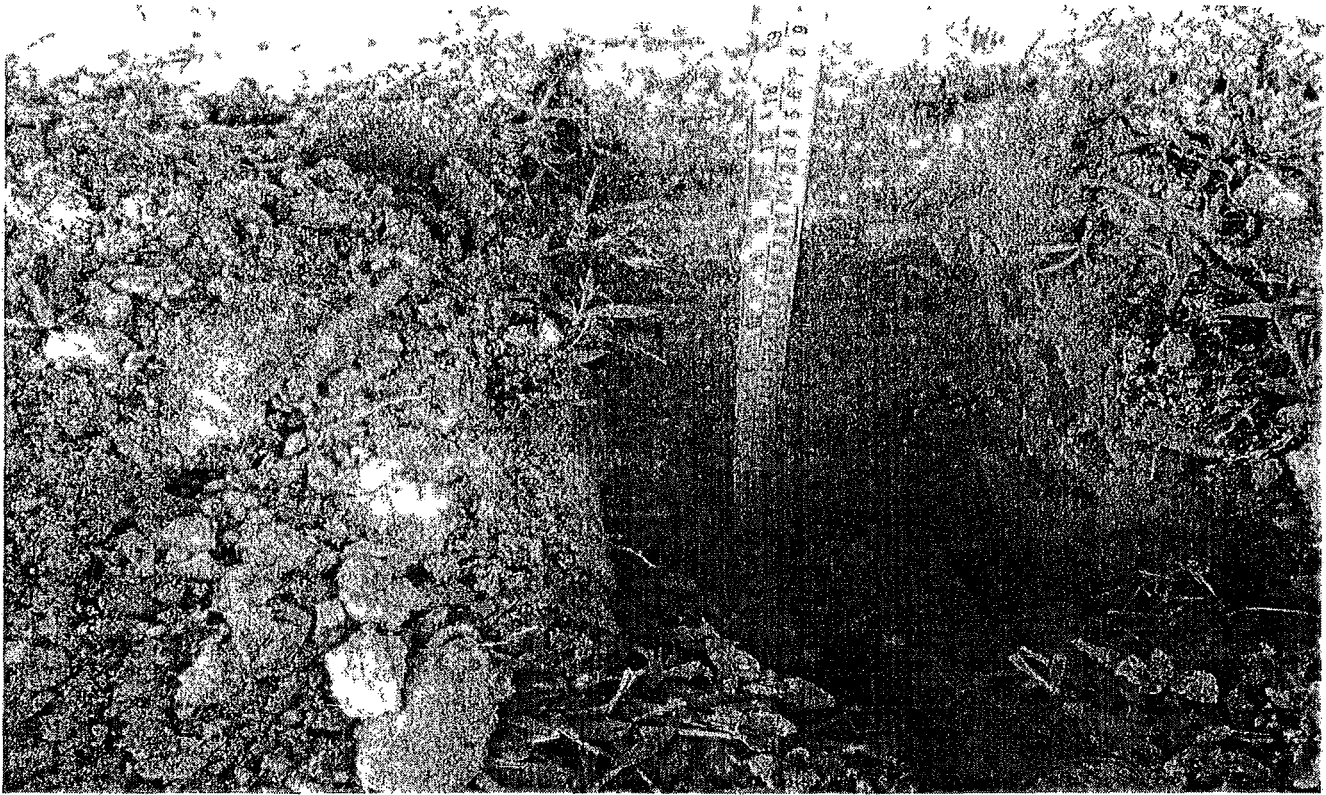
A test pit was excavated at the perimeter of the house. The purpose of this exercise was to expose and evaluate the adequacy of the existing foundation system to support the subject structure. The structure is supported on a stemwall footing type of foundation system with a thickness of 4.5 inches, width of 24.0 inches and soil embedment depth of 14.0± inches.

VIEW 5: TEST PIT

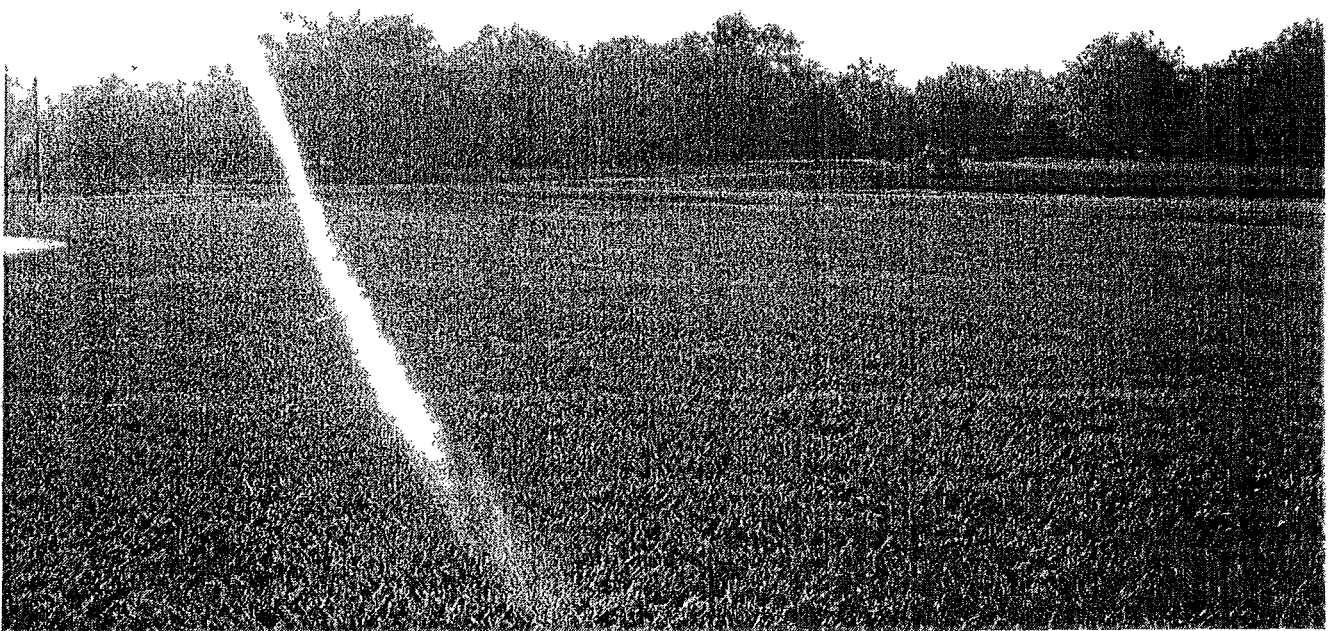
VIEW 6: VIEW OF UNEVEN FRONT LAWN

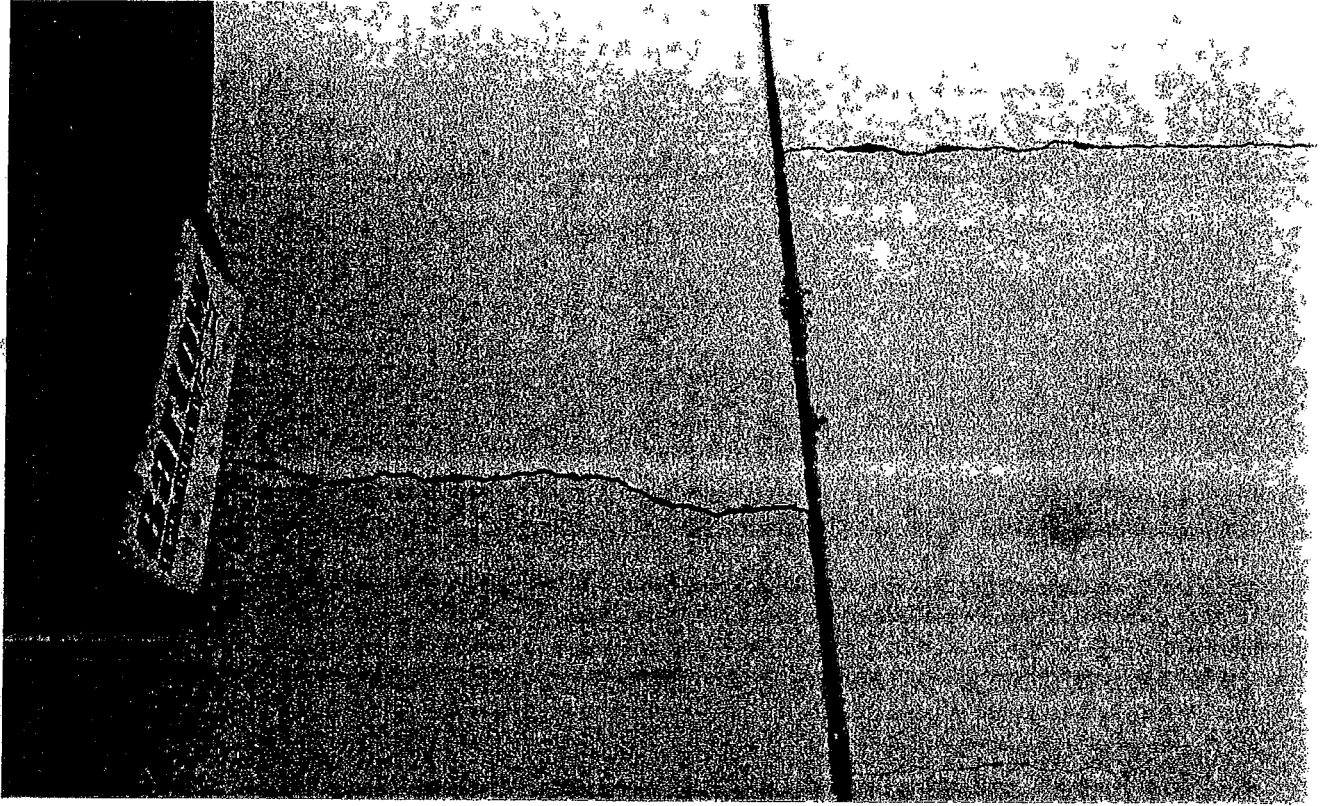
VIEW 7: SLAB CRACKS - DRIVEWAY - NORTH END

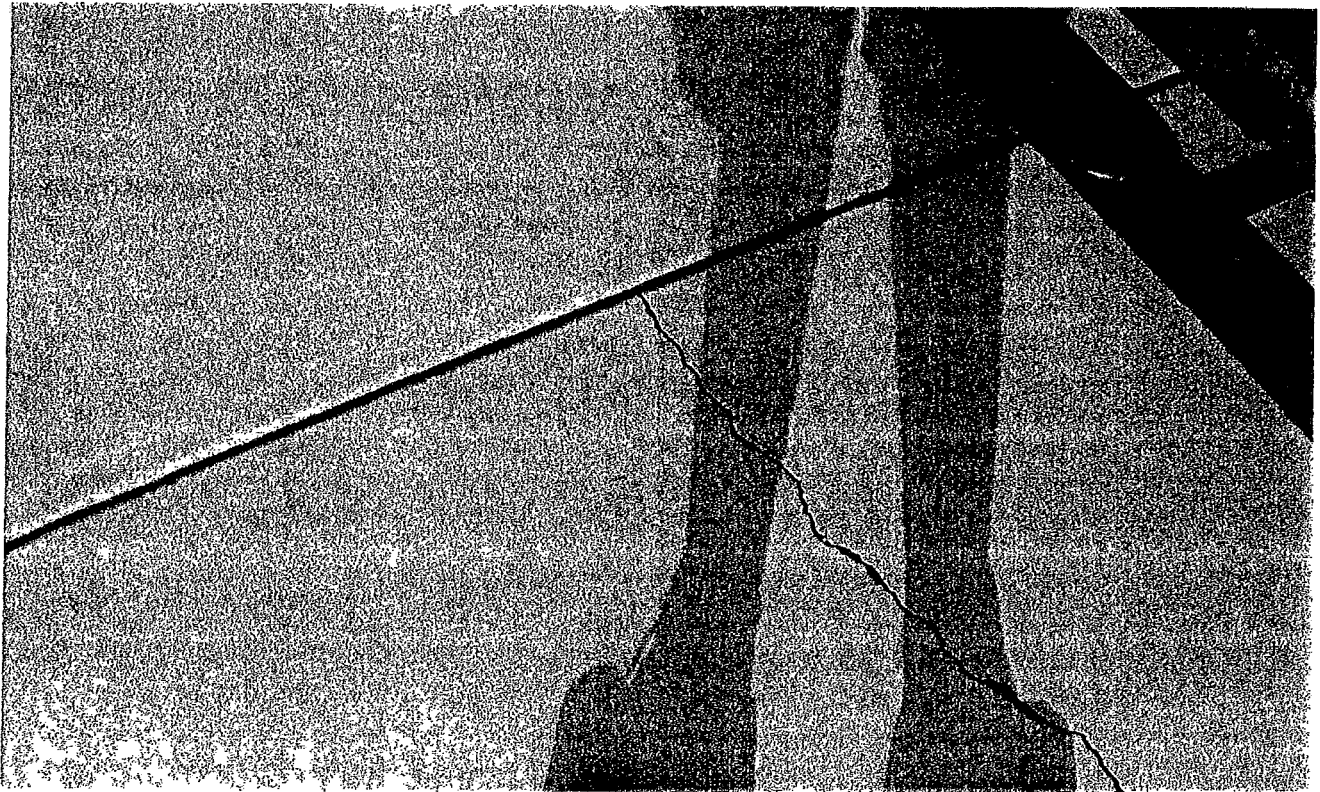
VIEW 8: SLAB CRACKS - DRIVEWAY - SOUTH END

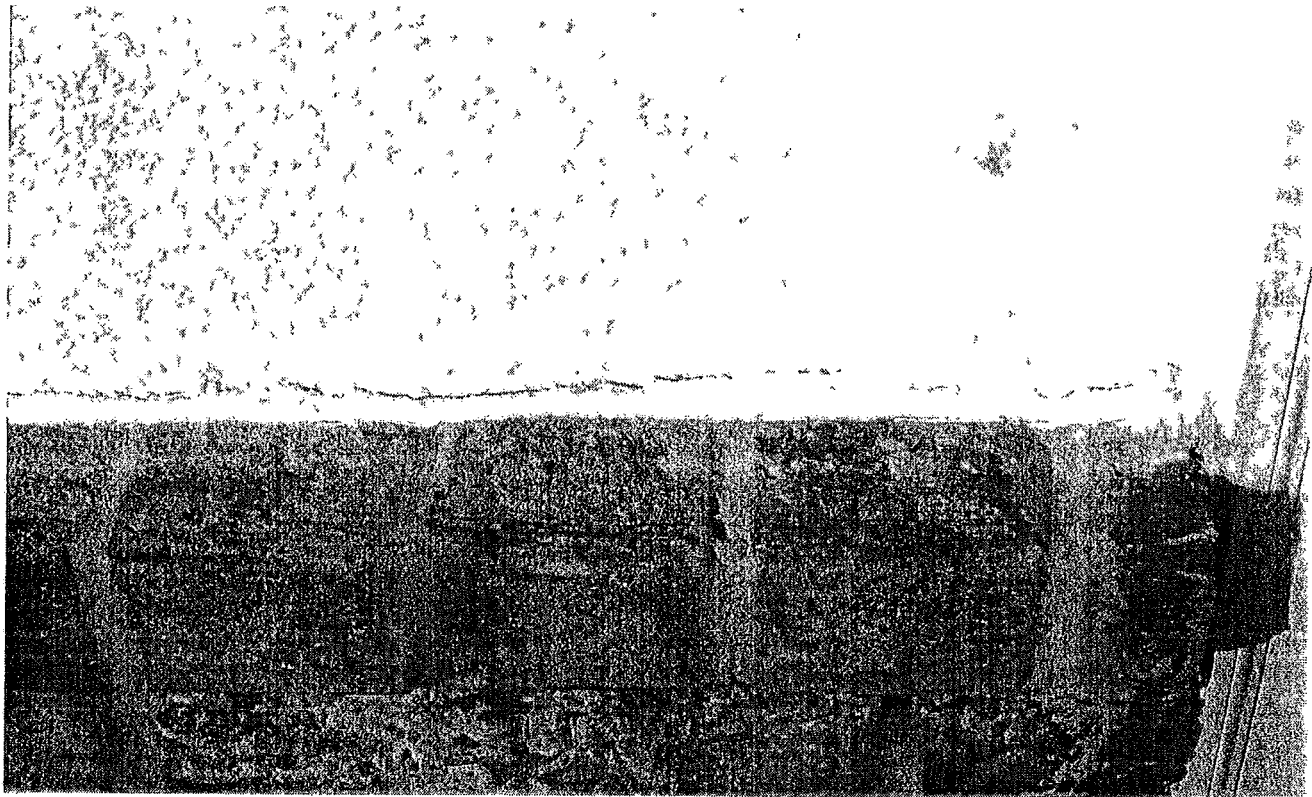
VIEW 9: HORIZONTAL CRACK - NORTH SIDE OF HOUSE - EAST OF GARAGE DOOR

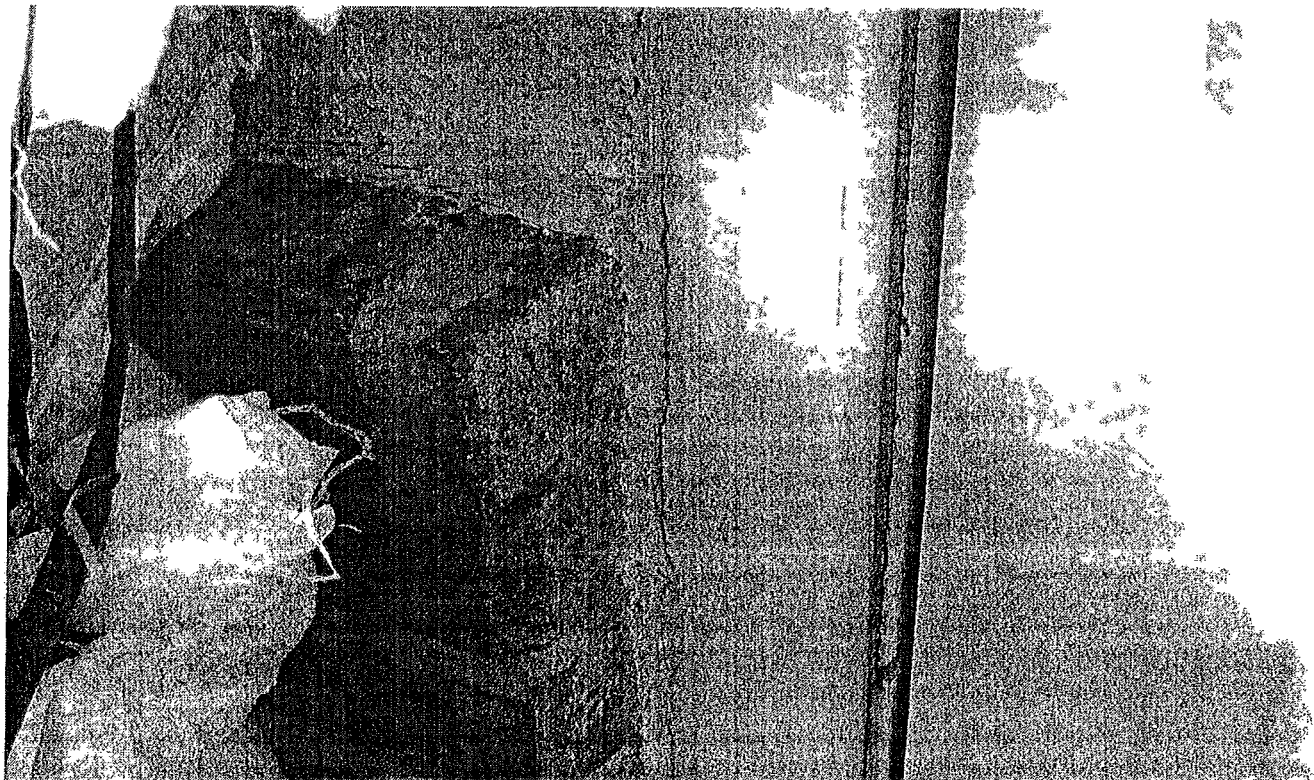
VIEW 10: DOOR TRIM SEPARATION - NORTH SIDE OF HOUSE - EAST DOOR ENTRANCE

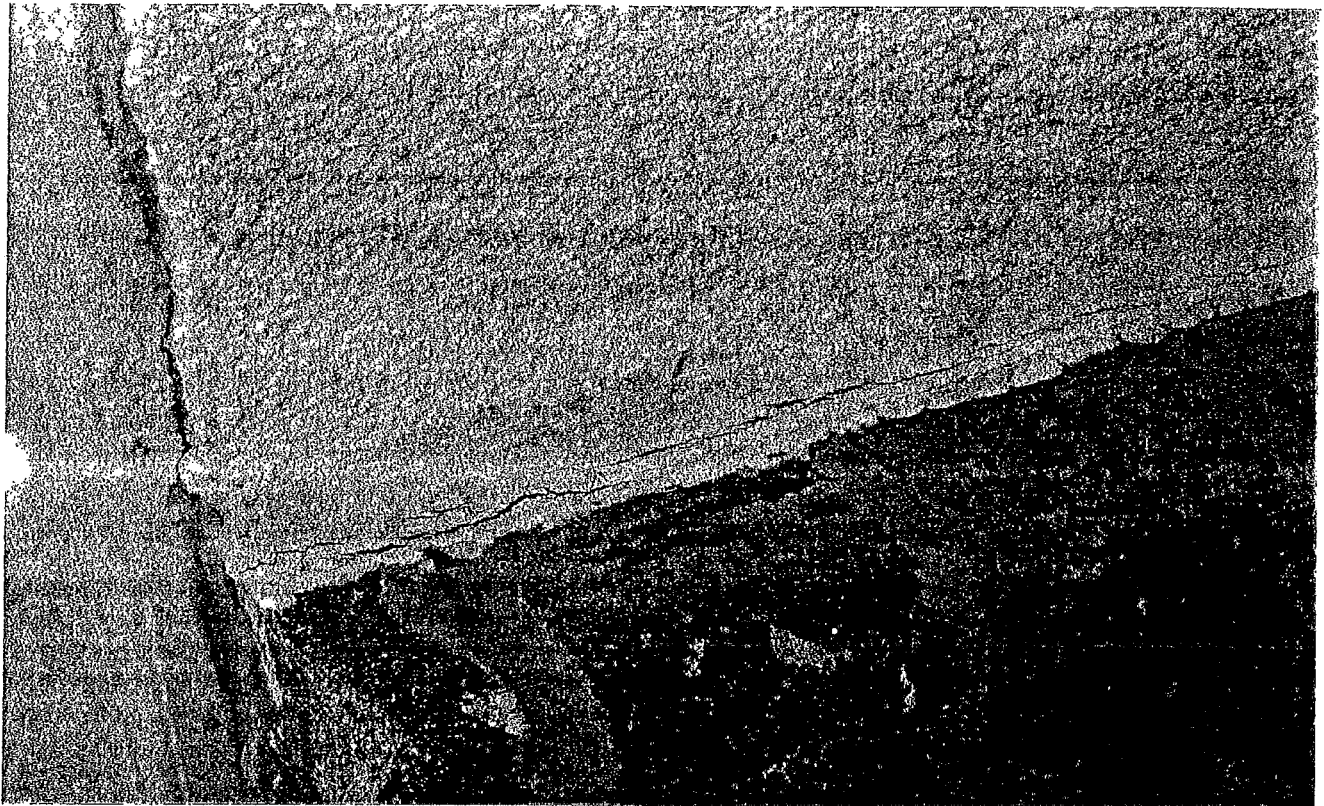
VIEW 11: HORIZONTAL CRACK - NORTH SIDE OF HOUSE - WEST OF EAST DOOR ENTRANCE

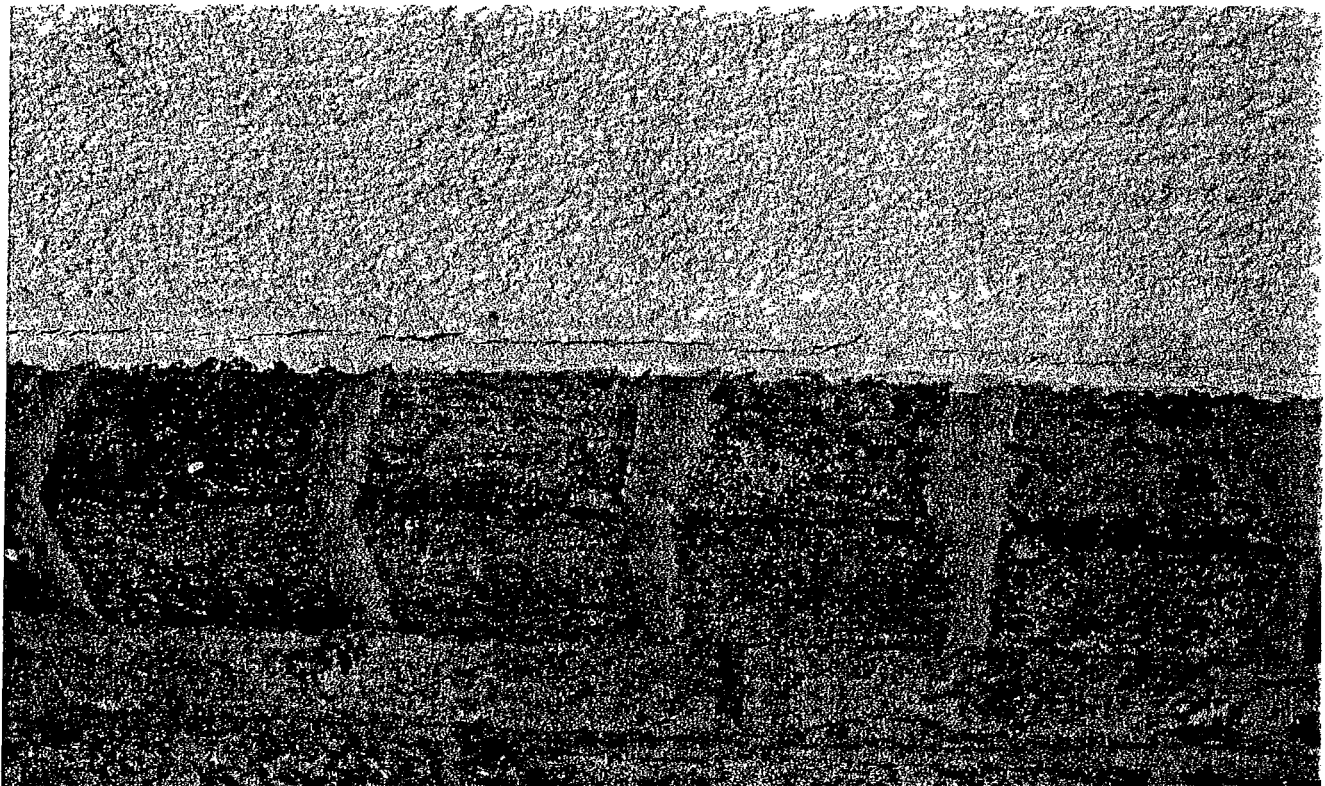
VIEW 12: HORIZONTAL CRACK - NORTH SIDE OF HOUSE - NEAR TEST PIT

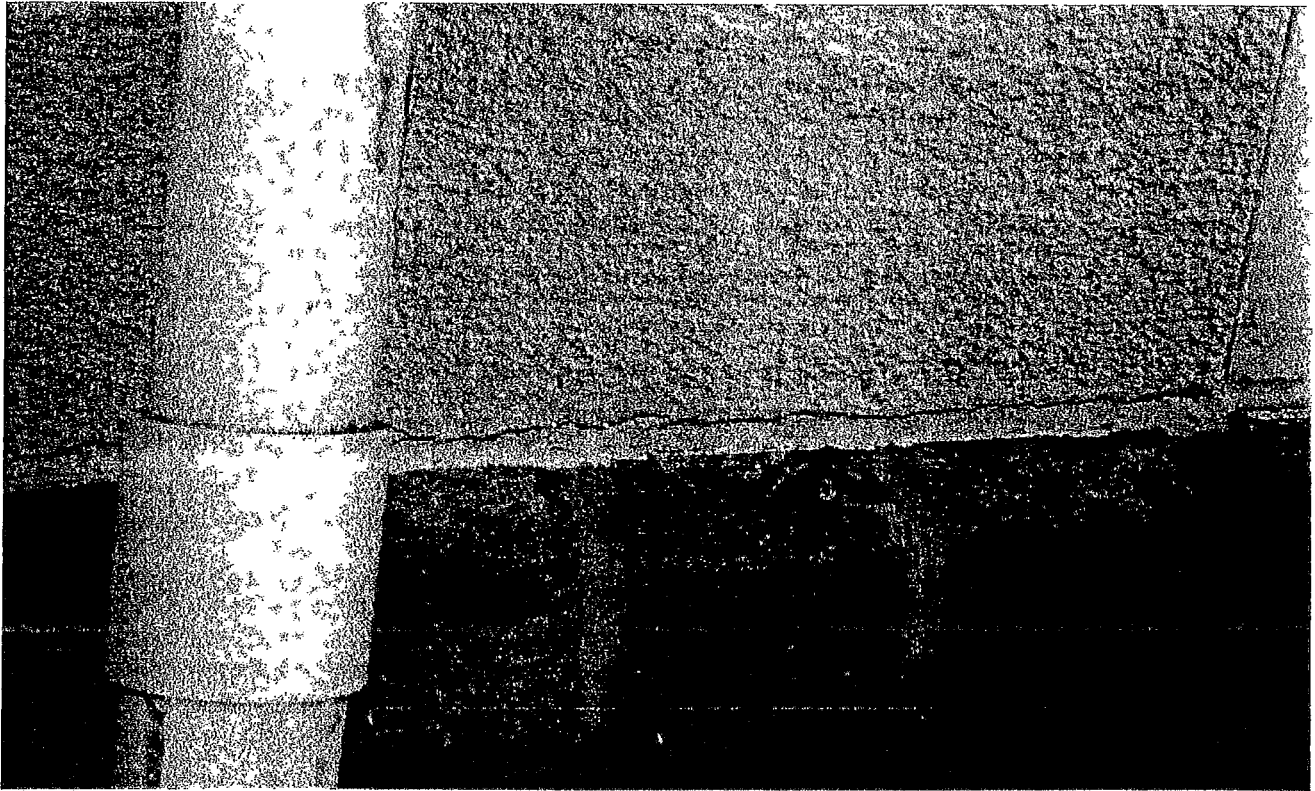
VIEW 13: HORIZONTAL CRACK - BACK OF HOUSE - NORTH OF NORTH WINDOW

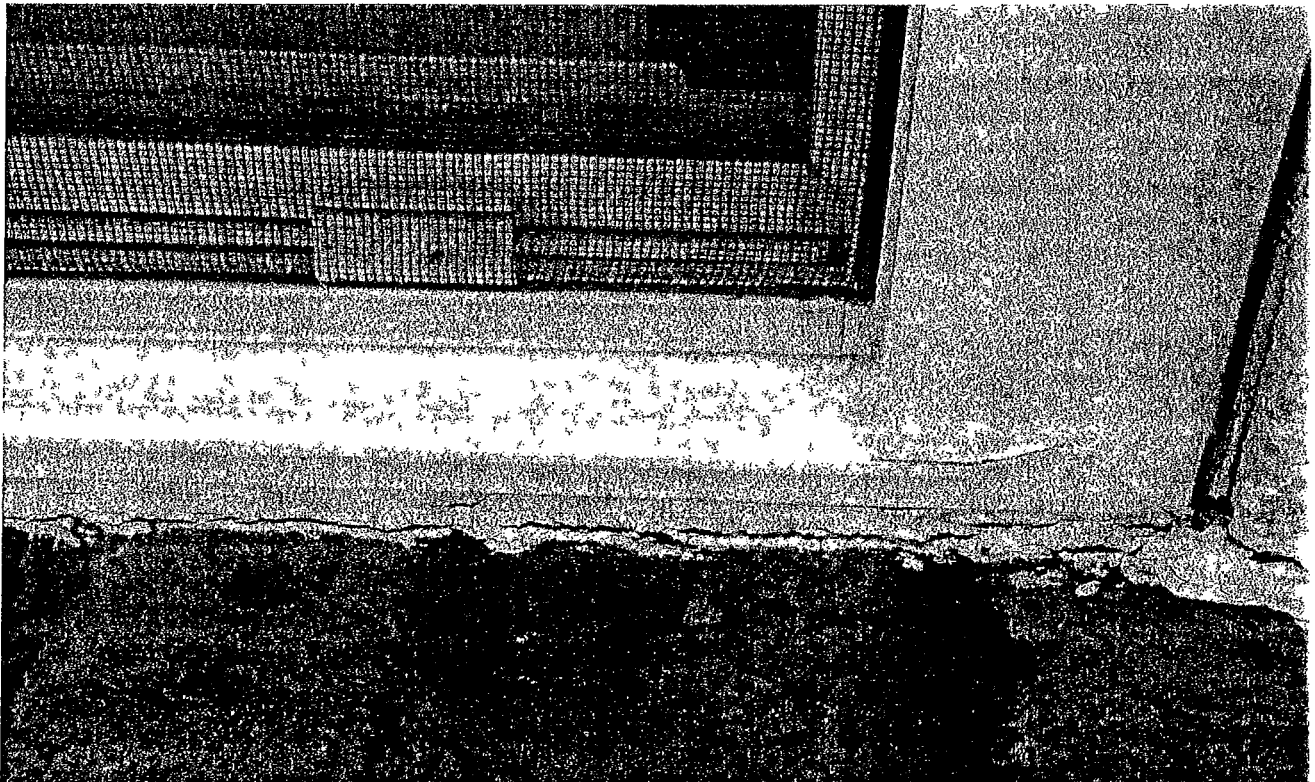
VIEW 14: WINDOW SEPARATION - BACK OF HOUSE - NORTH WINDOW

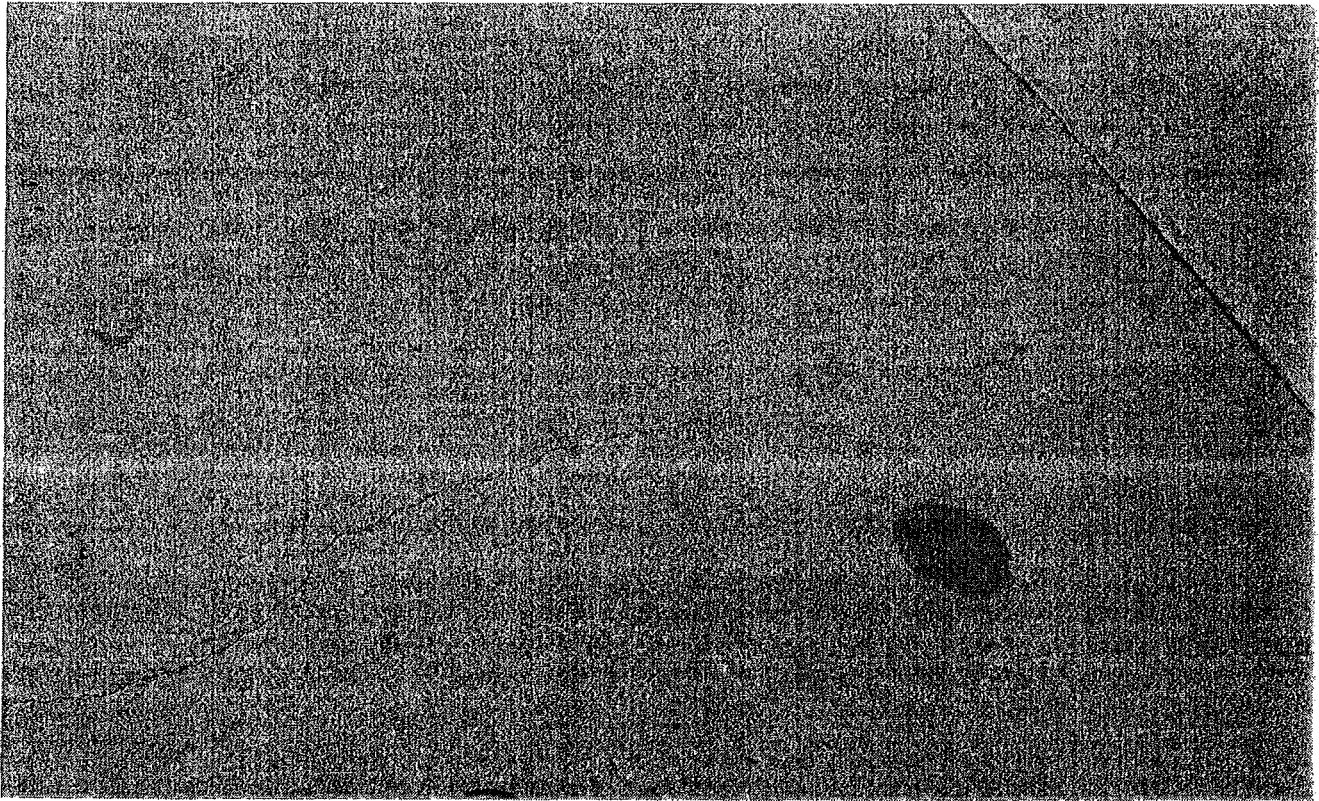
VIEW 15: SLAB CRACK - BACK OF HOUSE - BACK PORCH, NORTH END

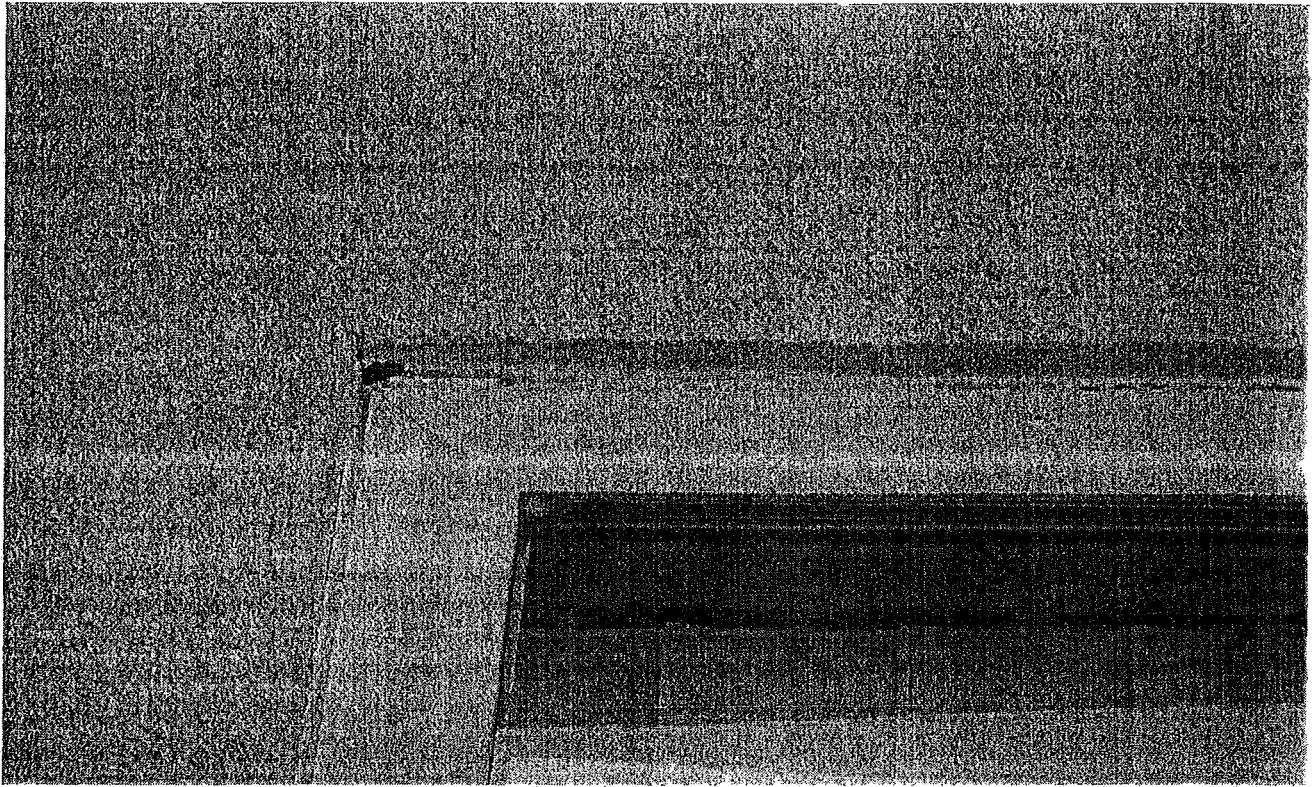
VIEW 17: WINDOW SEPARATION - BACK OF HOUSE - BACK PORCH, EAST WALL, NORTH WINDOW

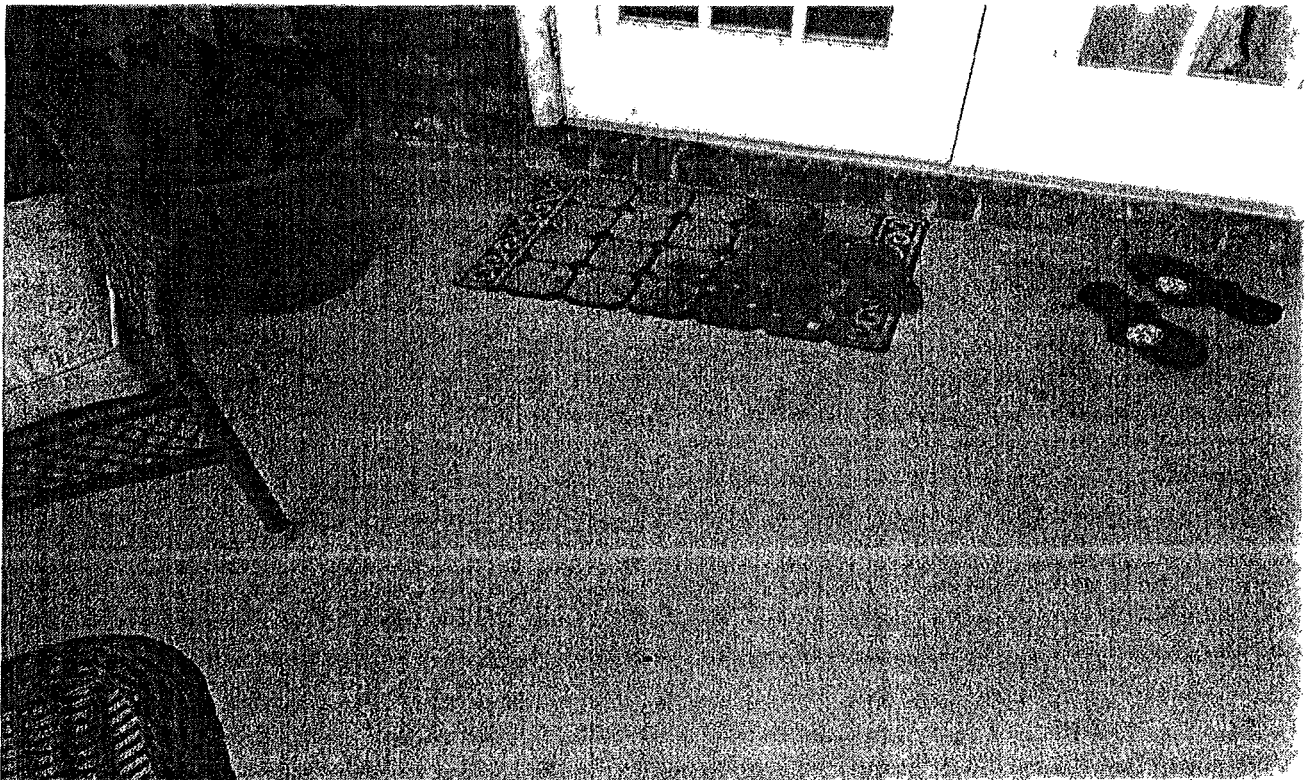
VIEW 18: SLAB CRACK - BACK OF HOUSE - BACK PORCH, NEAR NORTH FRENCH DOORS

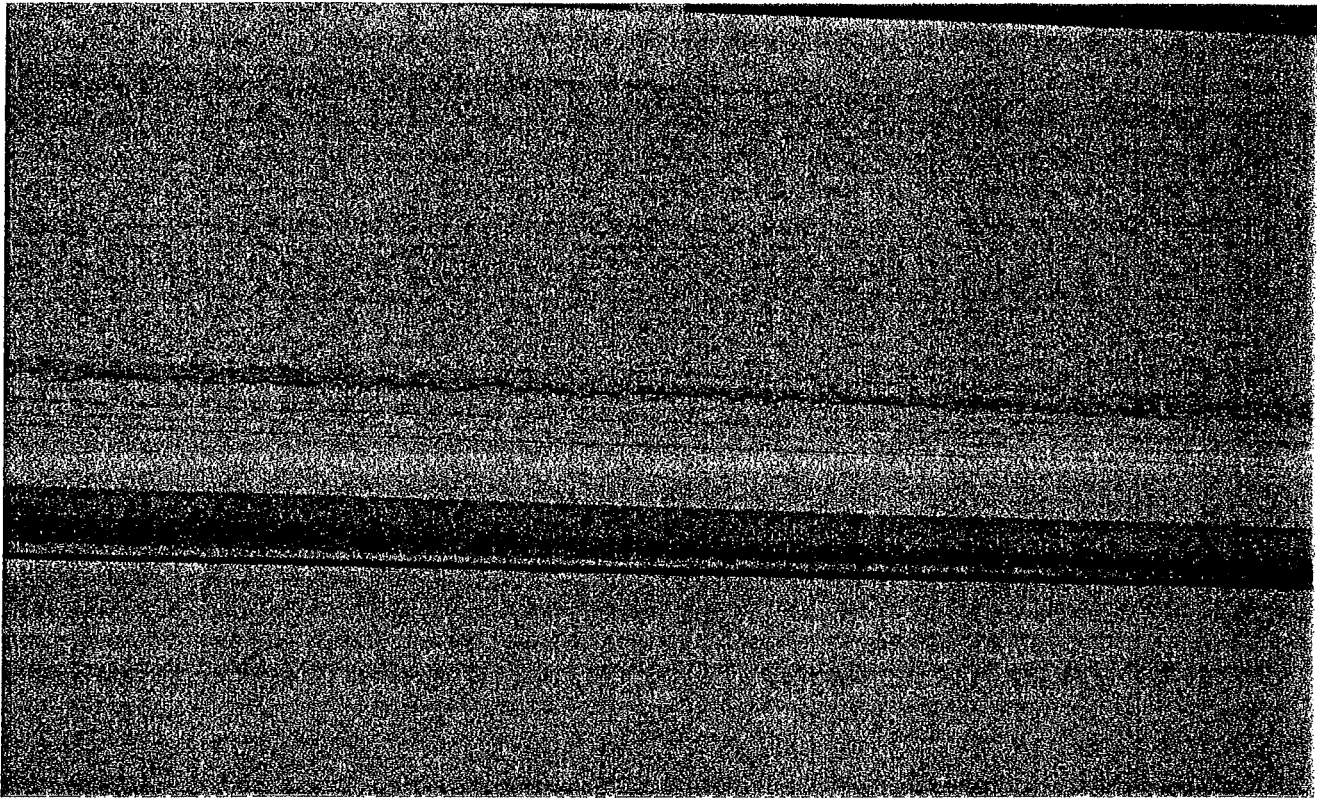
VIEW 19: HORIZONTAL CRACK - BACK OF HOUSE - BACK PORCH, ABOVE NORTH FRENCH DOORS

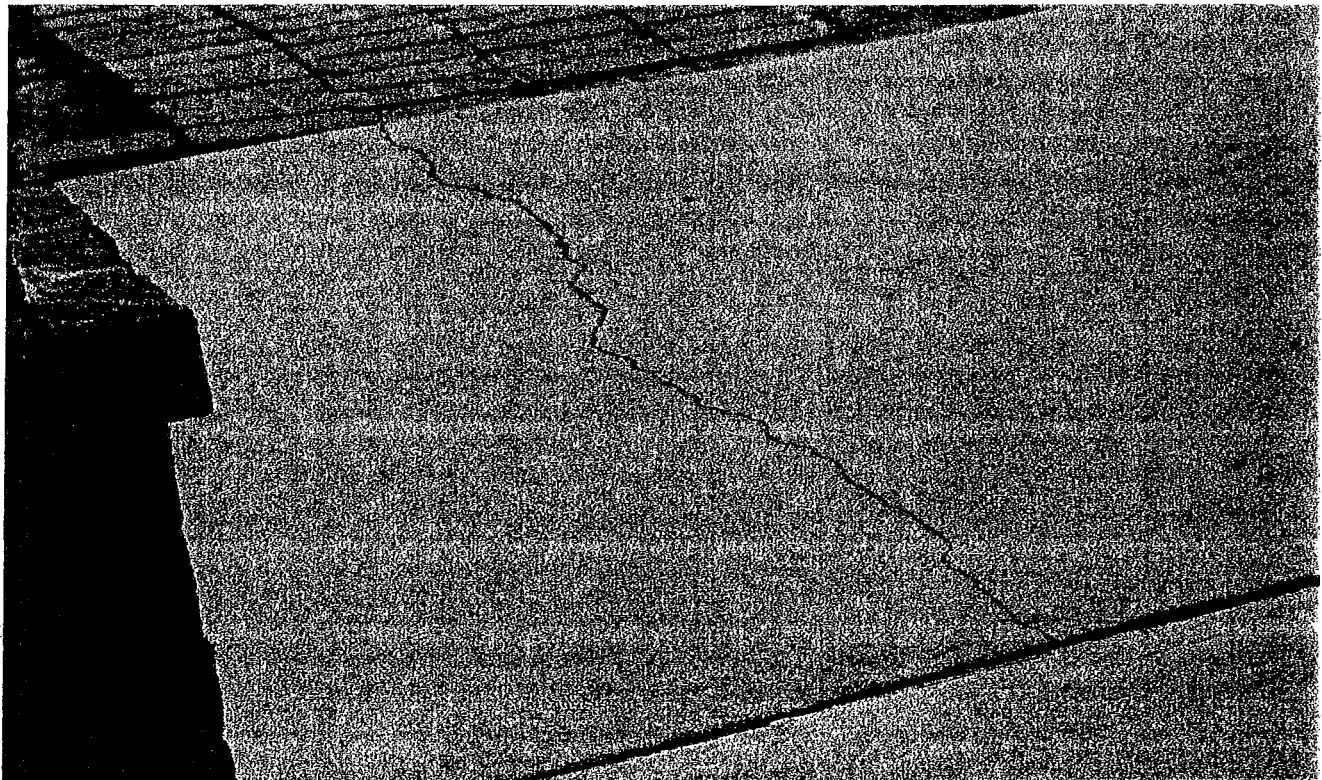
VIEW 20: SLAB CRACK - BACK OF HOUSE - BACK PORCH, WEST OF NORTH FRENCH DOORS

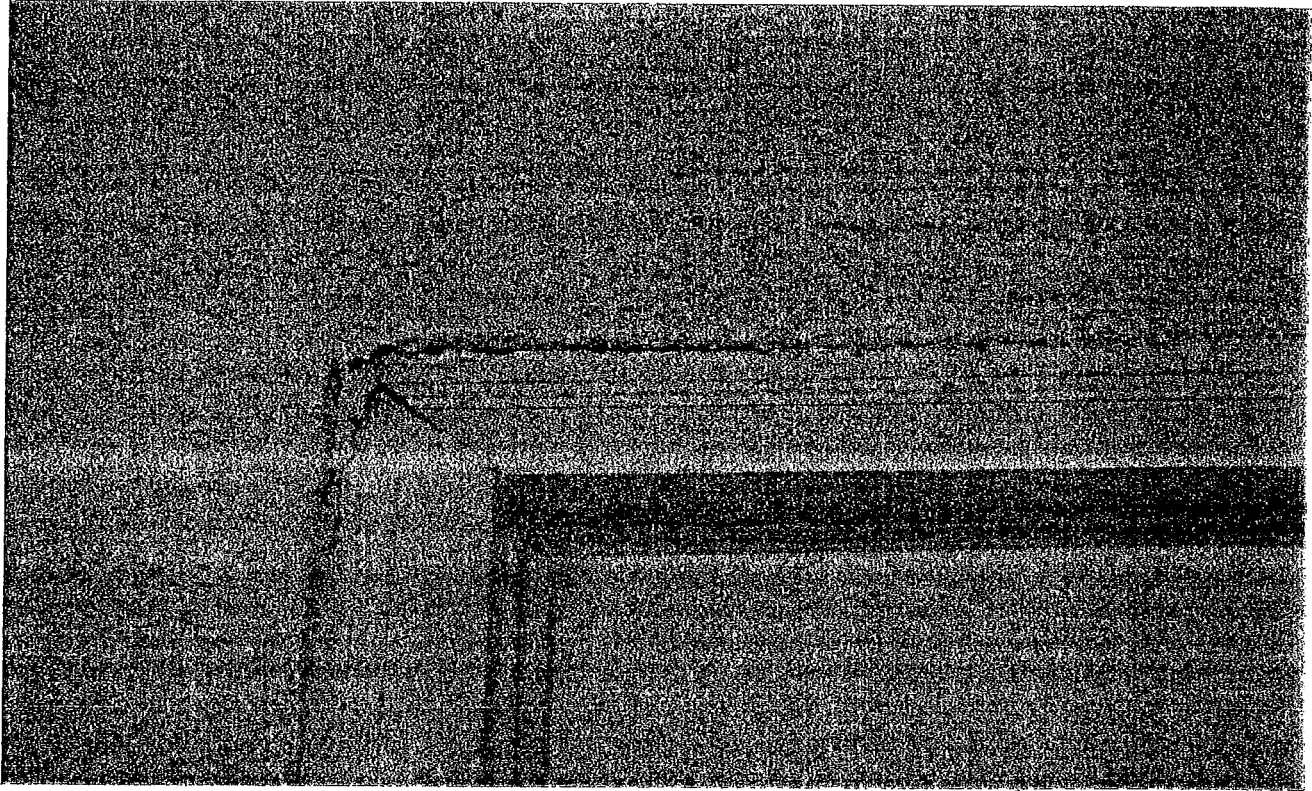
VIEW 21: DOOR TRIM SEPARATION - BACK OF HOUSE - BACK PORCH, EAST WALL, SOUTH FRENCH DOORS

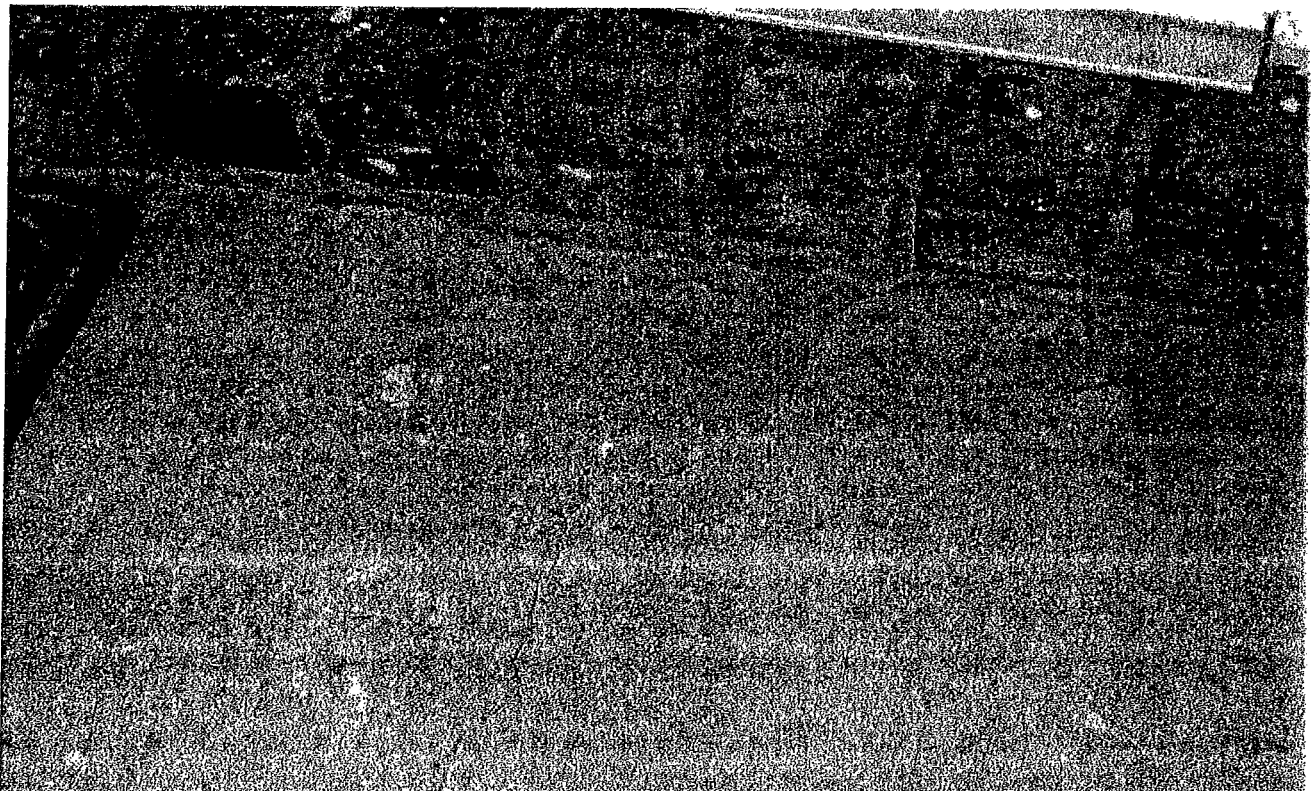
VIEW 22: SLAB CRACK - BACK OF HOUSE - BACK PORCH, EAST WALL, UNDER SOUTH FRENCH DOORS

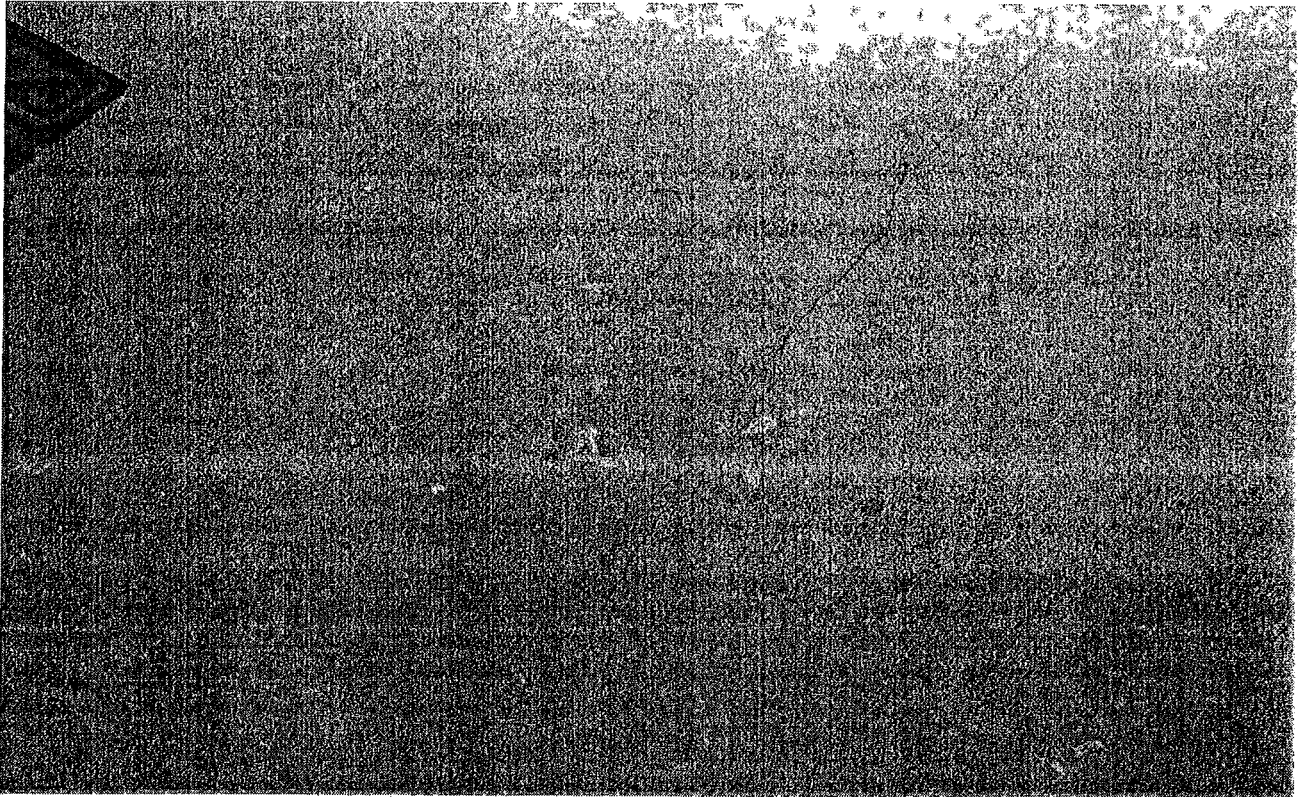
VIEW 23: SLAB CRACK - BACK OF HOUSE - BACK PORCH, NEAR PICTURE # 22

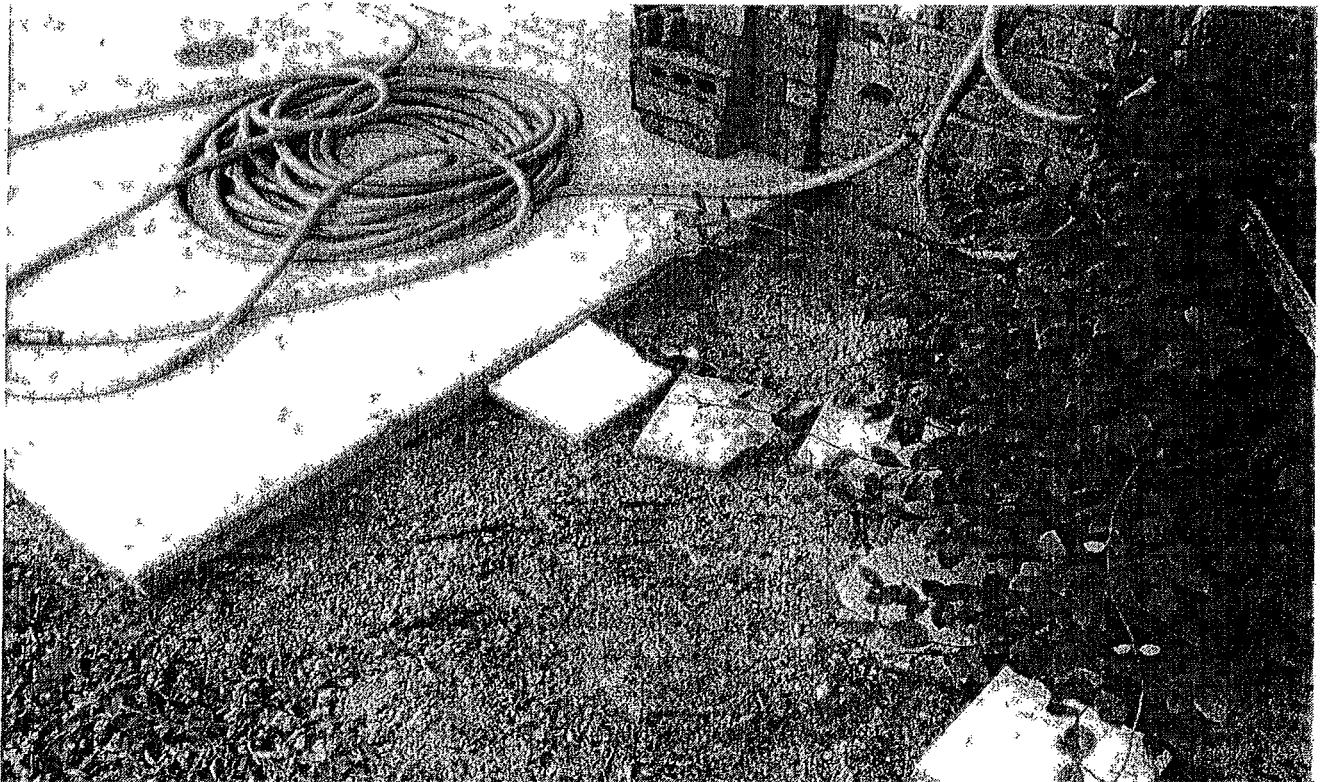
VIEW 24: DEPRESSED AREA - BACK OF HOUSE - SOUTH END OF BACK PATIO SLAB

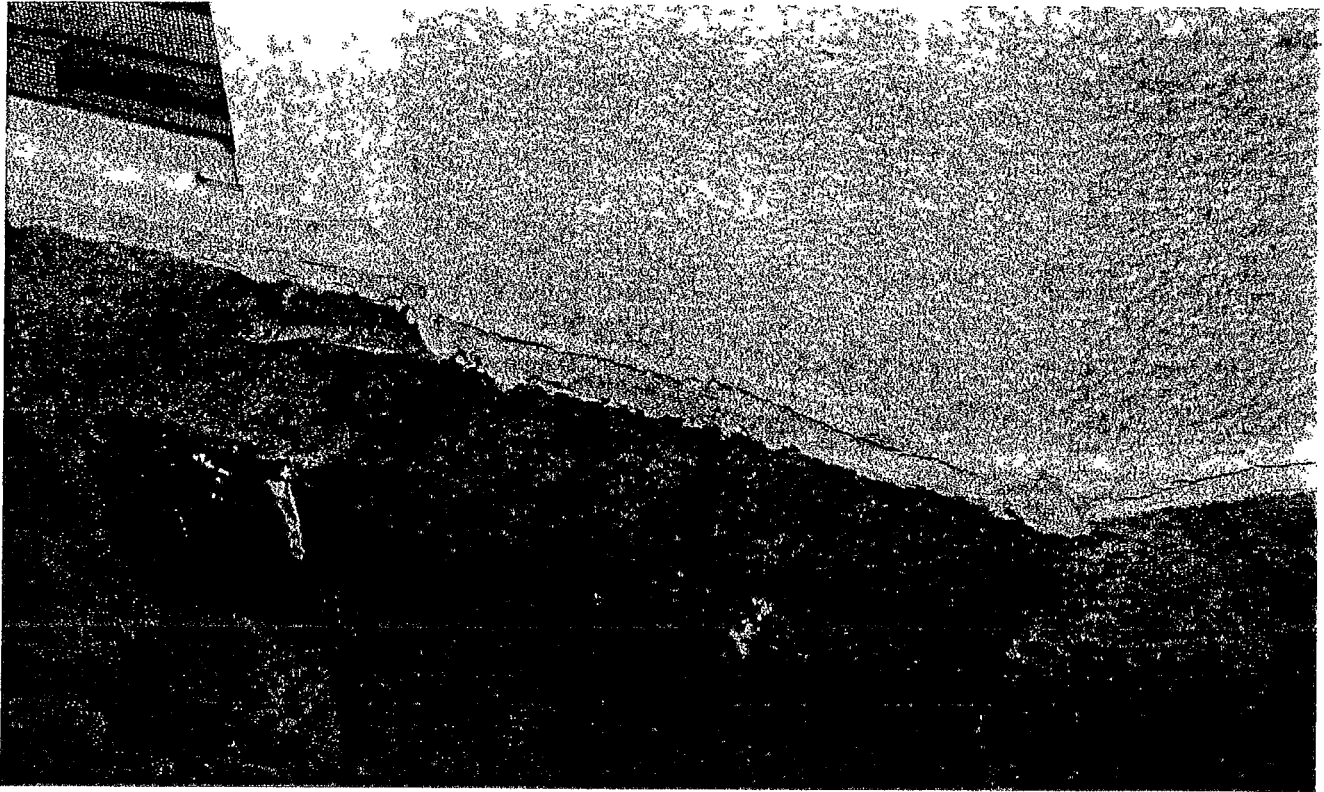
VIEW 25: HORIZONTAL SEPARATION - BACK OF HOUSE - SOUTH BAY WINDOW, NORTH END
