**FOUNDATION CERTIFICATION REPORT  
SOSA RESIDENCE  
152 SW NIGHTSHADE DRIVE  
LAKE CITY, FLORIDA 32024**

**MAY 21, 2014  
FOUNDATION CERTIFICATION REPORT  
JOB #14-3258**

Subject: Report of Settlement Investigation  
Existing One Story Masonry Block House  
Sosa Residence, 152 SW Nightshade Drive  
Lake City, Columbia County, Florida

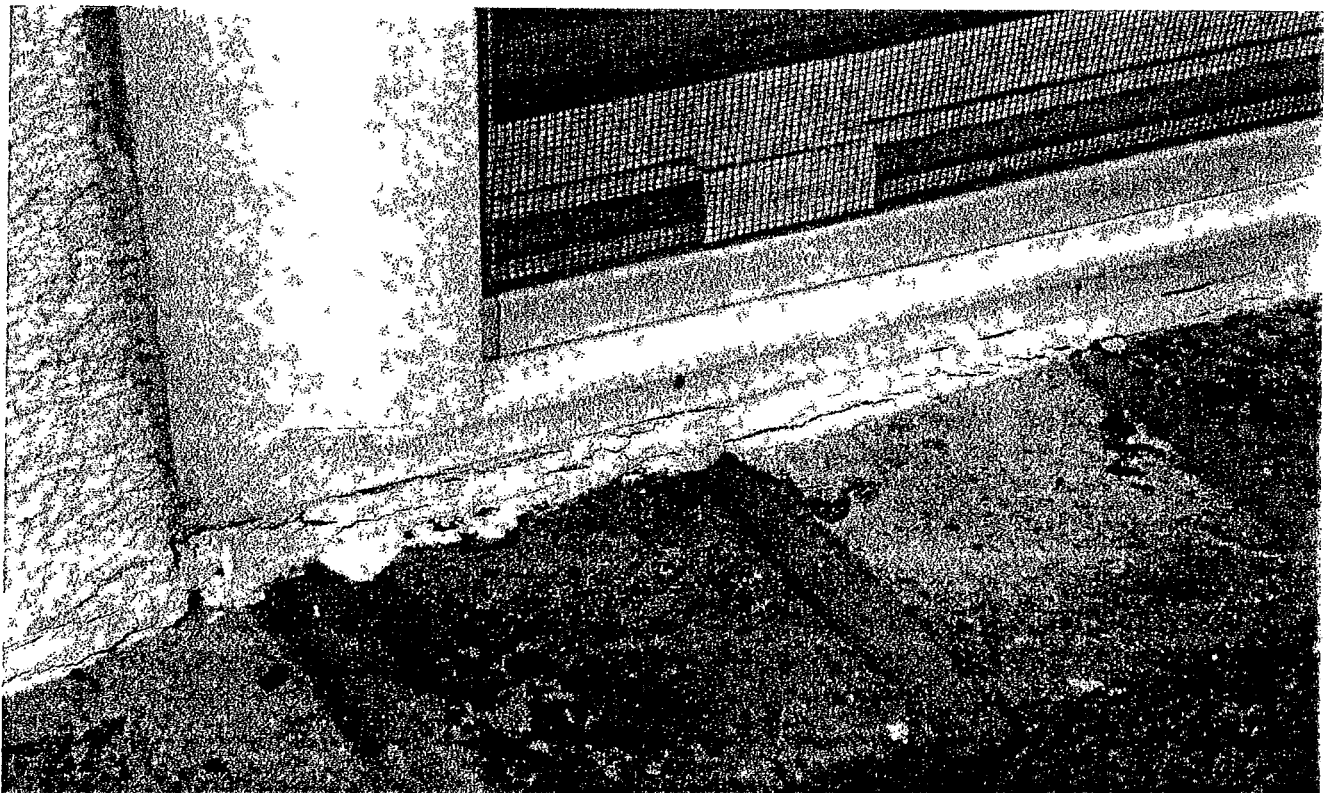
VIEW 26: WINDOW SEPARATION - BACK OF HOUSE - SOUTH BAY WINDOW, SOUTH END

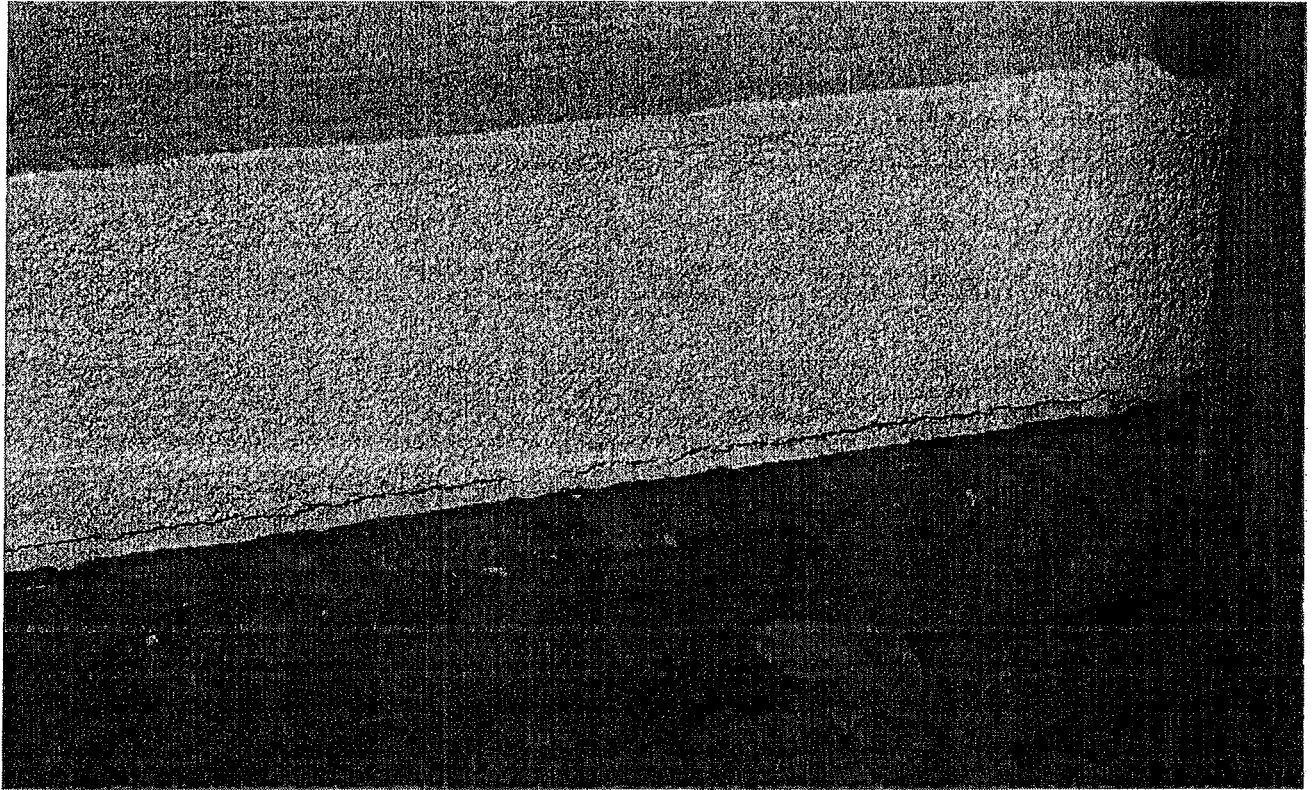
VIEW 27: HORIZONTAL CRACK - BACK OF HOUSE - SOUTH OF SOUTH BAY WINDOW, NEAR GATE

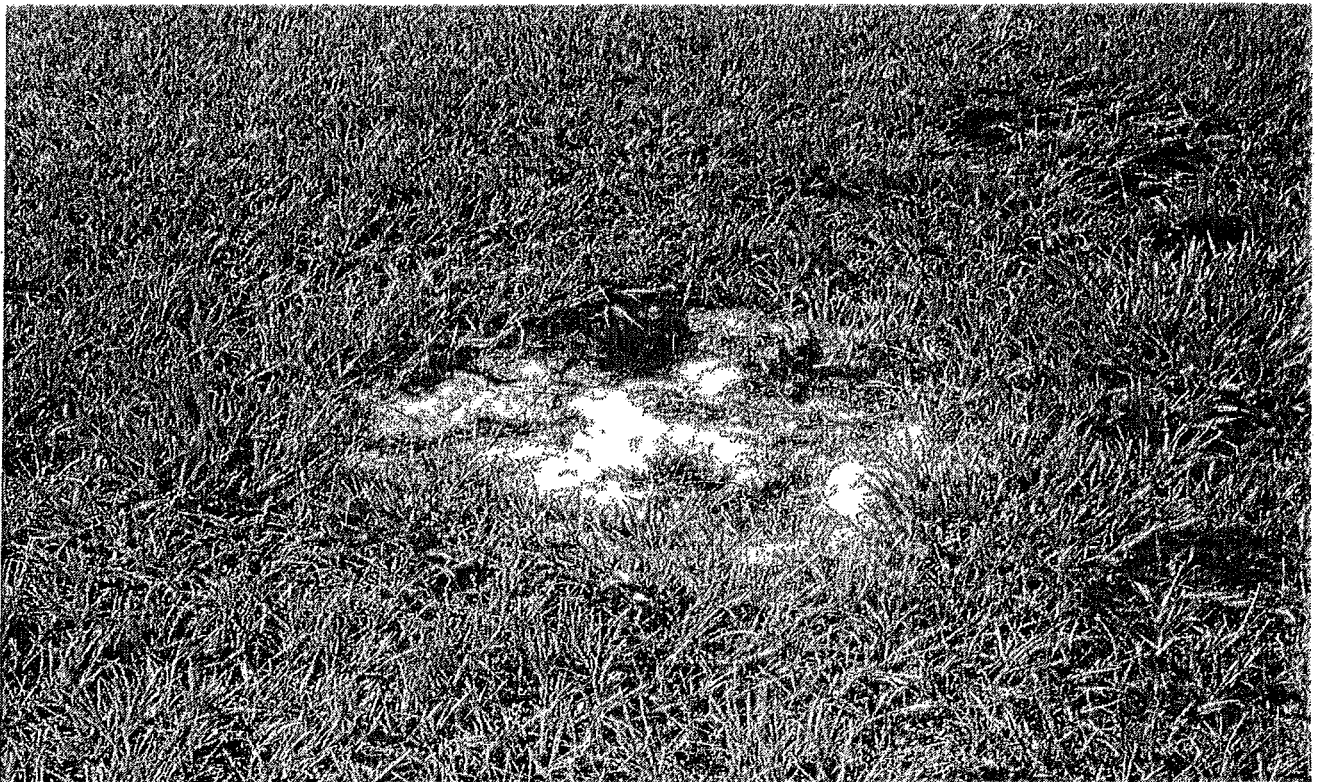
VIEW 28: VIEW OF DEPRESSION IN FRONT YARD - FILLED IN BY HOME OWNER

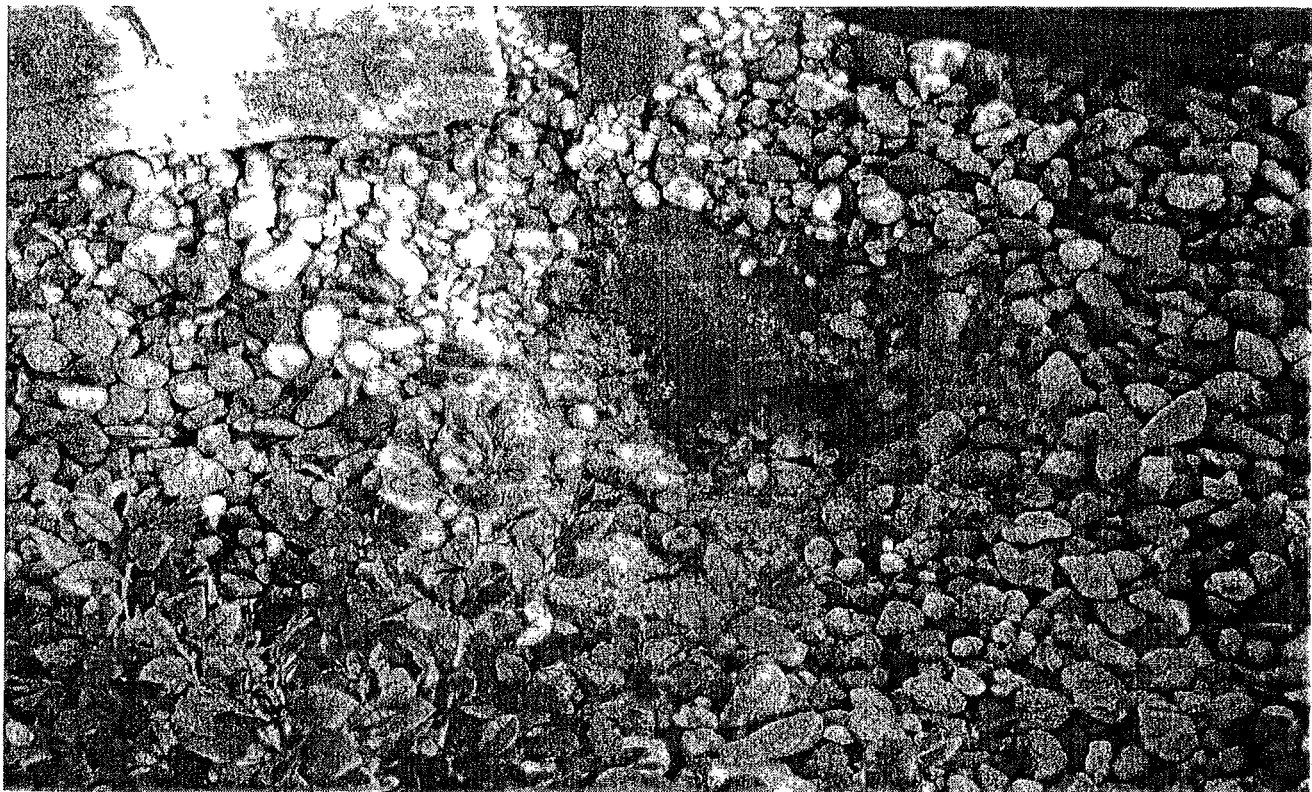
VIEW 29: VIEW OF DEPRESSION - NORTHEAST CORNER OF HOUSE

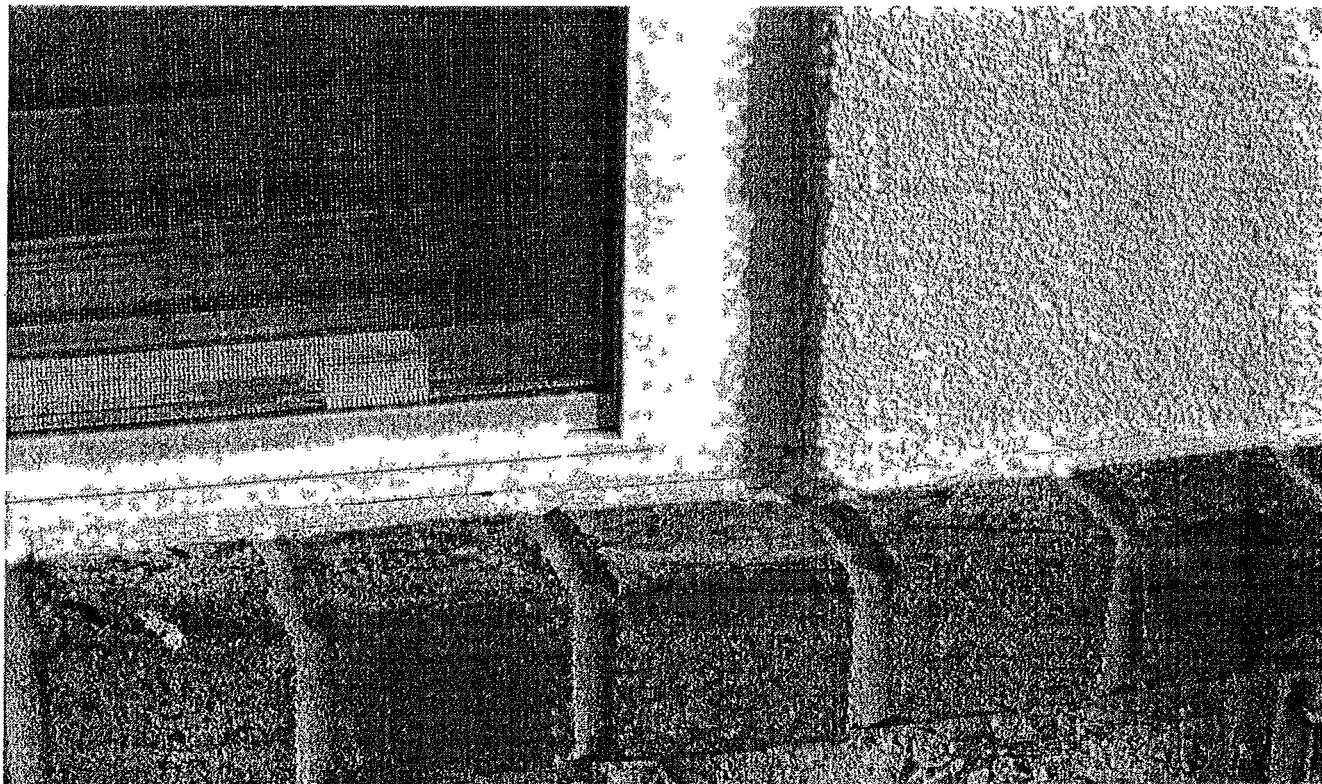
VIEW 30: WINDOW SEPARATION - FRONT OF HOUSE - NORTH WINDOW

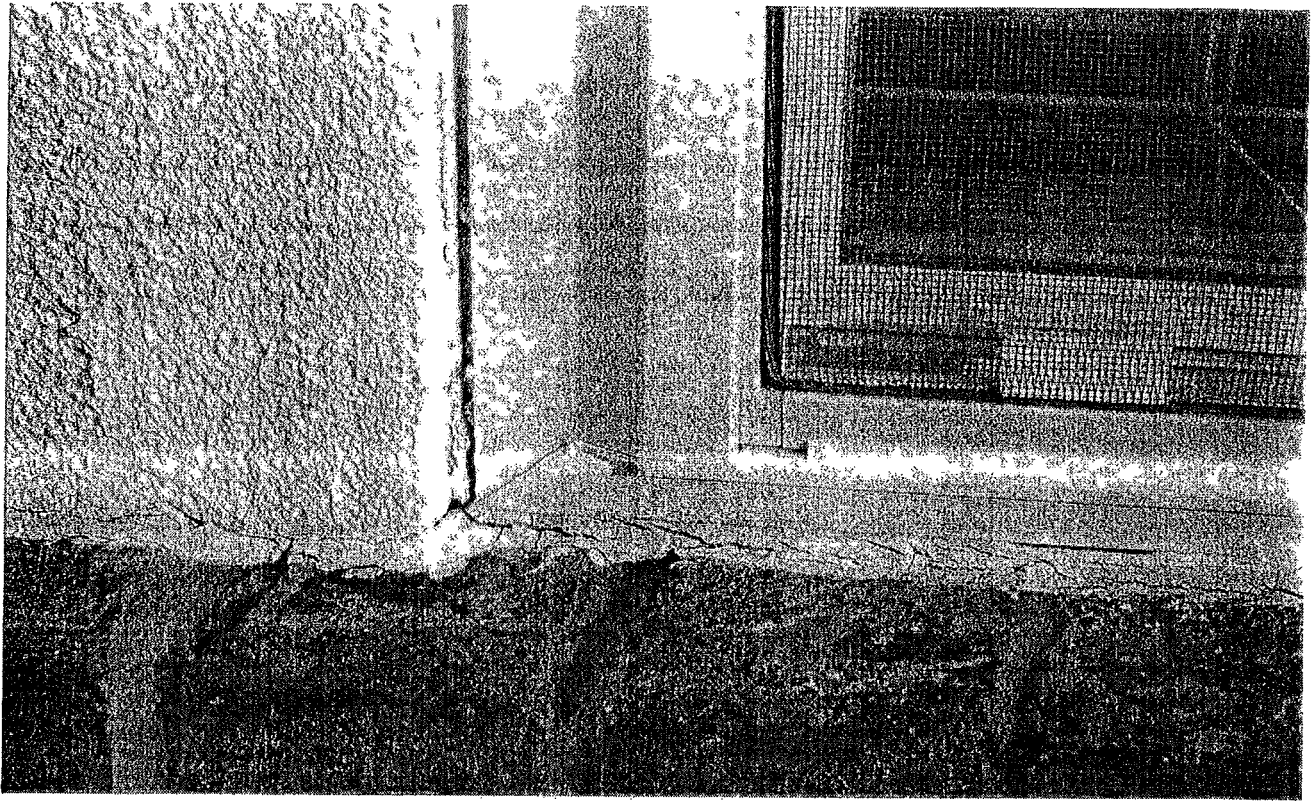
VIEW 31: WINDOW SEPARATION - FRONT OF HOUSE - 2<sup>ND</sup> WINDOW FROM NORTH

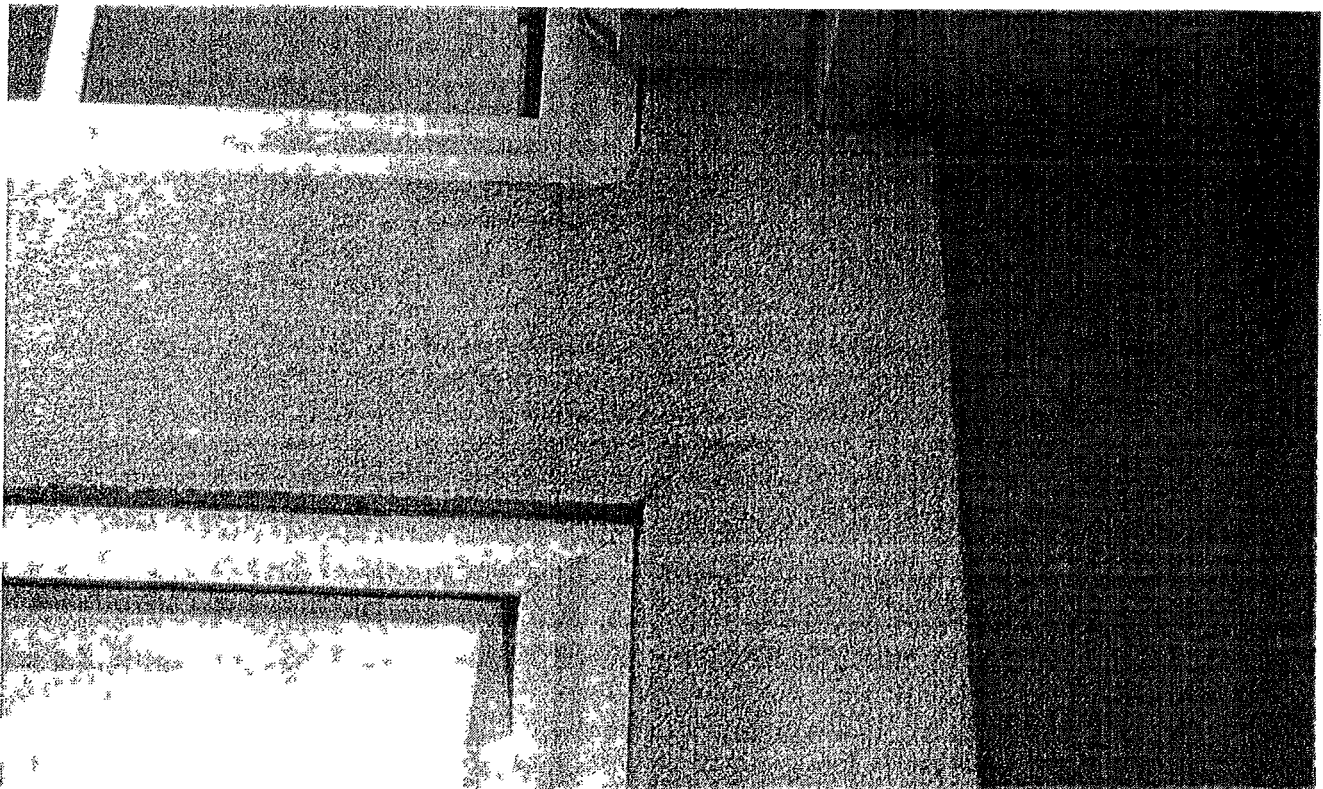
VIEW 32: DIAGONAL CRACK - FRONT OF HOUSE - ABOVE 4<sup>TH</sup> WINDOW FROM SOUTH

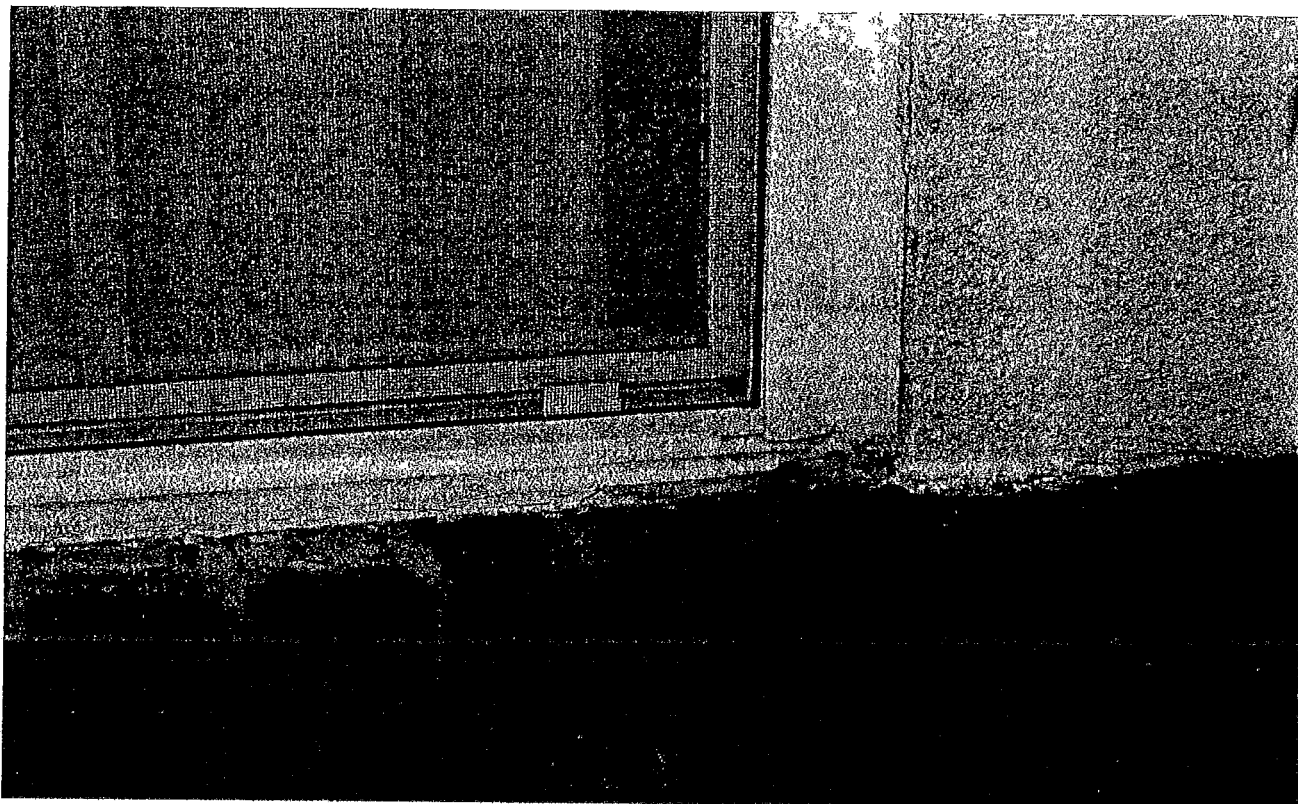
VIEW 33: WINDOW SEPARATION - FRONT OF HOUSE - ABOVE 4<sup>TH</sup> WINDOW FROM SOUTH

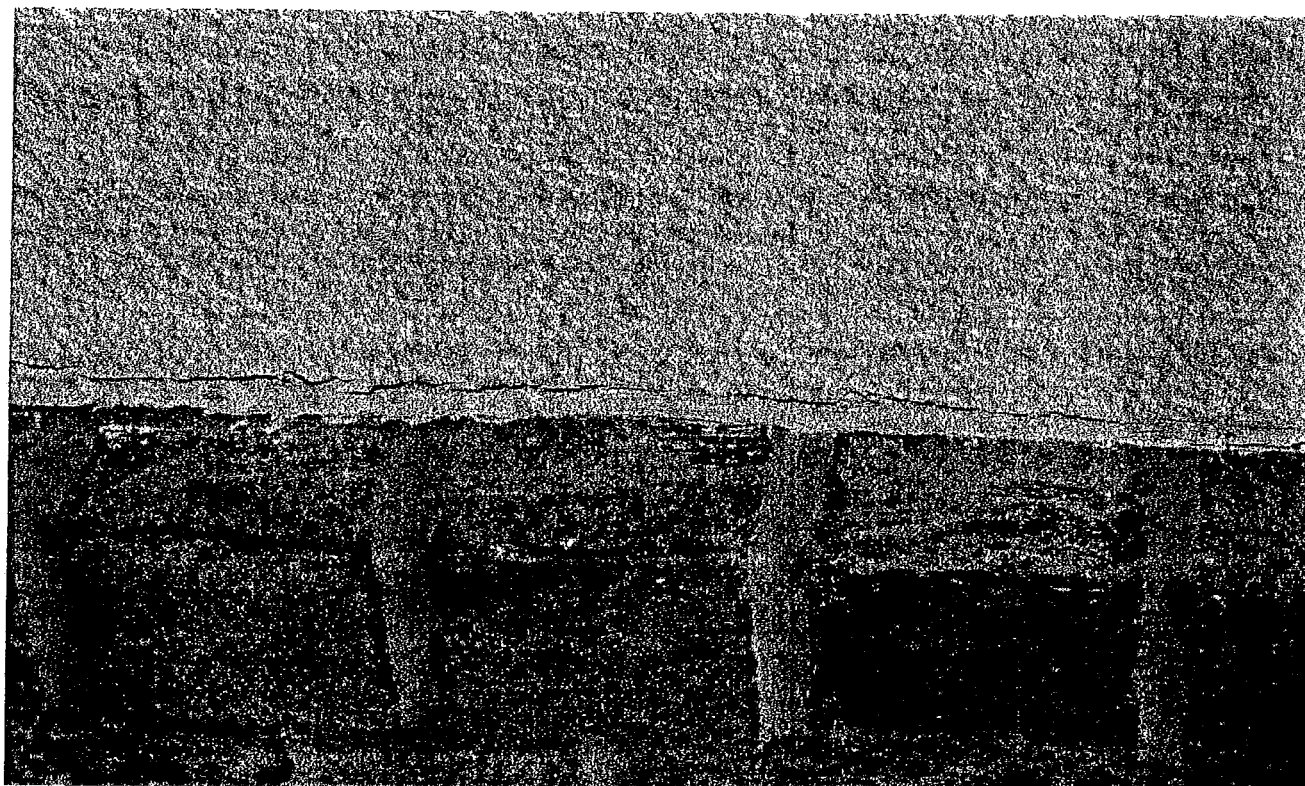
VIEW 34: HORIZONTAL SEPARATION - FRONT OF HOUSE - NORTH FRONT PORCH WALL, EAST END

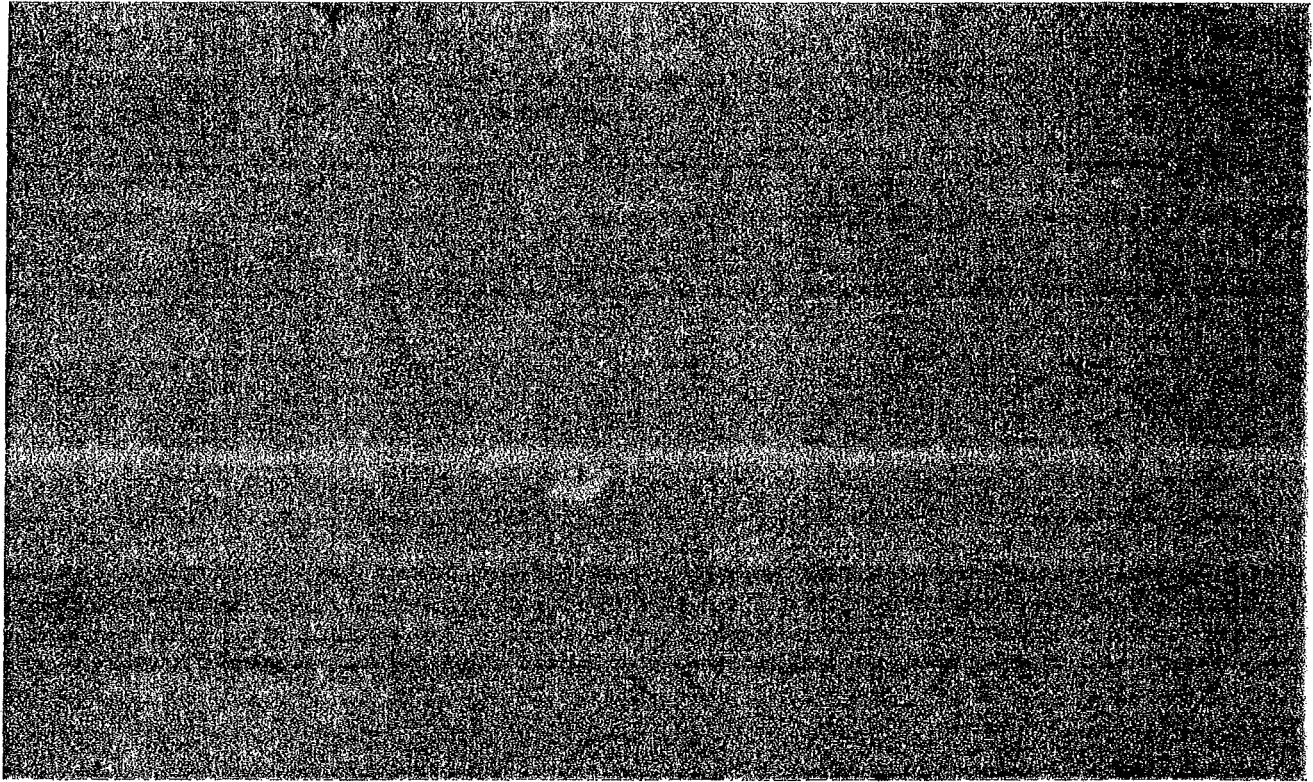
VIEW 35: SLAB CRACK - FRONT OF HOUSE - UNDER FRONT DOOR

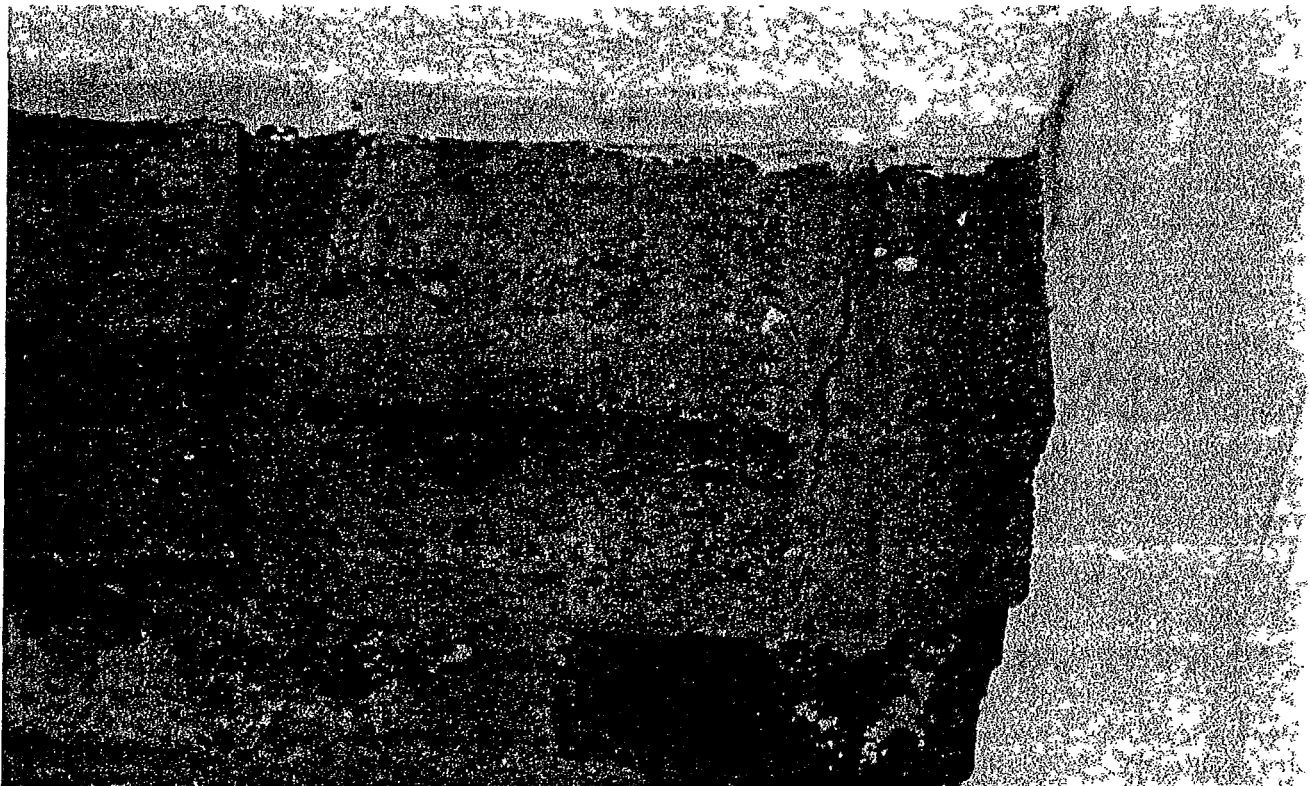
VIEW 36: VERTICAL CRACK - FRONT OF HOUSE - SOUTH OF FRONT DOOR, NEAR GROUND

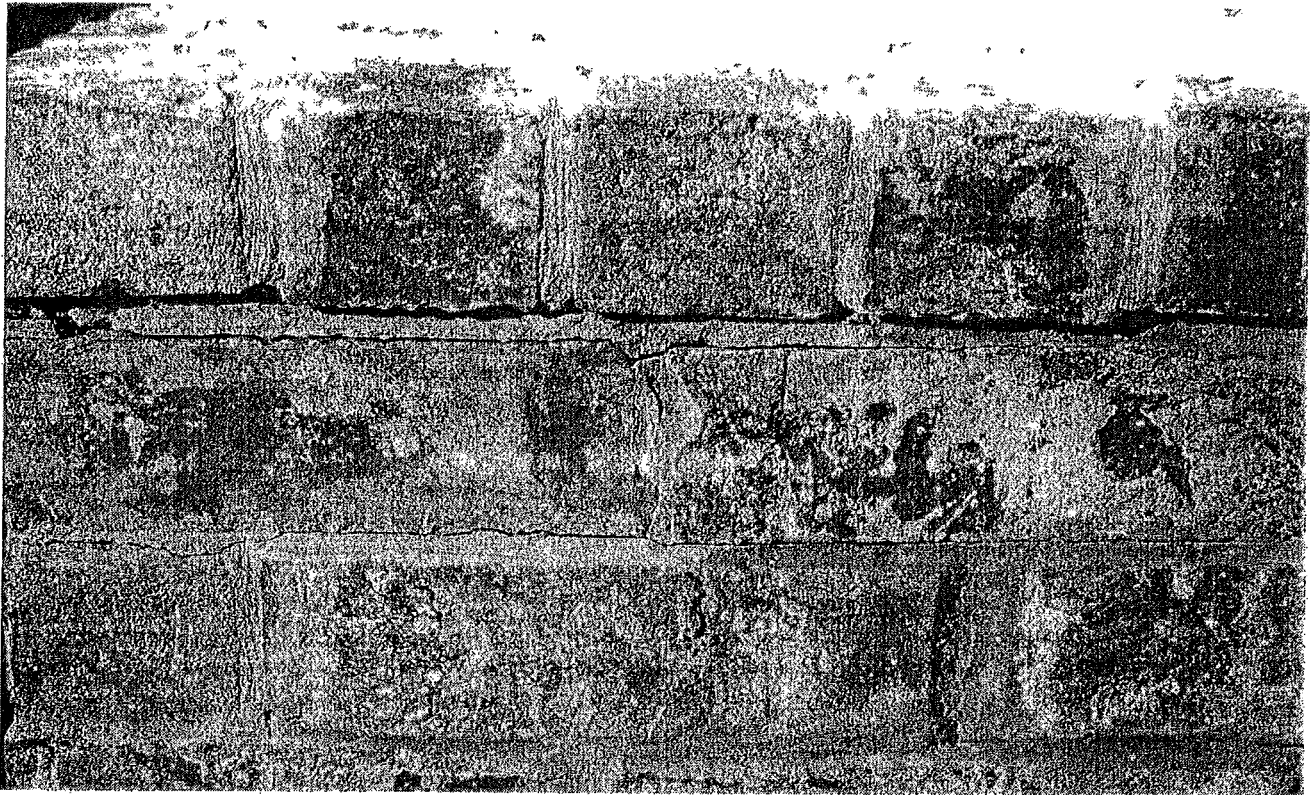
VIEW 37: STEP CRACK - FRONT OF HOUSE - SOUTH FRONT PORCH WALL, EAST END

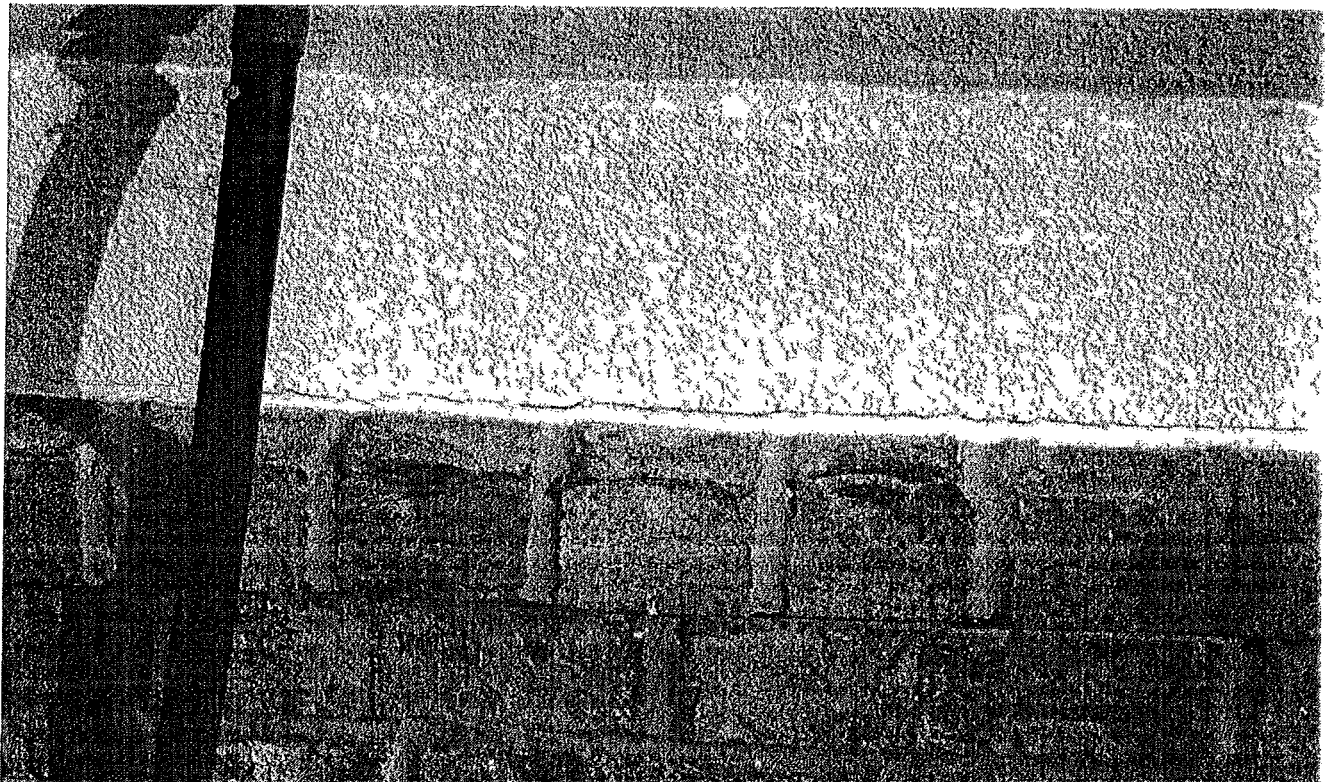
VIEW 38: HORIZONTAL SEPARATION - FRONT OF HOUSE - UNDER SOUTH SPIGOT

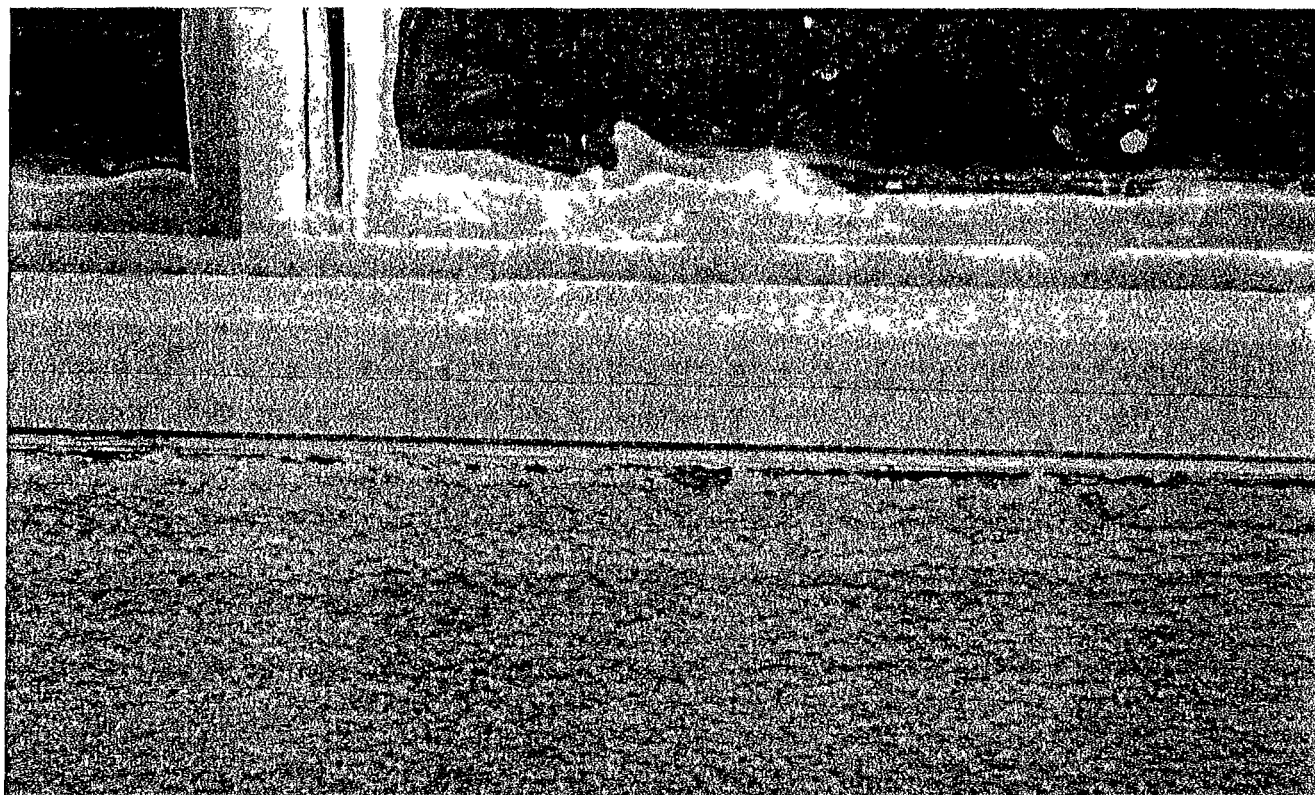
VIEW 39: WINDOW SEPARATION - SOUTH SIDE OF HOUSE - EAST WINDOW

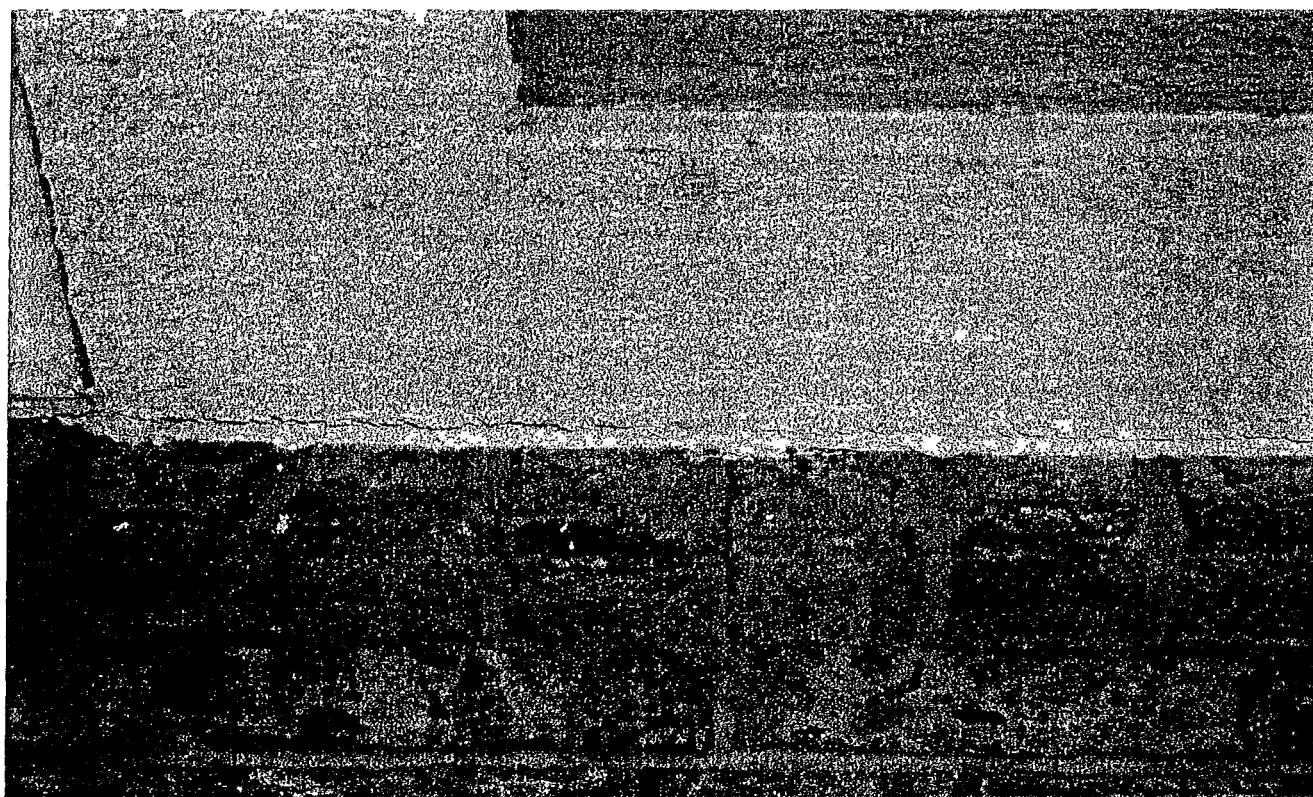
VIEW 40: HORIZONTAL CRACK - SOUTH SIDE OF HOUSE - EAST OF WEST WINDOW

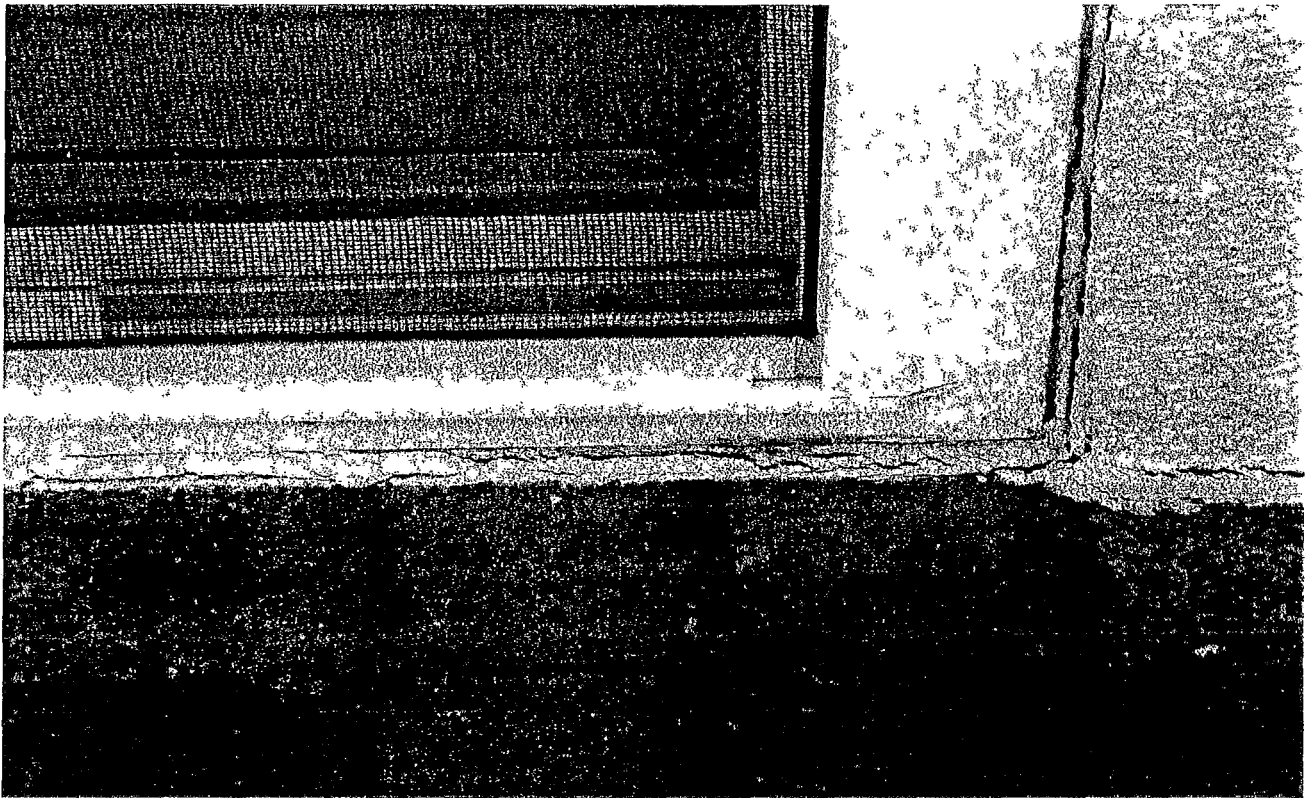
VIEW 41: WINDOW SEPARATION - SOUTH SIDE OF HOUSE - WEST WINDOW

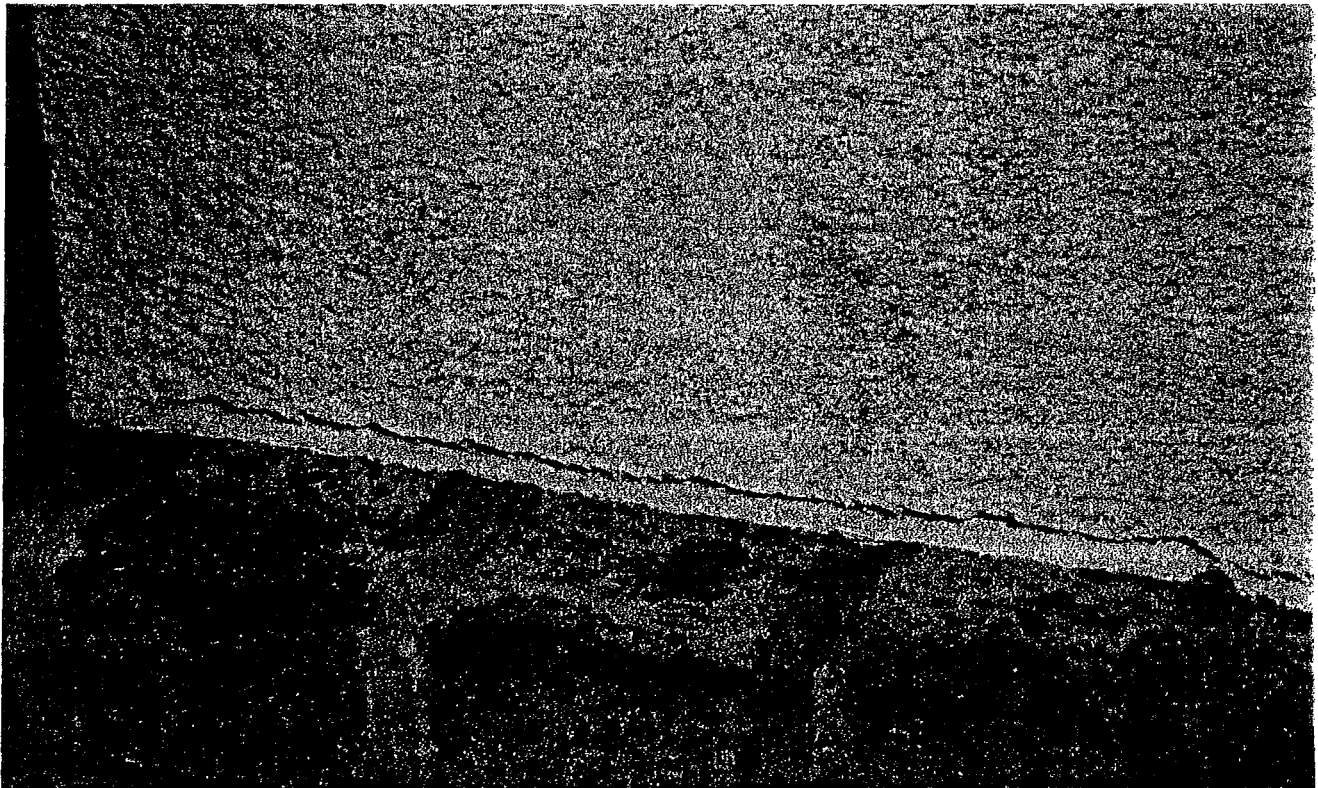
VIEW 42: HORIZONTAL CRACK - SOUTH SIDE OF HOUSE - SOUTHWEST CORNER

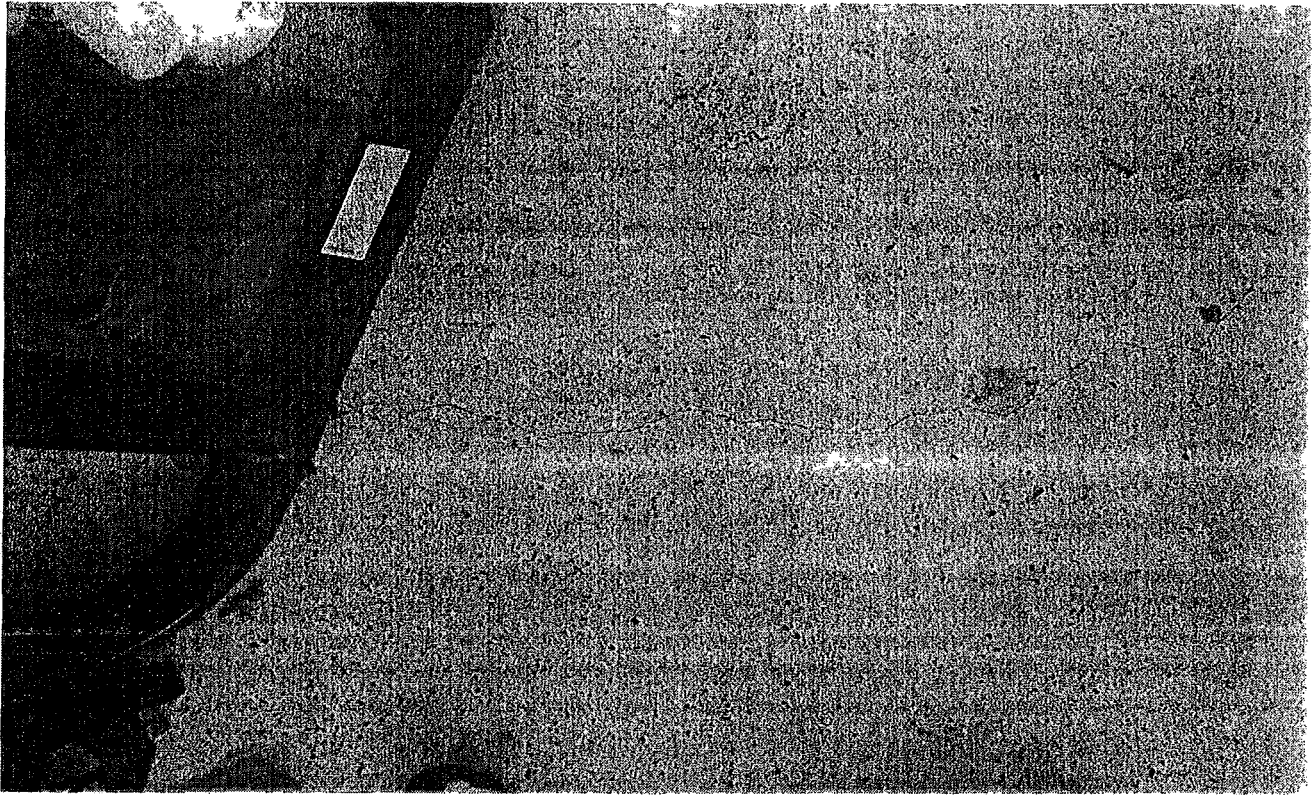
VIEW 43: SLAB CRACK - GARAGE - EAST END

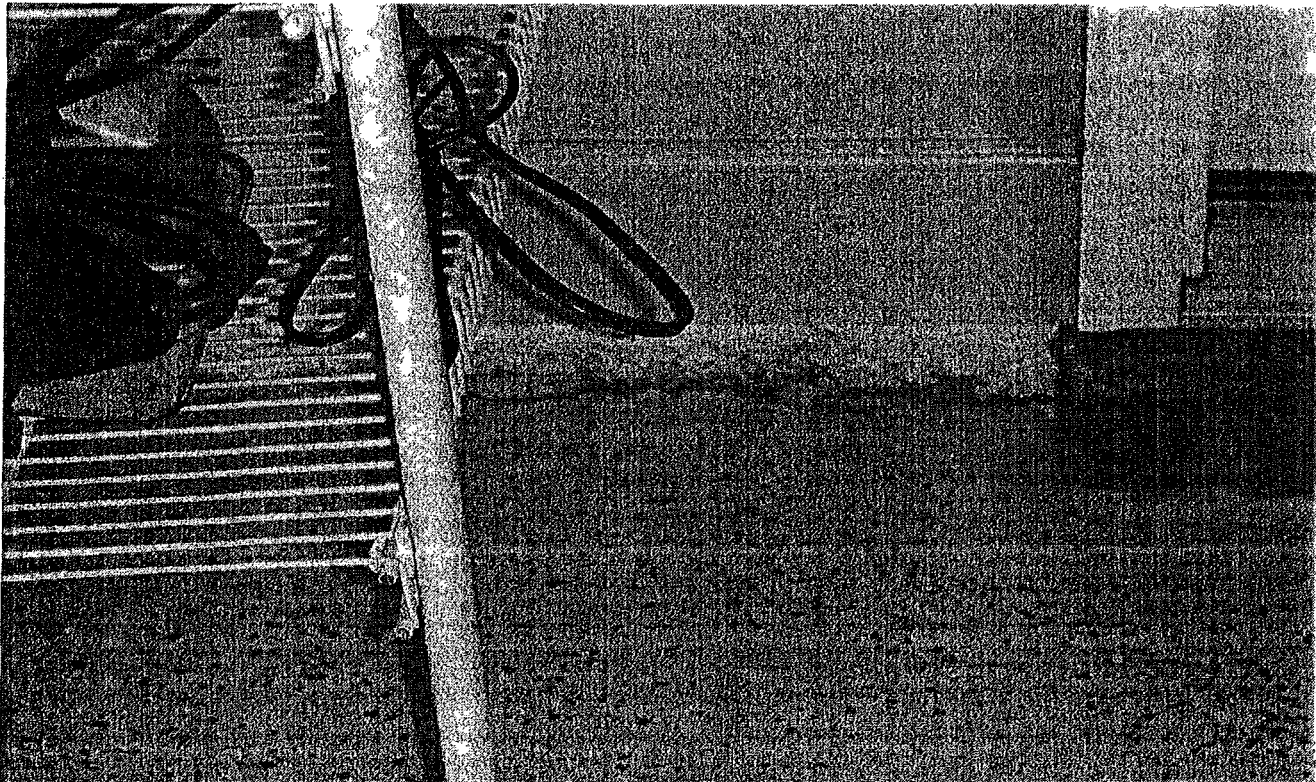
VIEW 44: SLAB SEPARATION - GARAGE - SOUTHWEST CORNER

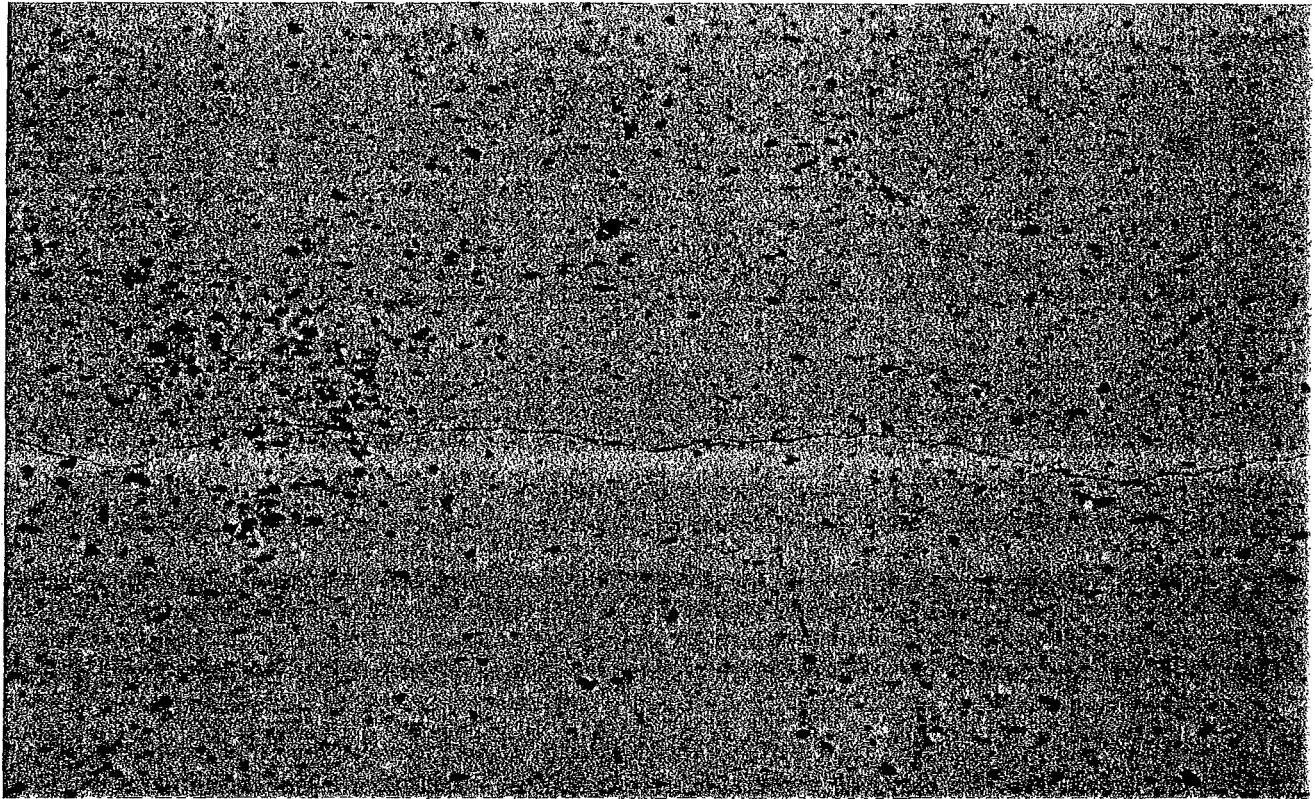
VIEW 45: SLAB CRACK - GARAGE - WEST END

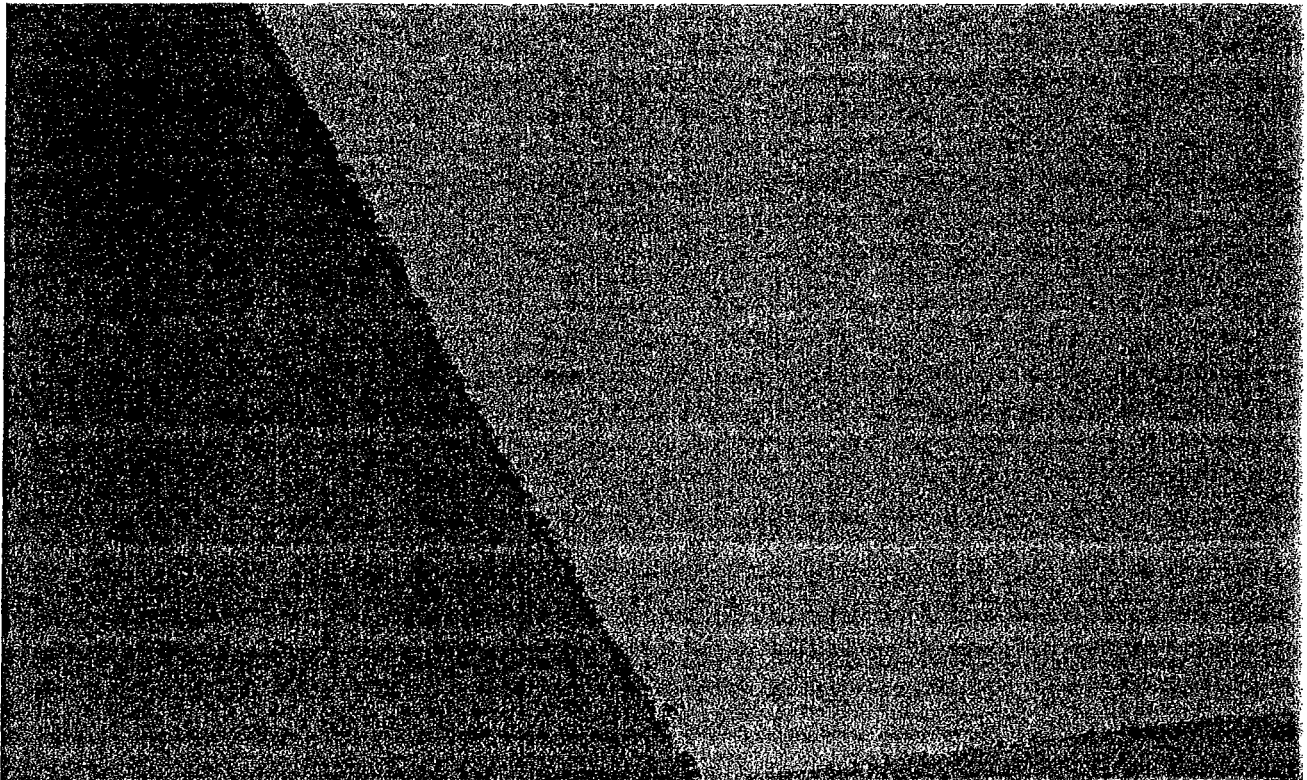
VIEW 46: NAIL POP - GARAGE - ABOVE FUSE BOX, WEST WALL

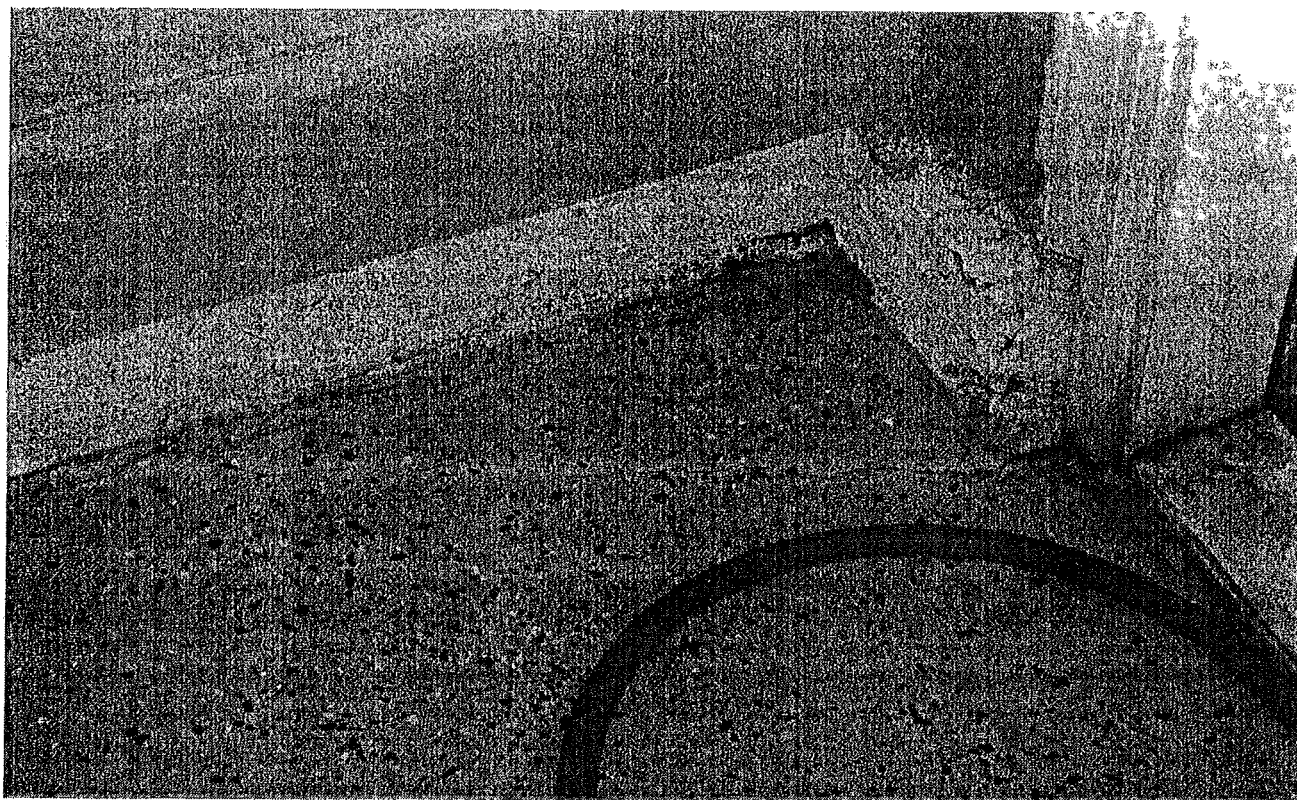
VIEW 47: SLAB CRACK - GARAGE - NORTHWEST CORNER
