**FOUNDATION CERTIFICATION REPORT  
SOSA RESIDENCE  
152 SW NIGHTSHADE DRIVE  
LAKE CITY, FLORIDA 32024**

**MAY 21, 2014  
FOUNDATION CERTIFICATION REPORT  
JOB #14-3258**

Subject: Report of Settlement Investigation  
Existing One Story Masonry Block House  
Sosa Residence, 152 SW Nightshade Drive  
Lake City, Columbia County, Florida

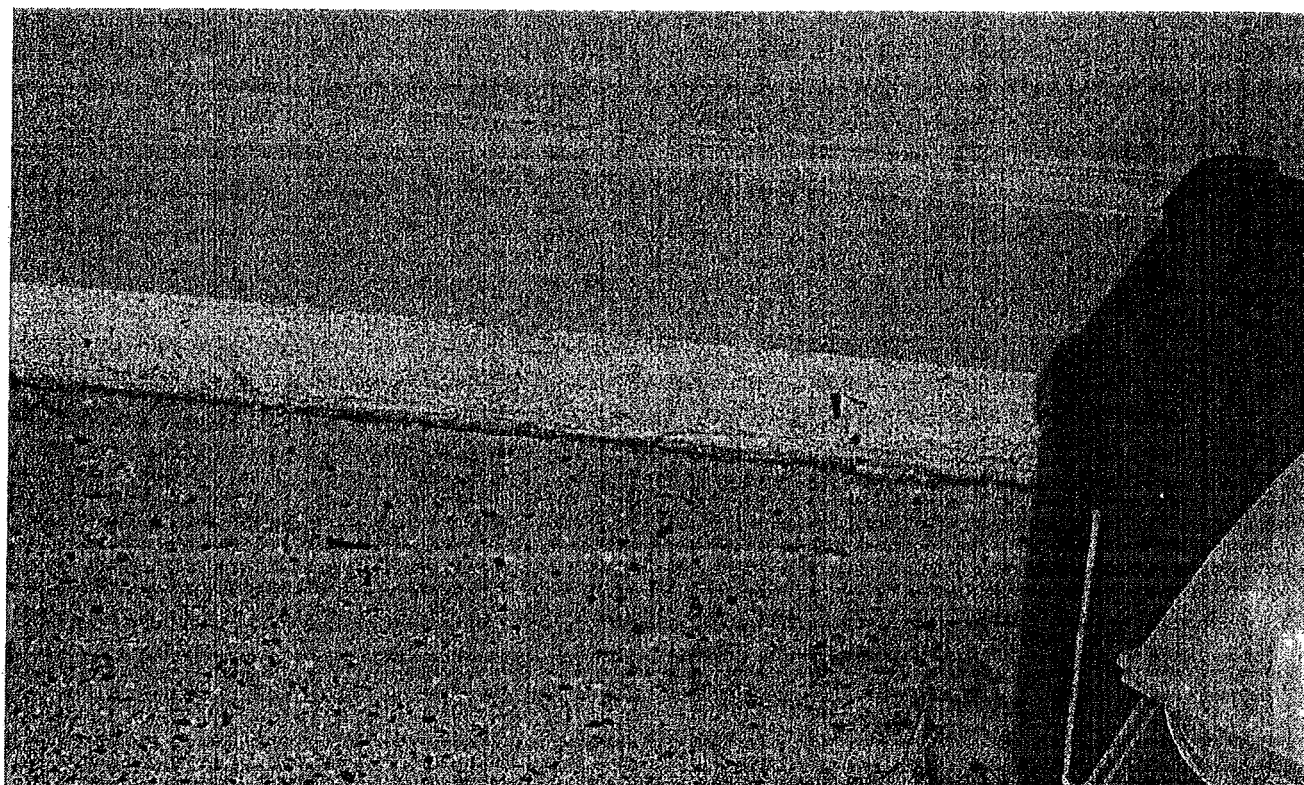
VIEW 48: SLAB SEPARATION - GARAGE - NEAR PICTURE # 47

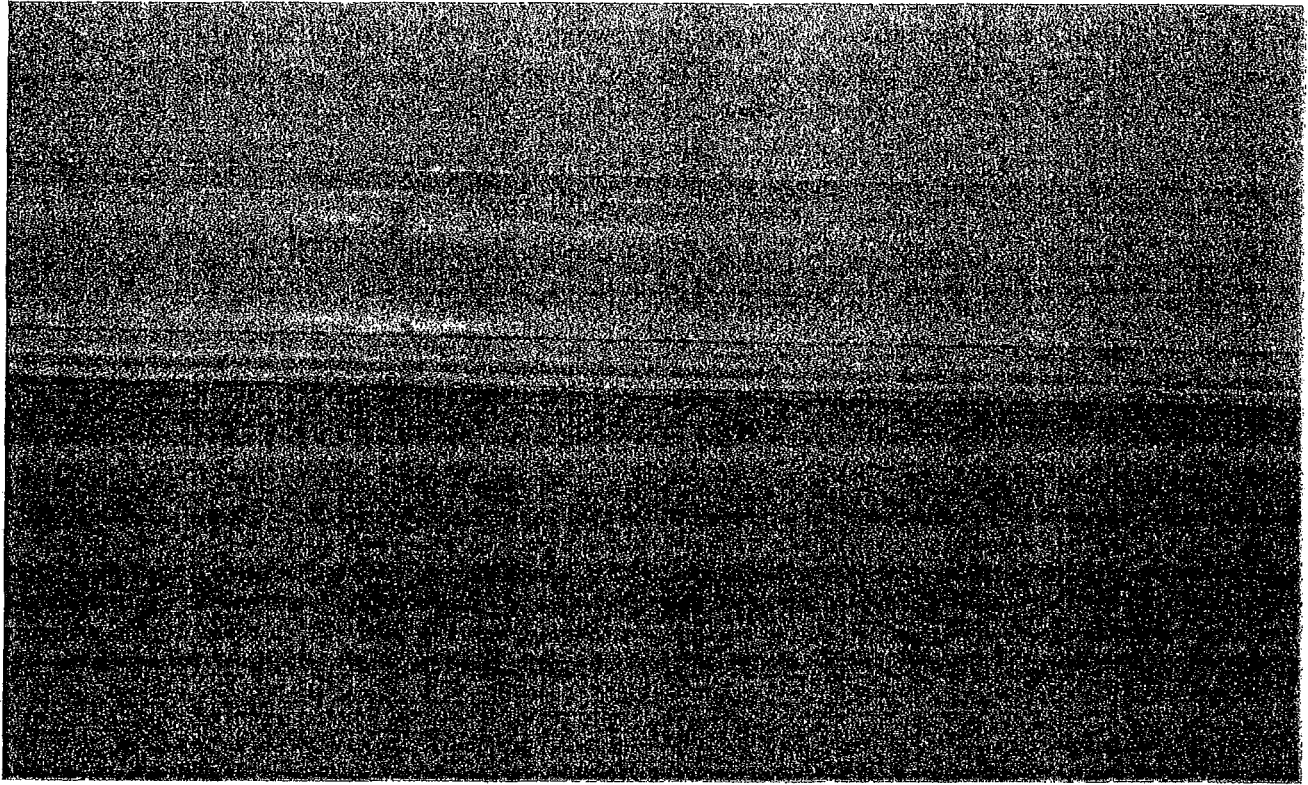
VIEW 49. CEILING TRIM SEPARATION - KITCHEN - NORTH WALL

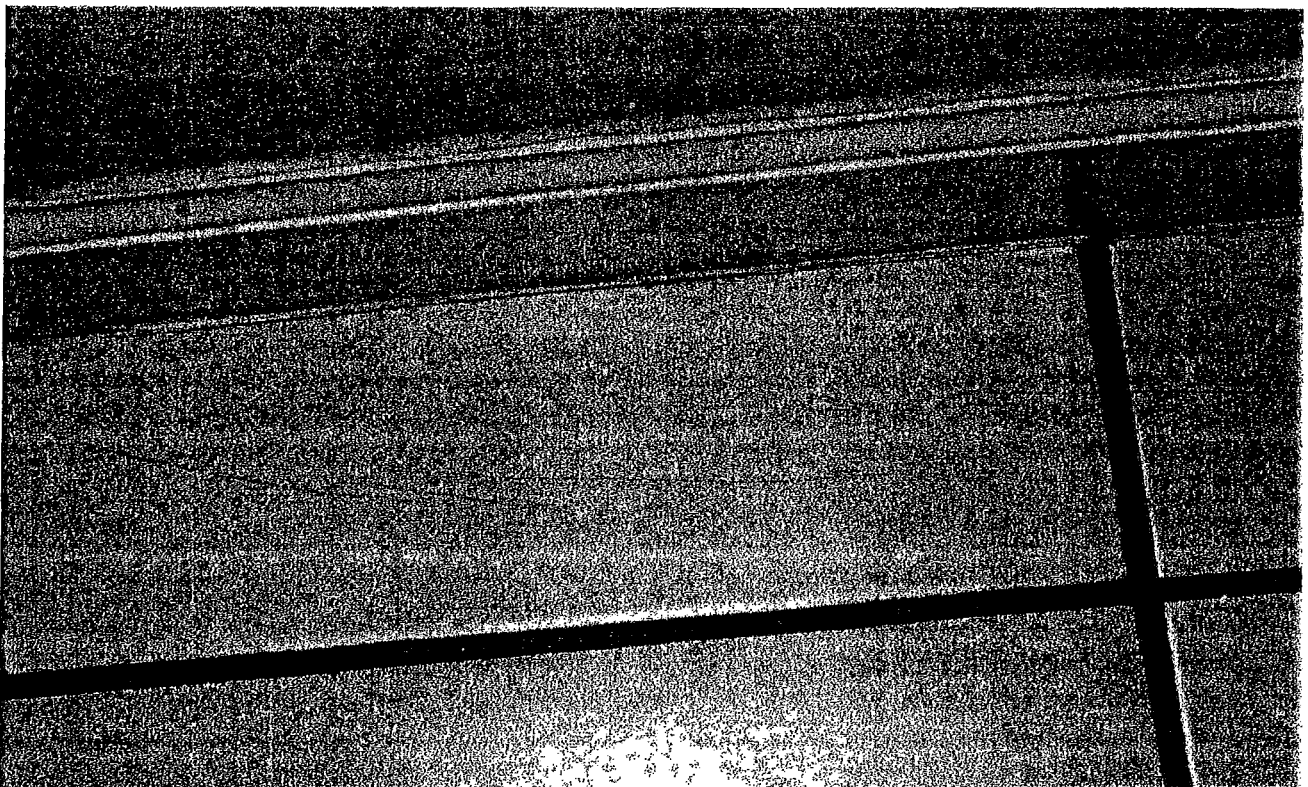
VIEW 50. TILE CRACK - KITCHEN - EAST END, NEAR HALLWAY ENTRANCE

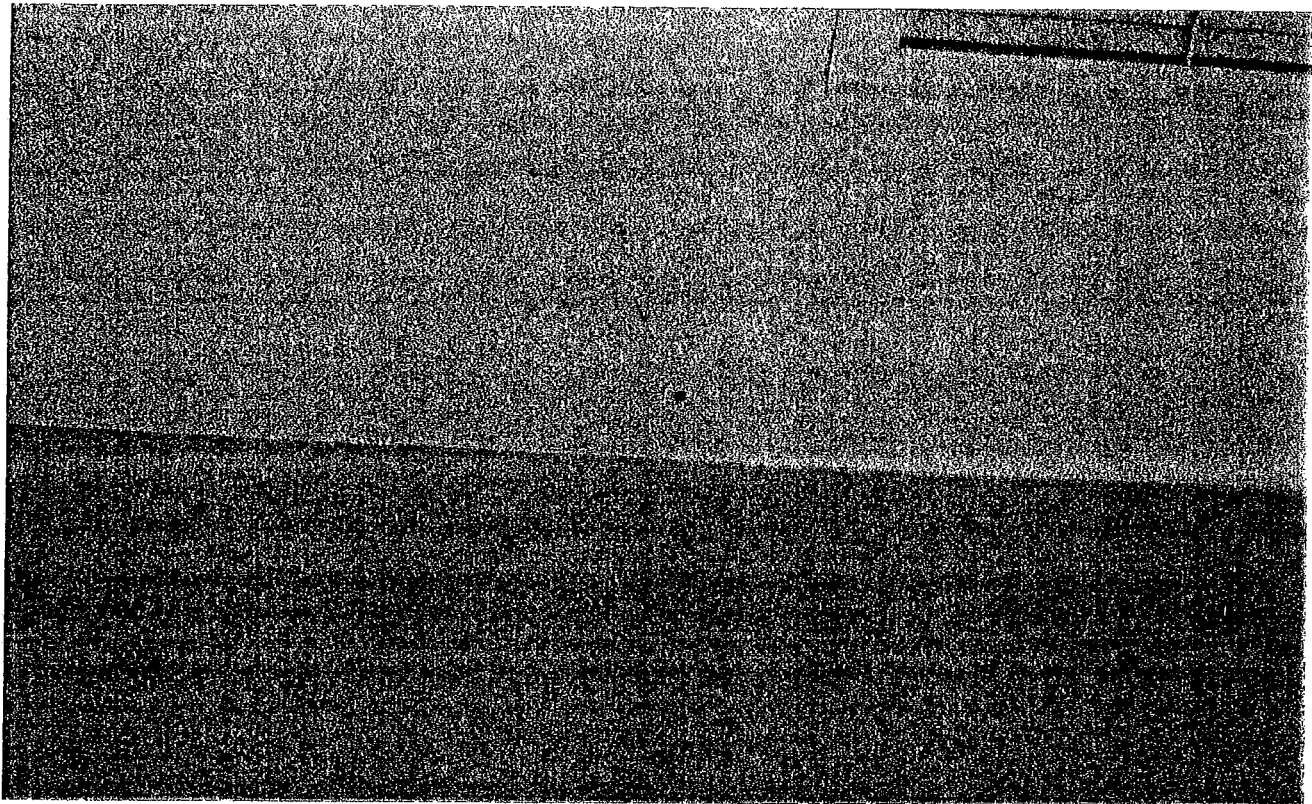
VIEW 51: NAIL POP - EAST BEDROOM - NORTHWEST CORNER OF CEILING

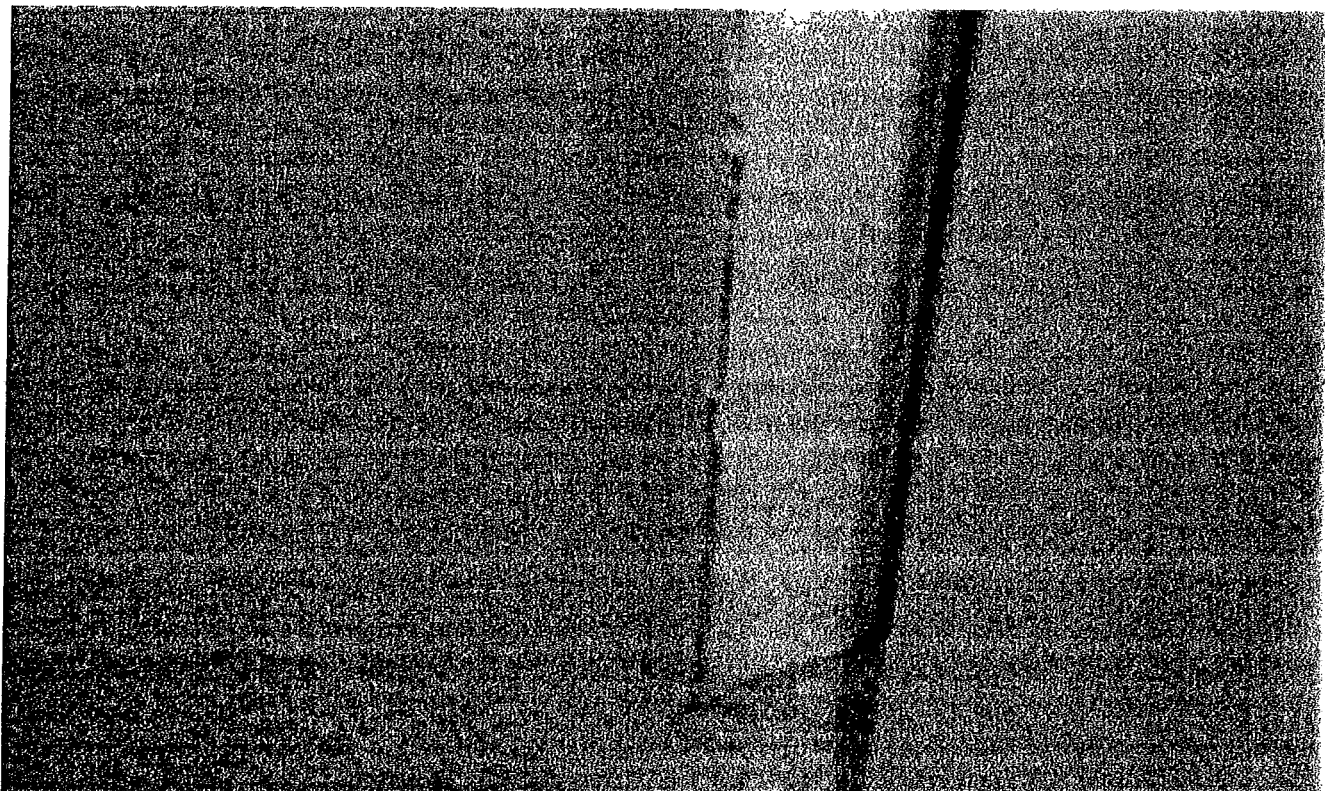
VIEW 52: WINDOW SEPARATION - EAST BEDROOM - EAST WALL

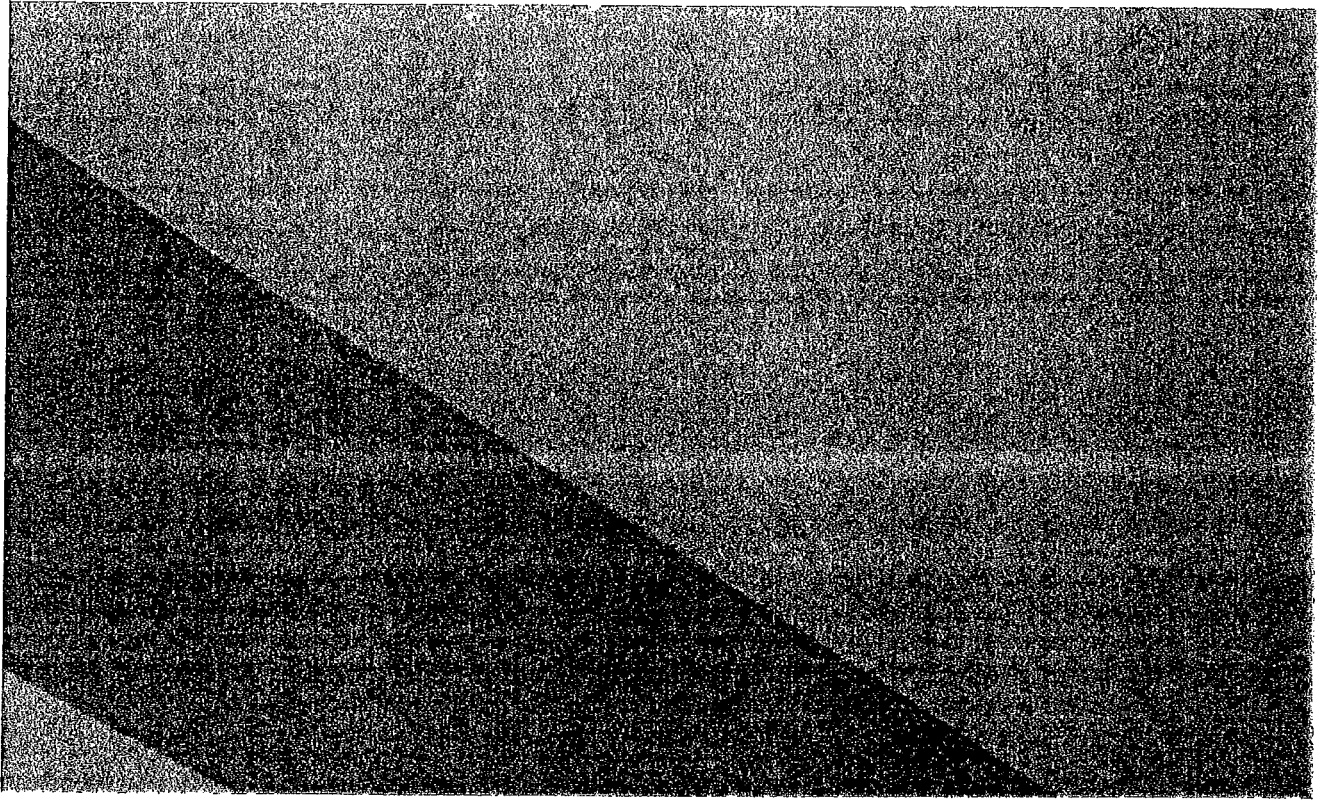
VIEW 53: CEILING CRACK - EAST BEDROOM - ABOVE EAST WALL
