*April 29, 2020*

Project: Welcome Center and Boot Store  
131 Southwest Webbs Glen  
Lake City, Florida 32024

Reference: **Roof Observations**

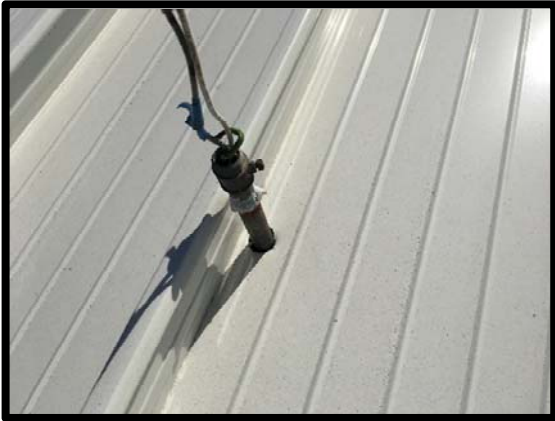
Picture 1: Penetration with no caulking

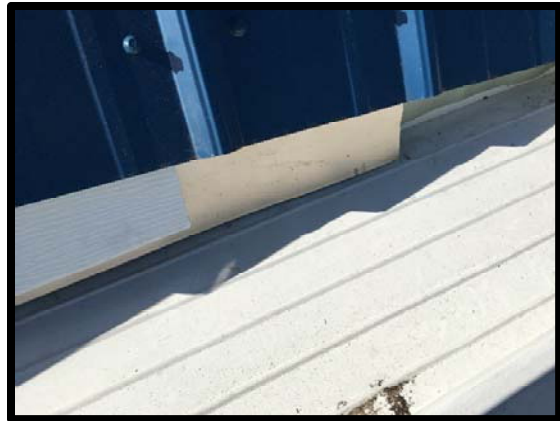
Picture 2: Limited or no flashing

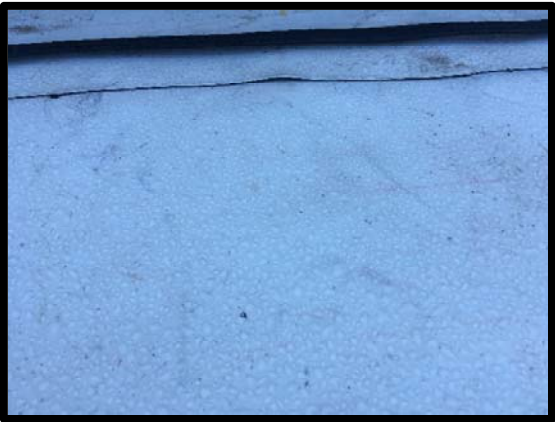
Picture 3: Fish eye in TPO

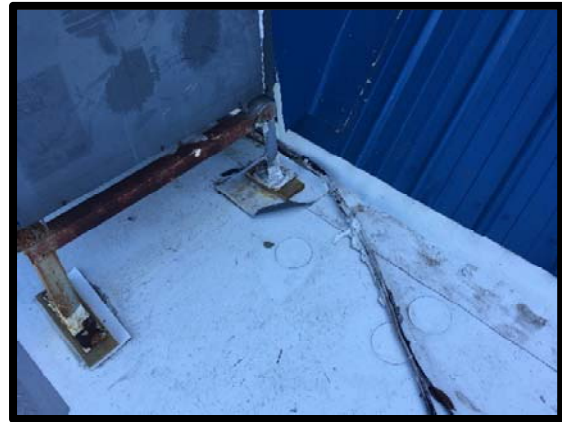
Picture 4: AC Unit on loose TPO section

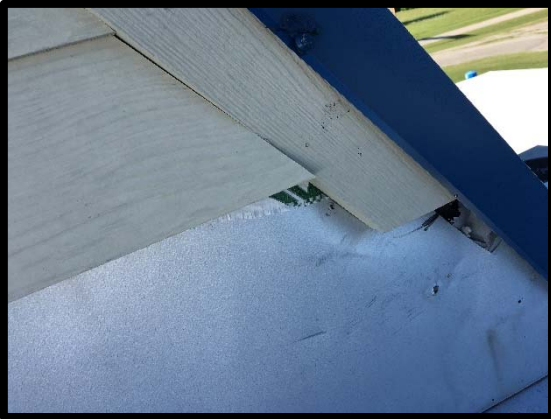
Picture 5: Limited Tyvek behind Hardi plank

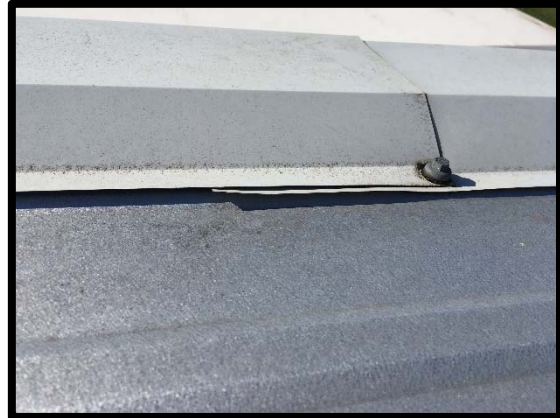
Picture 6: Overlapping of metal decking

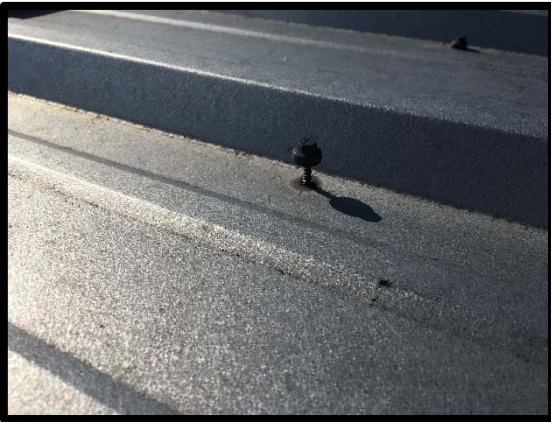
Picture 7: Loose roof screw

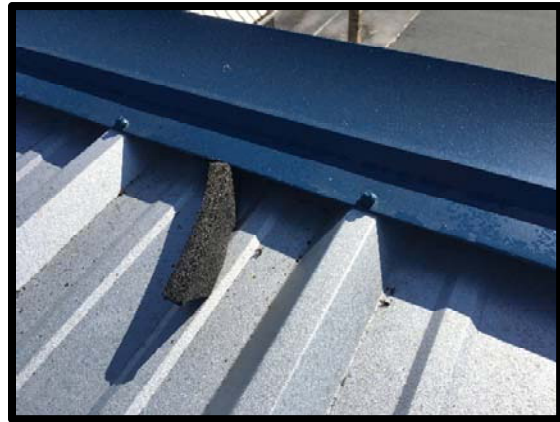
Picture 8: Loose foam beneath roof cap

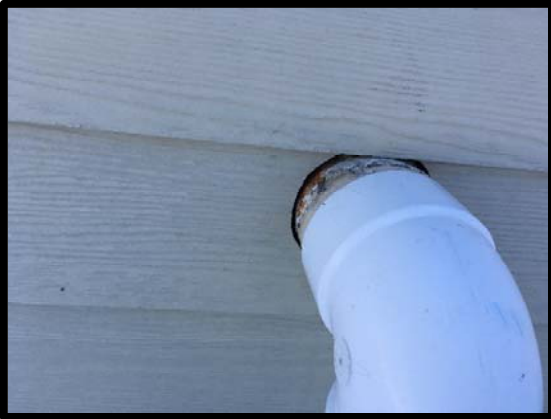
Picture 9: Typical penetration in Hardi plank

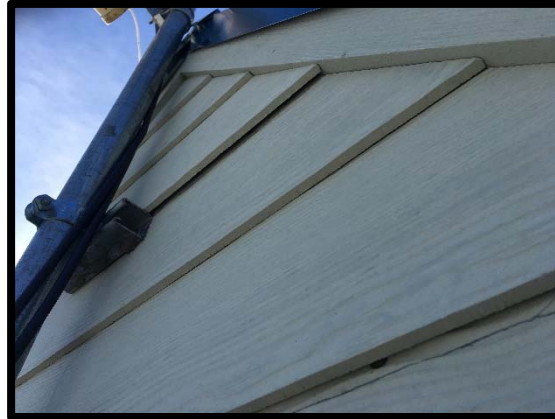
Picture 10: Loose Hardi plank siding

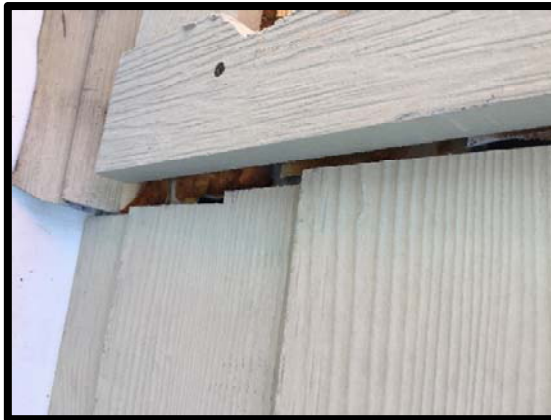
Picture 11: Limited or no Tyvex and caulking at gaps

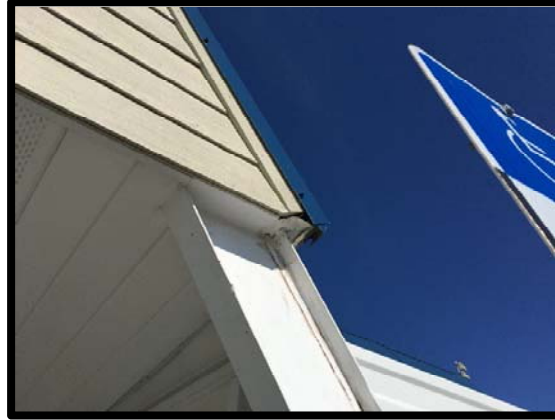
Picture 12: Gap at roof and gable edges
