**ADDENDUM NO 2
2026-F
DECOMMISSIONING AND REMOVING CUMORAH HILL AND
JAIL TOWERS**

NOTICE TO CONTRACTORS

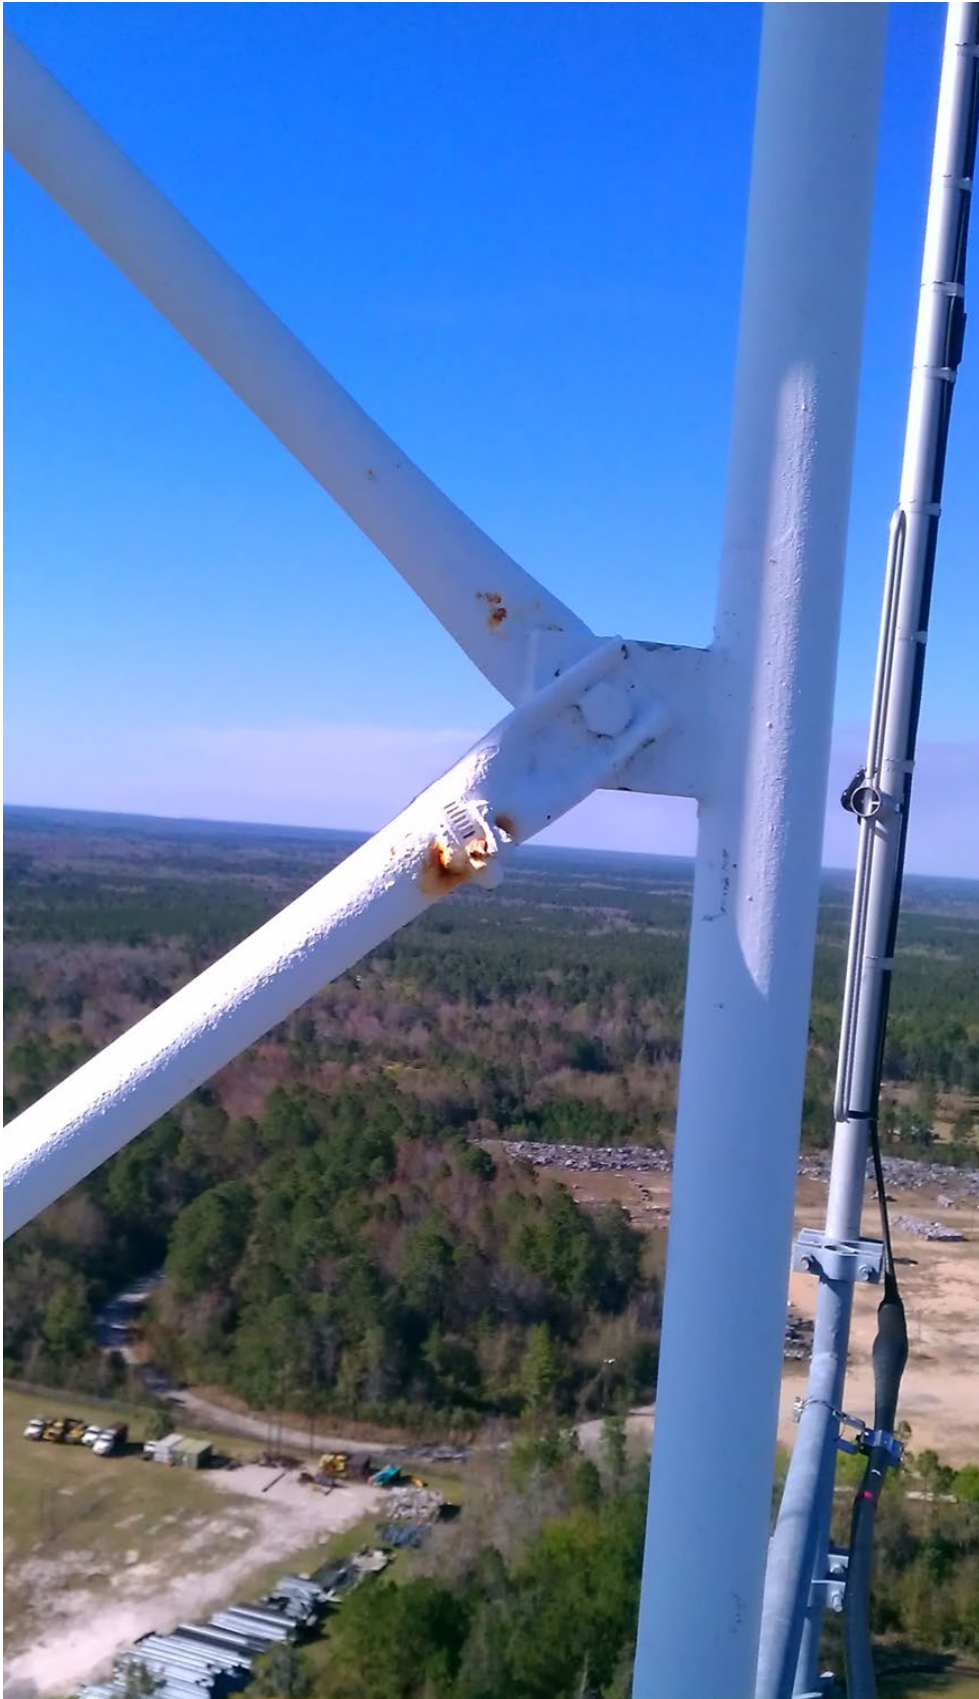
1. At Approximately 340 Feet.

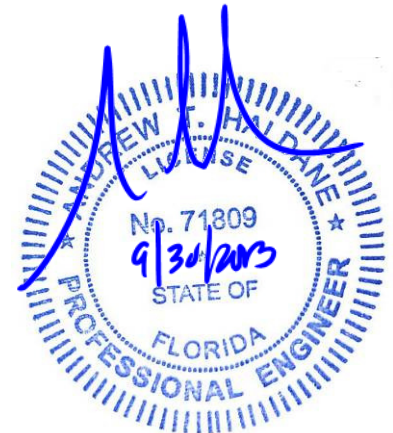
ANSI/TIA-222-G MAINTENANCE AND CONDITION ASSESSMENT

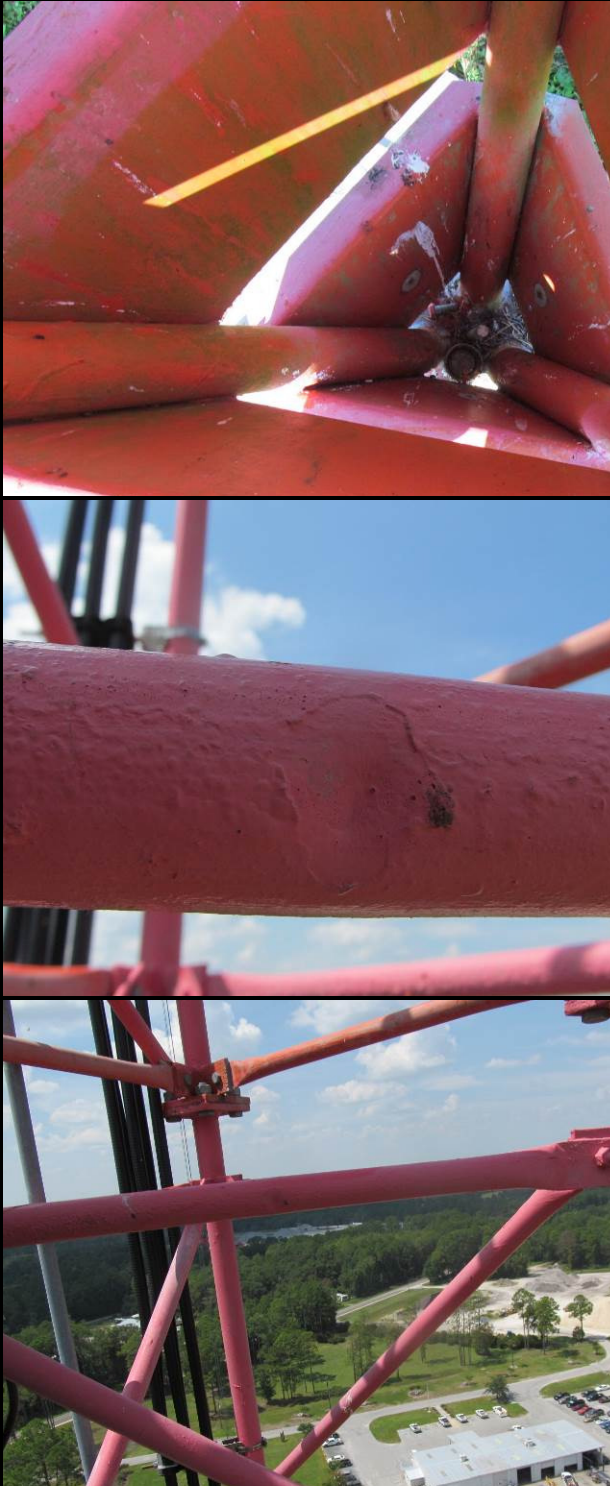
<p><u>A.1. Damaged members (legs and bracing)</u></p> <p>Observation:</p> <ul style="list-style-type: none">• Bend in tower base pin.• Dented top girt, 1-1/2"Ø x 16 gauge tube of section 12 on the AB face at 245-ft <p>Recommendation:</p> <ul style="list-style-type: none">• No action required for tower base pin.• Replace 1-1/2"Ø x 16 gauge tube.

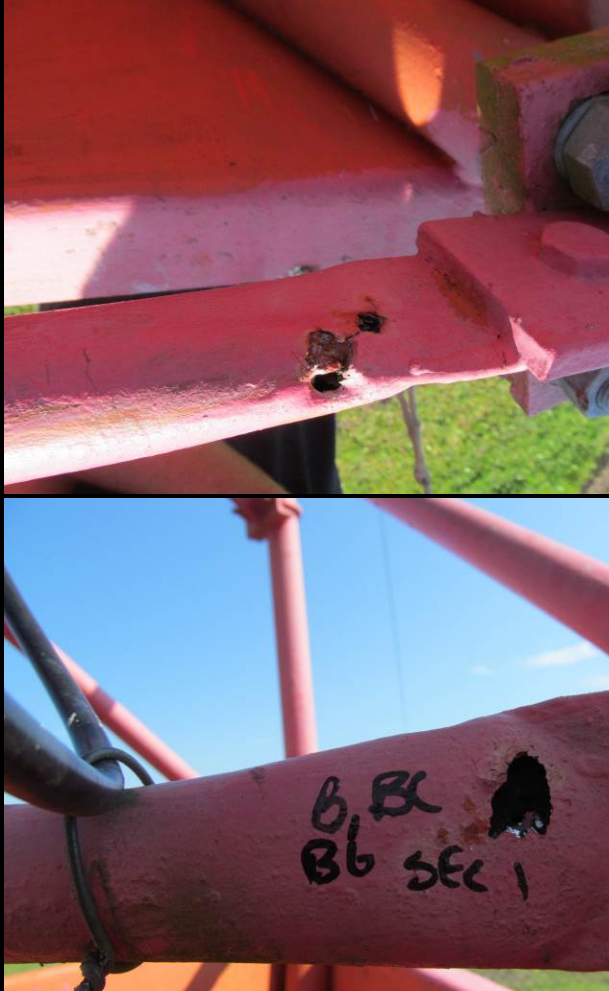
<p><u>A.1. Damaged members (legs and bracing)</u></p> <p>Observation: Corrosion through member at the following locations:</p> <ul style="list-style-type: none"> • A-B Face, bottom girt, section 1 at 5-ft. • B-C Face, bottom girt, section 1 at 5-ft. <p>Recommendation: Replace 1-1/2"Ø x 16 gauge tube.</p>

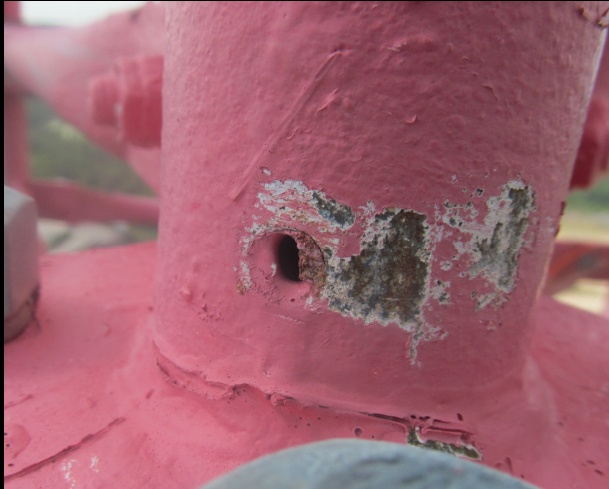
<p><u>B.1. Paint and/or galvanizing condition</u></p> <p>Observation: Surface abrasions at the following locations:</p> <ul style="list-style-type: none"> • B-leg, section 19 at 366-ft. <p>Recommendation: Clean areas of surface corrosion and coat with at least two brush coats of ZRC cold galvanizing compound or approved equivalent.</p>

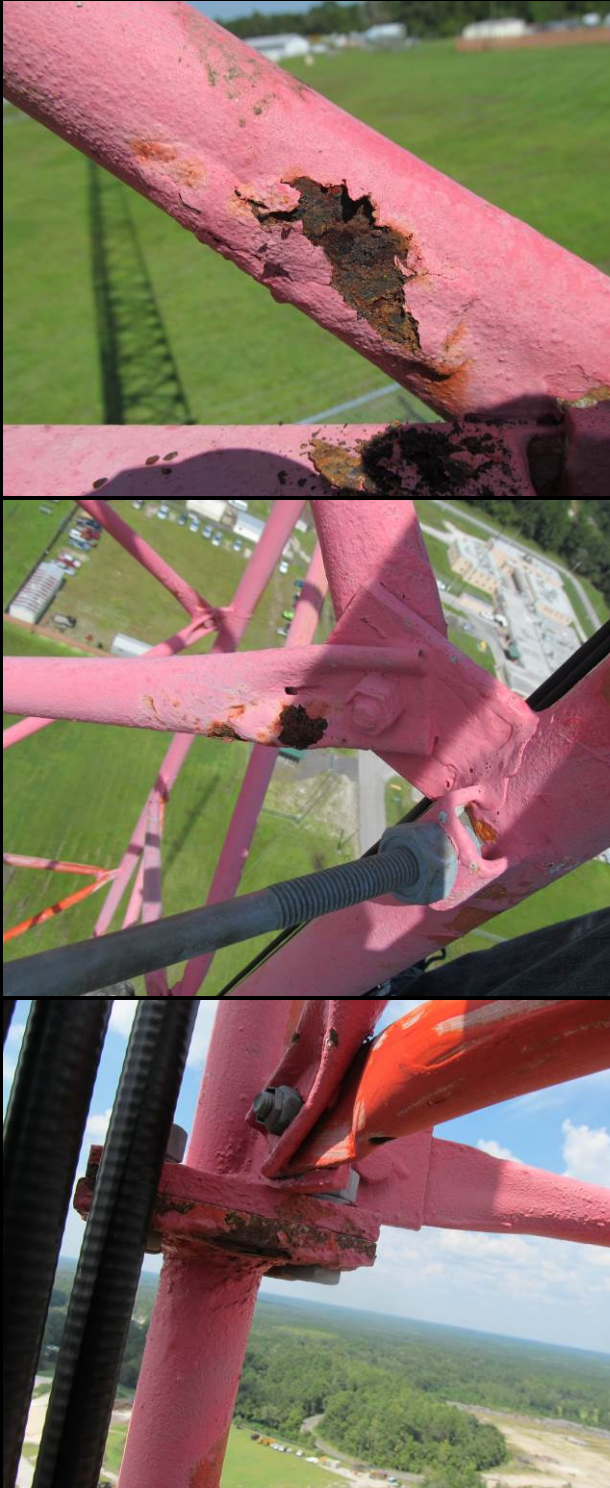
Photograph	Observations and Recommendations

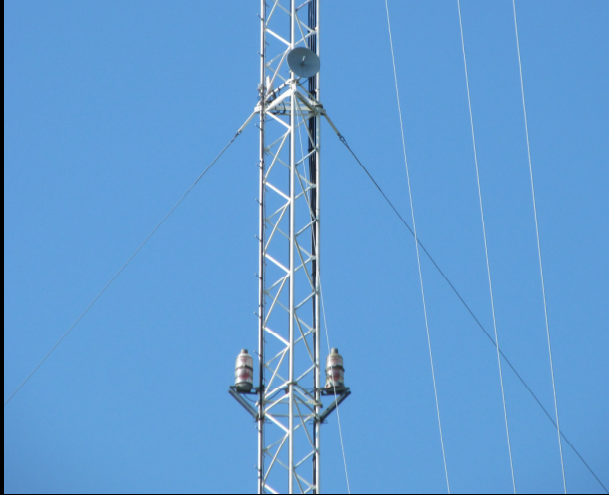
<p><u>C.5. Bulb condition</u></p> <p>Observation: Tower light system temporarily out of service.</p> <p>Recommendation: Service electrical system and replace any damaged or nonoperational equipment.</p>

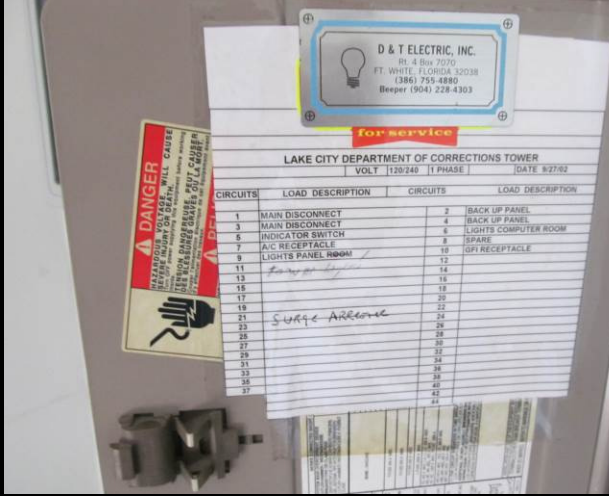
<table><tr> <th colspan="4">LAKE CITY DEPARTMENT OF CORRECTIONS TOWER</th> </tr></table>

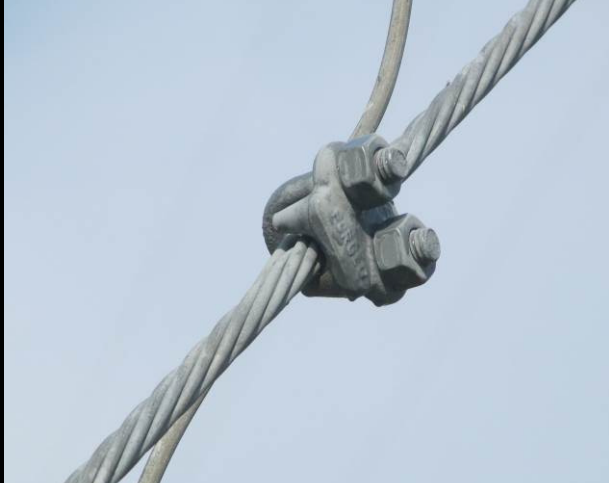
<p><u>D.1.Connections</u></p> <p>Observation: Improper grounding hardware for waterfall grounding at all anchors</p> <p>Recommendation: Replace existing waterfall grounding hardware with correct grounding fasteners.</p>

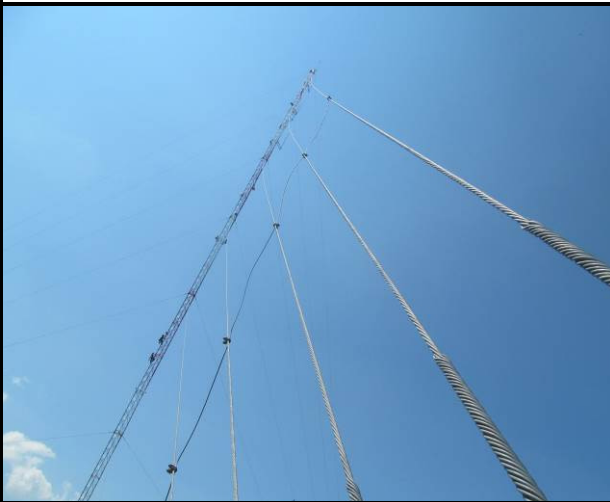
<p><u>D.1. Connections (continued)</u></p> <p>Observation: Improper grounding hardware for waterfall grounding at all anchors</p> <p>Recommendation: Replace existing waterfall grounding hardware with correct grounding fasteners.</p>

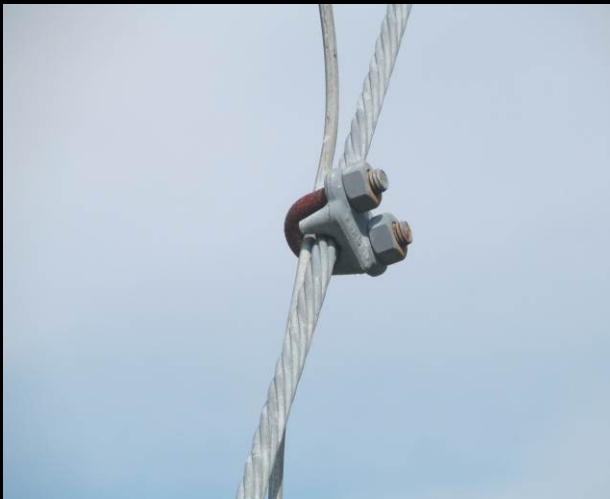
<p><u>D.2. Corrosion</u></p> <p>Observation: Surface corrosion on Anchor C, guy level 3 waterfall grounding Crosby.</p> <p>Recommendation: Refer to D.1. Connections recommendation for same hardware.</p>

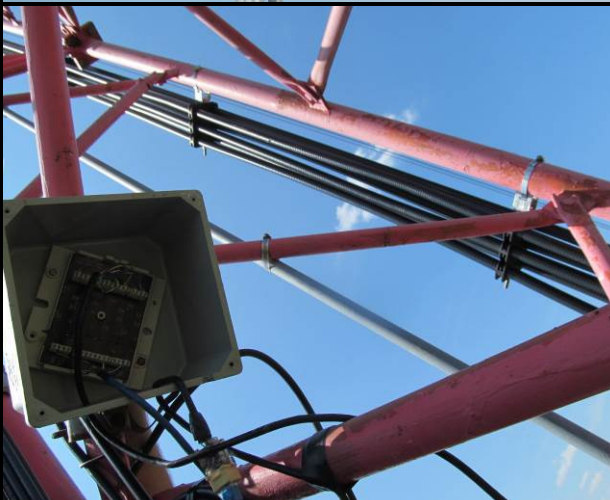
<p><u>E.1. Antenna condition</u></p> <p>Observation: No housing panel on disconnected junction box at 138-ft.</p> <p>Recommendation: Remove disconnected equipment.</p>

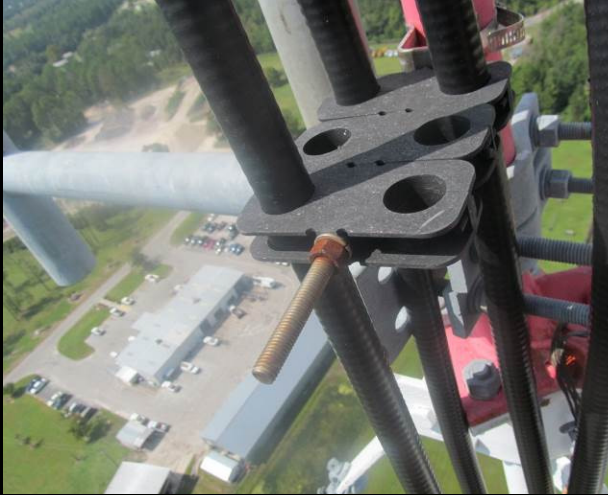
<p><u>E.4. Hanger condition (snap-ins, bolt on, kellum grips, etc.)</u></p> <p>Observation: Surface corrosion on coax support block bolts throughout the tower.</p> <p>Recommendation: Clean areas of surface corrosion and coat with at least two brush coats of ZRC cold galvanizing compound or approved equivalent.</p>

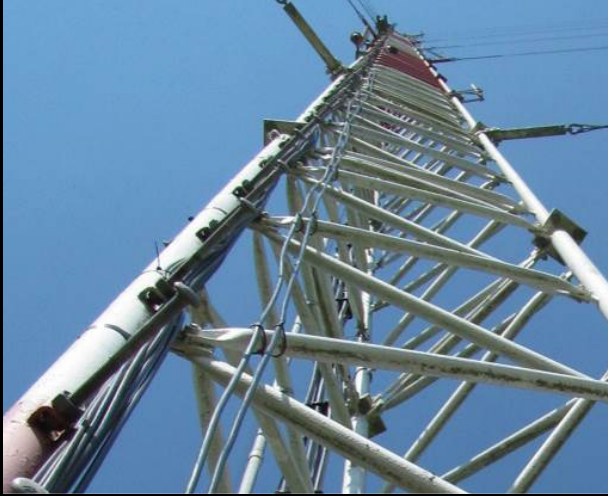
<p><u>E.5. Secured to structure</u></p> <p>Observation: Tower fasteners for the following coaxial cables:</p> <ul style="list-style-type: none"> • Coax # 10-11 mounted to tower using wire ties • Coax # 1-9, 12-15 mounted to tower using zip ties <p>Coax # 1-19 wrapping around climbing leg at section 1.</p> <p>Recommendation: Secure coax at section 1 to tower away from the climbing leg. No action required for specified tower fasteners.</p>

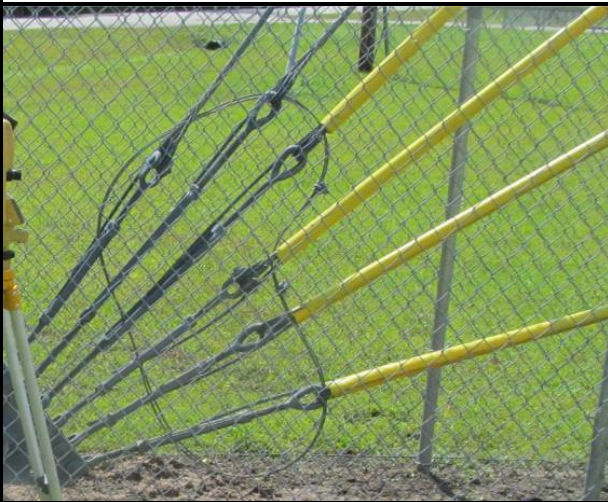
<p><u>H.2.a Guy hardware conditions (turnbuckles or equivalent (secure and safety properly applied))</u></p> <p>Observation: Incorrect configuration of all figure 8 safety wires. Safety wire does not route through turnbuckle jaw adjacent the anchor head.</p> <p>Recommendation: Re-configure the safety wire as shown in Appendix D.</p>

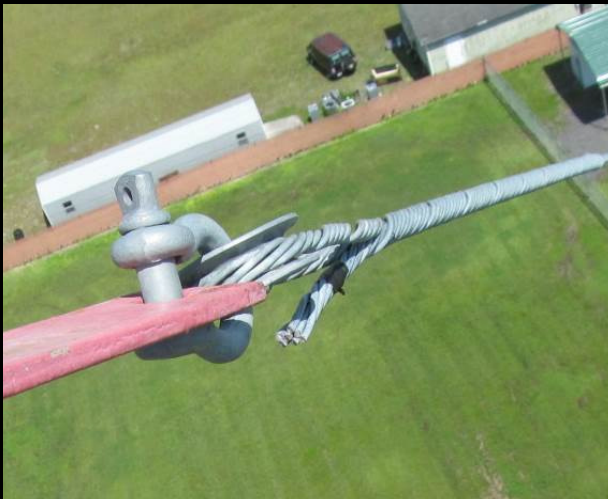
<p><u>H.2.d.ii. Guy Hardware Conditions (Cable connectors (end fittings)(Wire serving properly applied))</u></p> <p>Observation: No wire serving on the tower or ground sides for all guy levels, (typical).</p> <p>Recommendation: Install wire serving to all guy levels on the tower and ground sides.</p>

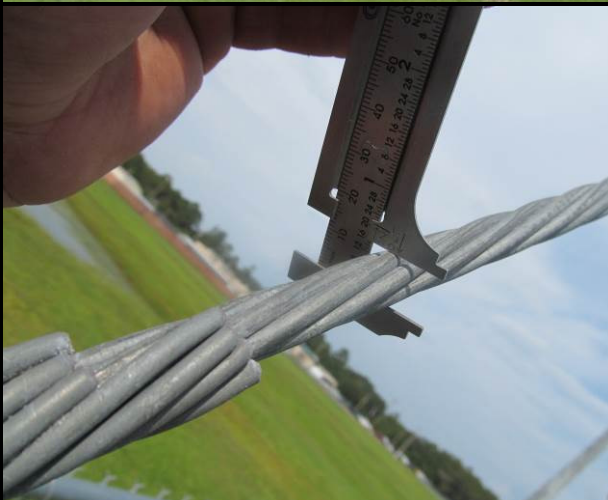
<p><u>H.2.d.iv. Guy Hardware Conditions (Cable connectors (Preformed wraps – properly applied, fully wrapped, & sleeve in place))</u></p> <p>Observation: No end sleeves on the tower or ground sides for all guy levels, (typical).</p> <p>Recommendation: Install end sleeves on preform wraps to prevent unraveling to all guy levels on the tower and ground sides.</p>

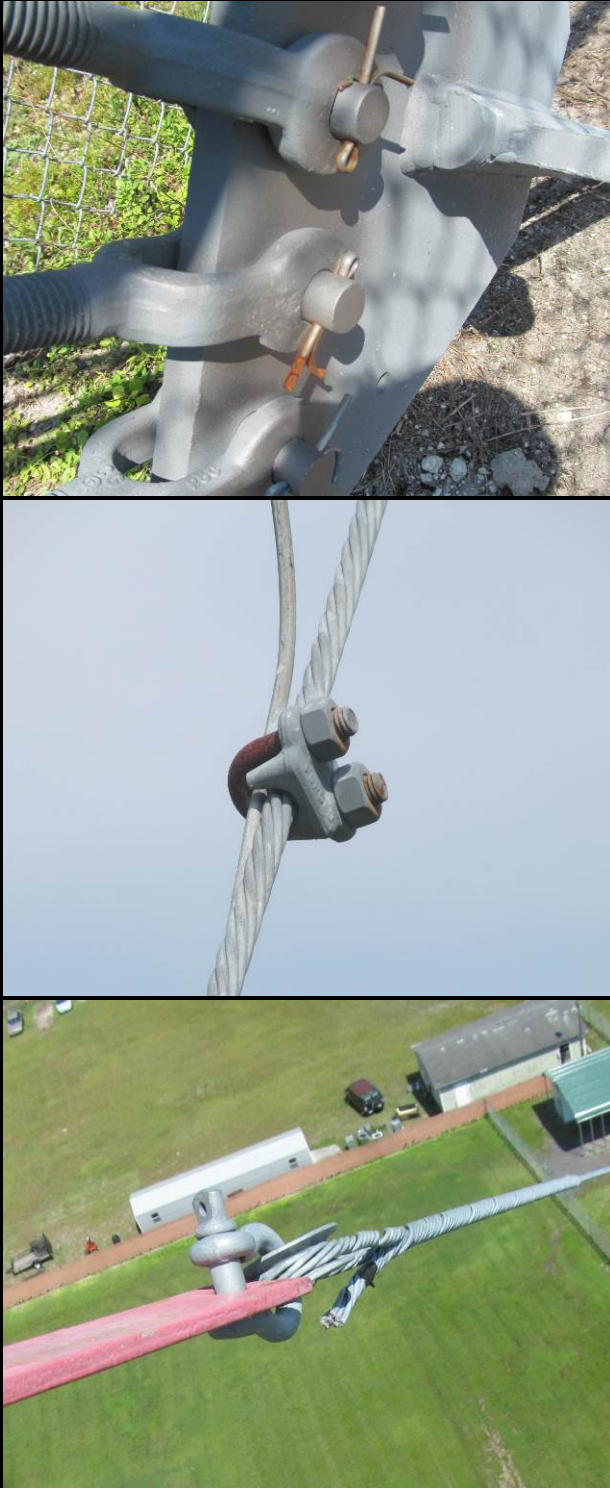
<p><u>H.2.d.vi. Guy Hardware Conditions (Cable connectors (Shackles, bolts, pins, and cotter pins, secure and in good condition))</u></p> <p>Observation: Surface corrosion at the following locations:</p> <ul style="list-style-type: none"> • Anchor shackle cotter pins, all guy levels (Typical) • Anchor C, guy level 3 waterfall grounding crosby <p>Screw pin shackles used (typical) are for temporary load applications.</p> <p>Recommendation: Clean areas of surface corrosion and coat with at least two brush coats of ZRC cold galvanizing compound or approved equivalent. Coordinate repair of members with EOR if material loss is found. Mouse all existing screw pin shackles with a galvanized annealed wired to prevent pin from turning as shown in appendix D.</p>

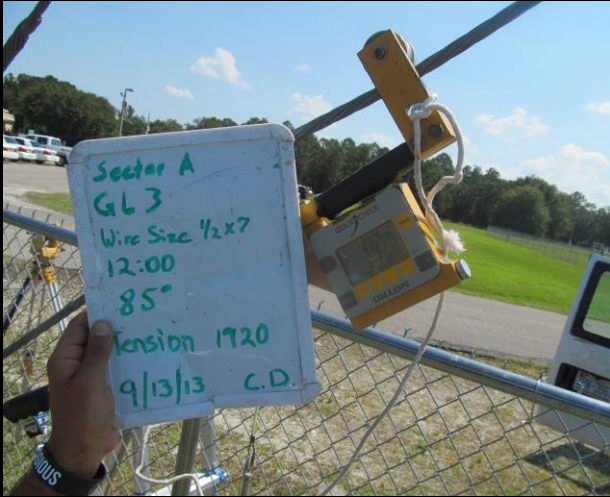
<p>H.3. Guy tensions</p> <p>Observation: Guy wire tensions are NOT within the allowable limits as defined by ANSI/TIA-222-G-2005 Section 13.3.2. See Appendix A for details.</p> <p>Recommendation: Re-tension guy wires into the TIA specified range.</p>

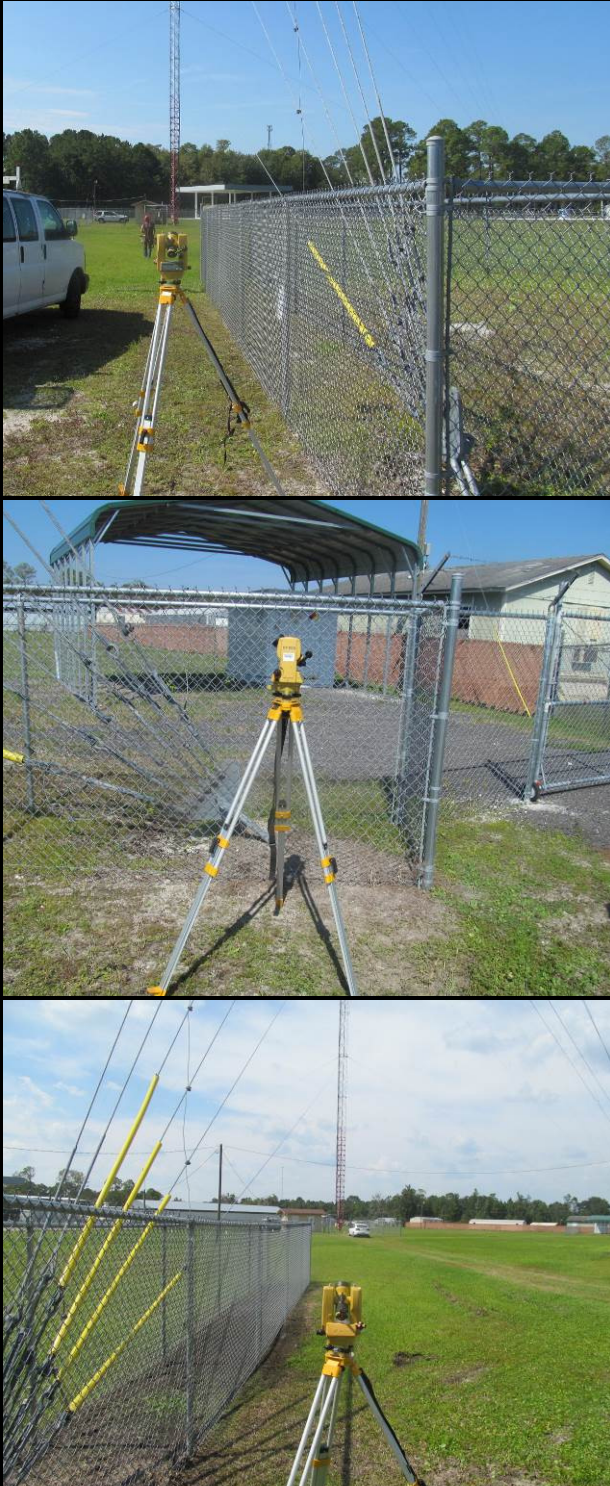
<p><u>K.1. Tower Plumb and Twist</u></p> <p>Observation: Tower Twist is NOT within the allowable limits as defined by ANSI/TIA-222-G-2005 Sections 13.3.3 and 13.3.4. See Appendix A and B for details.</p> <p>Recommendation: Re-plumb tower into the TIA specified range.</p>
