ola County Building onit Expires One Year From the I	
APPLICANT LINDA RODER		ONE 752-2281
ADDRESS 387 SW KEMP COURT	LAKE CITY	FL 32024
OWNER ED & DIANE WHITE	PH	ONE
ADDRESS 7018 SW STATE ROAD		FL 32024
CONTRACTOR ISAAC CONSTRUCTION		ONE <u>719-7143</u>
LOCATION OF PROPERTY 47S, 1 MI	LE PAST WALTER AVE ON RIGHT	
TYPE DEVELOPMENT ADDITION TO S	SFD ESTIMATED COST	OF CONSTRUCTION .00
HEATED FLOOR AREA 2440.00	TOTAL AREA 2440.00	HEIGHT00 STORIES 2
FOUNDATION CONC WAL	LS FRAMED ROOF PITCH	3/12 FLOOR SLAB
LAND USE & ZONING A-3		MAX. HEIGHT 32
Minimum Set Back Requirments: STREET-	FRONT 30.00 RE	AR 25.00 SIDE 25.00
NO. EX.D.U. 0 FLOOD ZONE	X DEVELOPMEN	T PERMIT NO.
PARCEL ID 02-5S-16-03443-002	SUBDIVISION	
LOT BLOCK PHASE	UNIT	TOTAL ACRES
EXISTING 05-0461-N Driveway Connection Septic Tank Number	Contractor's License Number BK LU & Zoning checked by	Applicant/Owner/Contractor N Approved for Issuance New Resident

July 28, 2006

In compliance with the directive that I received from Mr. Joe Haltiwanger issued with regard to my property at 7018 SW SR 47 on December 13, 2005, I am reporting to you on results of structural evaluations on a residential home at the above listed address. According

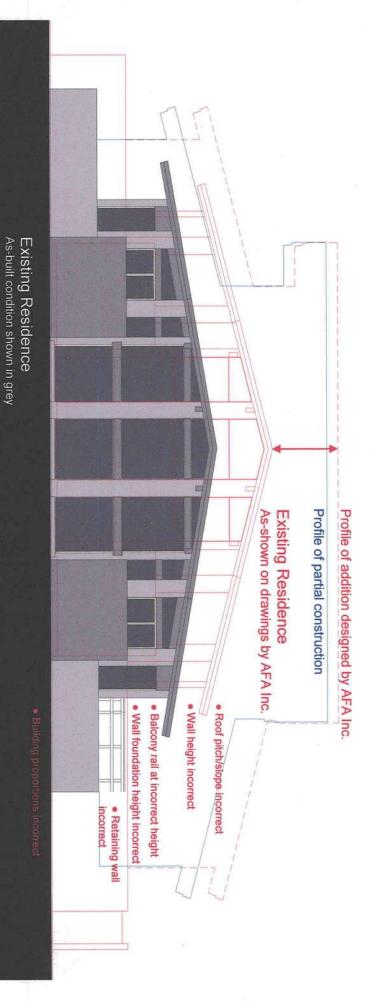
signed and sealed by Robert S. Taylor Sr., AR 0007526.

AFA, Inc. is Associated Florida Architects, Inc., the incorrect elevation drawing shown in red above is taken from Sheet A -4.01 updated 13 Sept. 2005 and
