PERMIT
000026894

PELHAM RESIDENCE
LAKE CITY, FLORIDA

SUBSIDENCE INVESTIGATION

Claim Number: 59D167-181

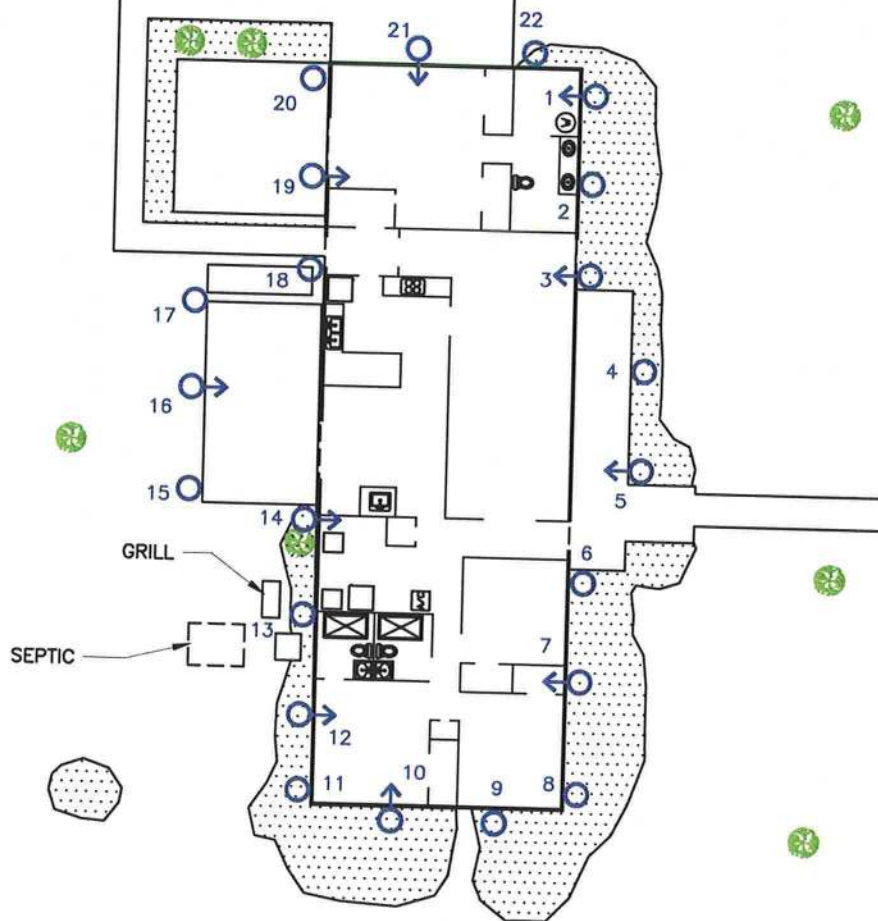
DESIGNED BY:	THF	PROJECT NO.:	3017309A	FIGURE
CHECKED BY:	THF	DRAWING NO.:	7309-2	2
CREATED BY:	JMW	DATE:	05/06/08

Based on the above information, it is our opinion that the deep injection grouting program has been completed in substantial compliance with SDII's engineering recommendations and local grouting practices. This grouting procedure was implemented to stabilize the subsurface conditions related to sinkhole activity in the immediate vicinity of the foundation of the structure. This procedure may not preclude development of new sinkhole activity in the future, however. Table 1 in the Appendix summarizes the grout injection, including estimated grout volume injected and initial depth of each point. Figure 2 illustrates the location and numbering of the grout points.

It is SDII's understanding that cosmetic repairs will be done following the pin pile installation, which is to follow the grouting operations. Accordingly, any existing damage and/or collateral damage associated with the grouting or underpinning operations should be repaired at that time by a qualified restoration contractor.

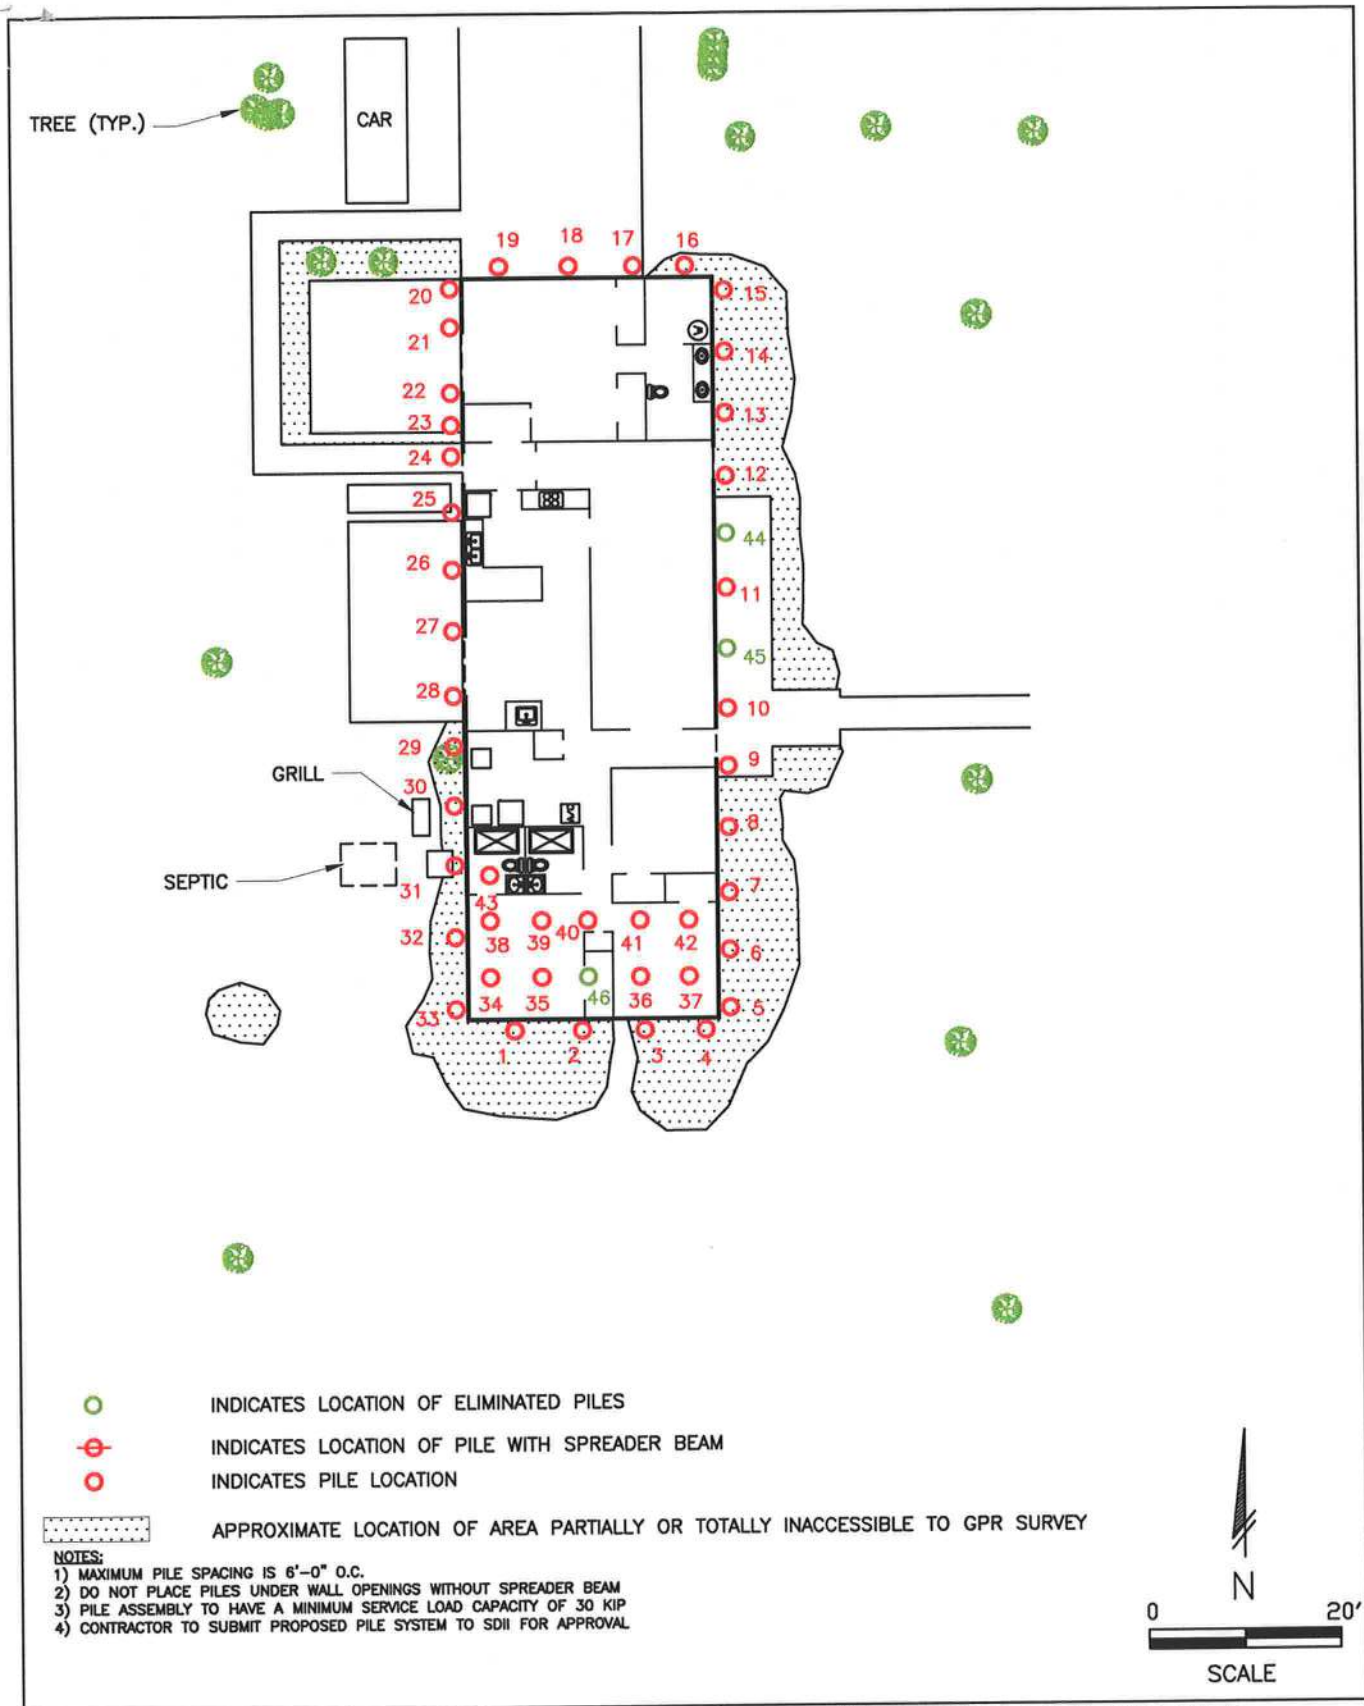
DESIGNED BY:	THF	PROJECT NO.:	3017309B	FIGURE
CHECKED BY:	THF	DRAWING NO.:	7309-2	2
CREATED BY:	JMW	DATE:	08/25/08

- ☐ Three pin piles (Nos. 44, 45 and 46) were eliminated due to as-encountered site conditions.
- ☐ The piles consisted of 3-inch diameter steel pipe and were hydraulically or manually advanced to bear on competent material. The hydraulic seating pressures for the perimeter piles ranged from 500 to 2,000 psi at the bearing depth and final seating pressures ranged from 300 to 500 psi. The tip depth of the perimeter piles ranged from 7 to 21 feet. The interior slab dowel depths ranged from 16 to 21 feet.
- ☐ The contractor used the installed underpinning piles and hydraulic rams to support the foundation and close the existing cracks on the interior and exterior of the home. The perimeter of the residence was lifted a 1/10 inch.

Based on our observations, the underpinning pile installations were documented as substantially complying with SDII's recommendations. Table 1 in the Appendix summarizes the pin pile installation. Figure 2 illustrates the location and numbering of the pin pile locations.

It is SDII's understanding that cosmetic repairs will be done following the underpinning operations. Accordingly, any existing damage and/or collateral damage associated with the underpinning operations should be repaired at that time by a qualified restoration contractor.

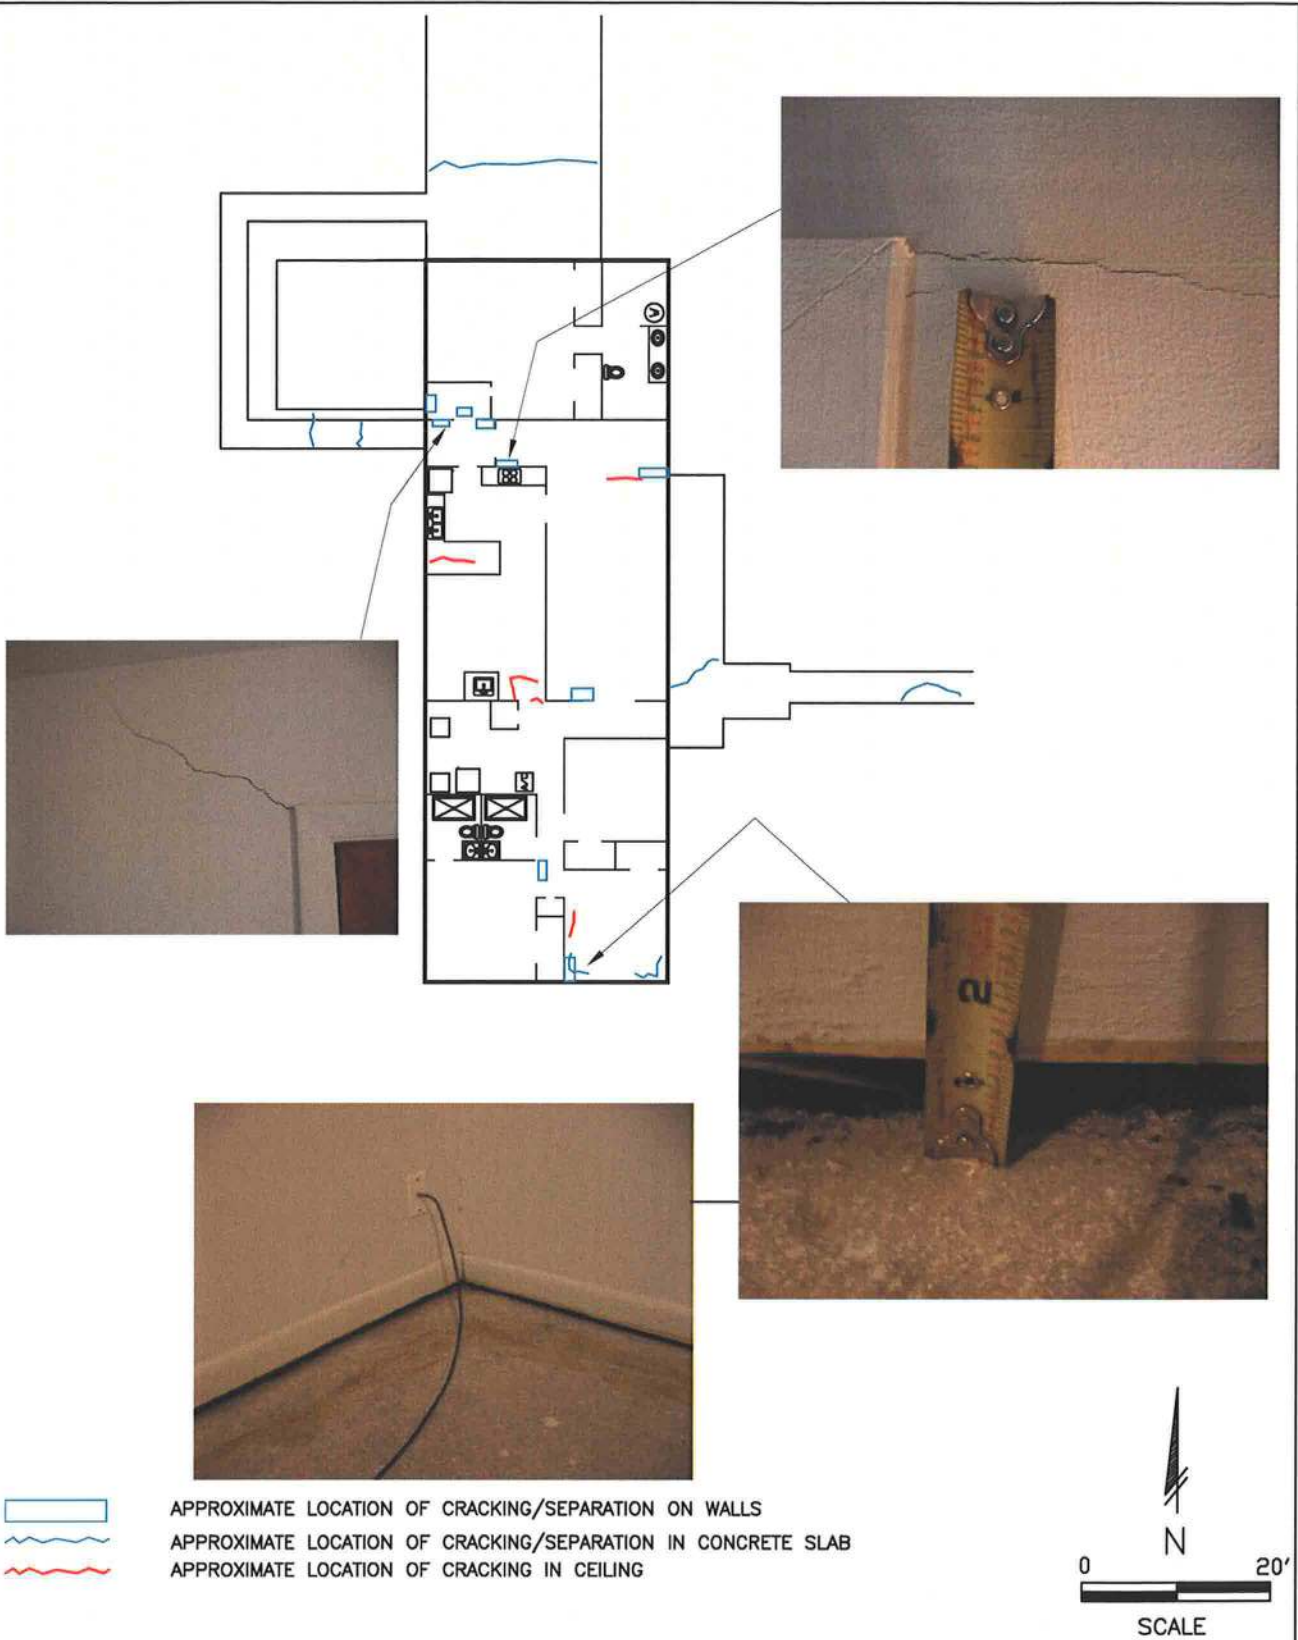
DESIGNED BY: MDZ	PROJECT NO.: 3017309	FIGURE 2
CHECKED BY: SU	DRAWING NO.: 7309-2	
CREATED BY: JMW	DATE: 08/22/07

The damage to the residence is the direct and/or collateral result of differential movement of the foundation.

The ground surface sloped down toward the southeast portion of the property. The observed damage to the house consisted of cracks in the walls, floor, and ceiling of the residence. According to the homeowner, the damage was first noticed in June 2007.

A more detailed description of the observed damage is discussed in "Section 3.0 Structural Evaluation". Photographs showing representative examples of the observed damage to the structure are provided on Figure 2. A complete set of photographs taken at the property has been archived and is available upon request.

SDII recommends that the sinkhole conditions be remediated through the use of grout injection. Following the grout injection it is our recommendation that the foundation of the residence be stabilized through the installation of underpinning piles around the perimeter of the structure.
