**CONSTRUCTION MANAGEMENT REPORT  
LIMITED ASBESTOS RENOVATION SURVEY  
(PERFORMED ON APRIL 10, 2014)**

**FORMER LUMBER STORAGE FACILITY  
1824 W. HIGHWAY 90  
LAKE CITY, FLORIDA 32025**

**AGC ENVIRONMENTAL CONSULTING, INC.  
13762 W. STATE ROAD 84  
SUITE 408  
DAVIE, FLORIDA 33325  
PROJECT NO. AGC-14-1194**

SUBJECT: Limited Asbestos Renovation Survey for the

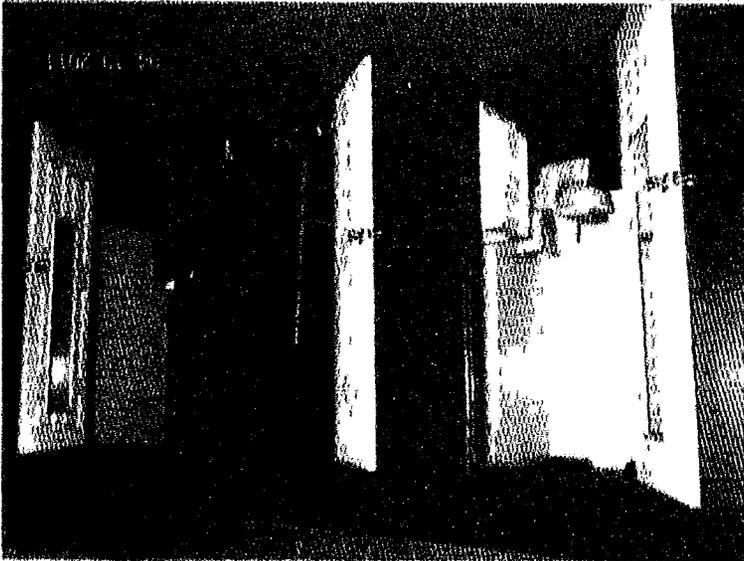
PHOTOGRAPH 1: Restrooms that will not be disturbed during future renovations

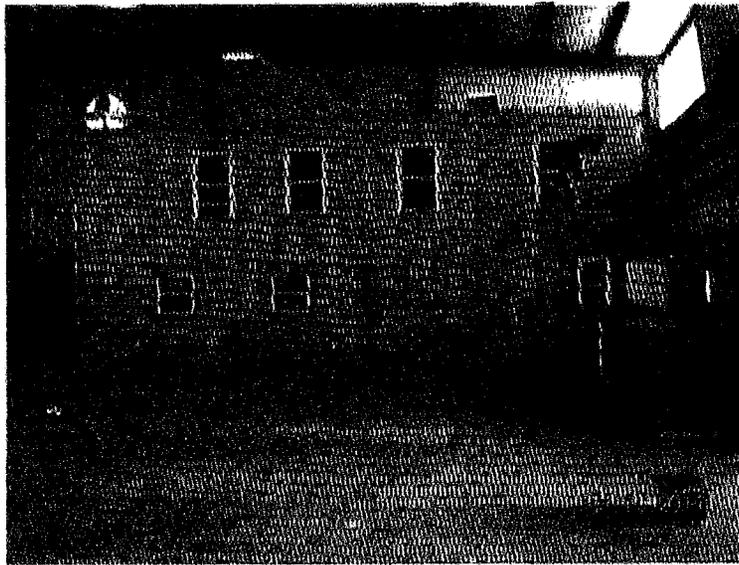
**PHOTOGRAPH 4: Offices planning to be demolished inside the warehouse**

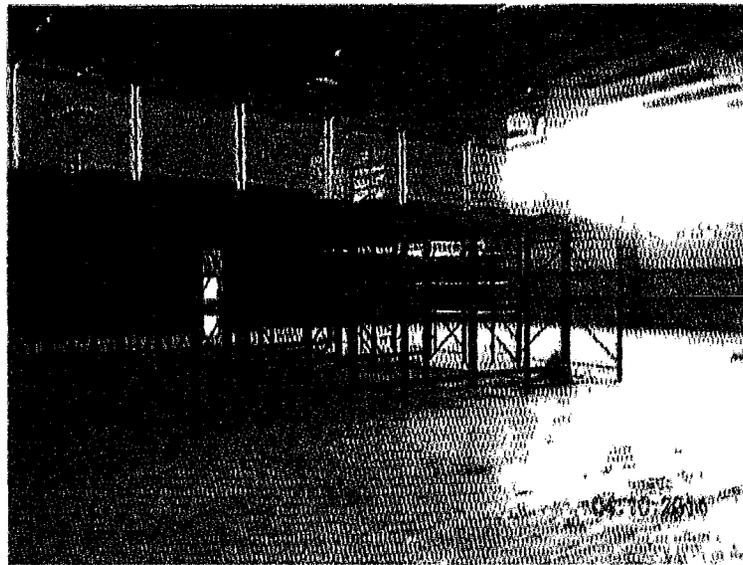
**PHOTOGRAPH 5: Middle shelving inside the warehouse**

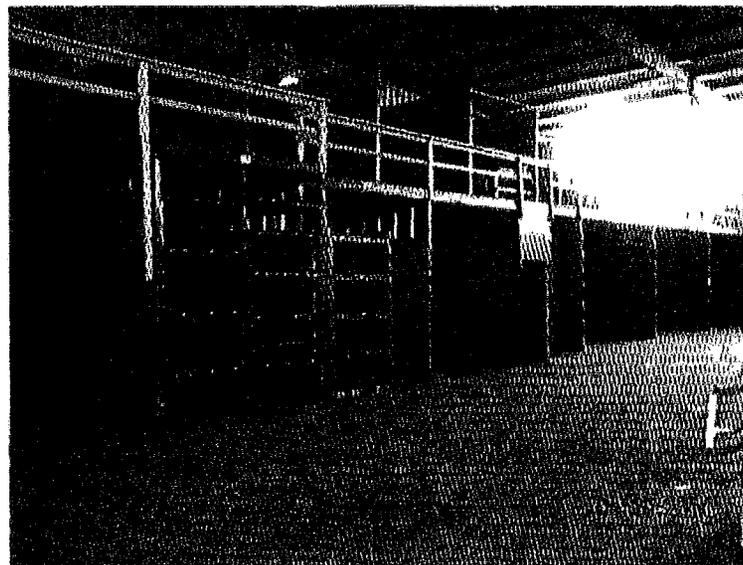
**PHOTOGRAPH 6: Additional shelving inside the warehouse**

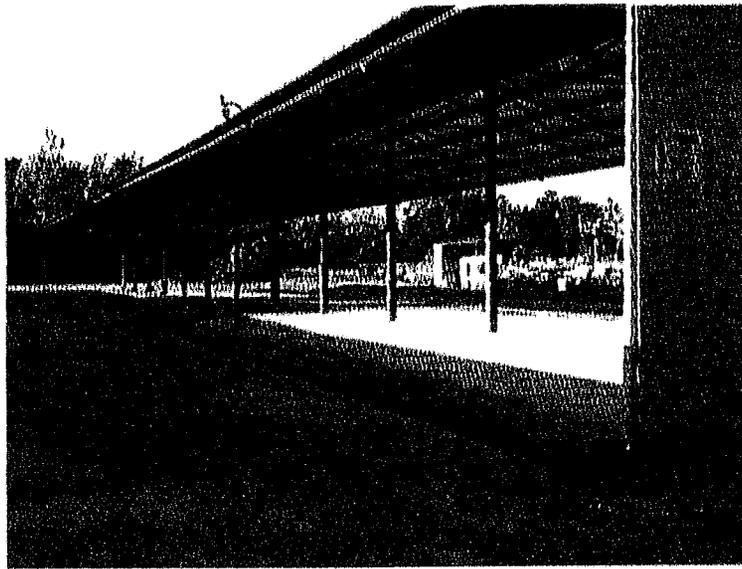
PHOTOGRAPH 7: Storage canopies in the rear of the property

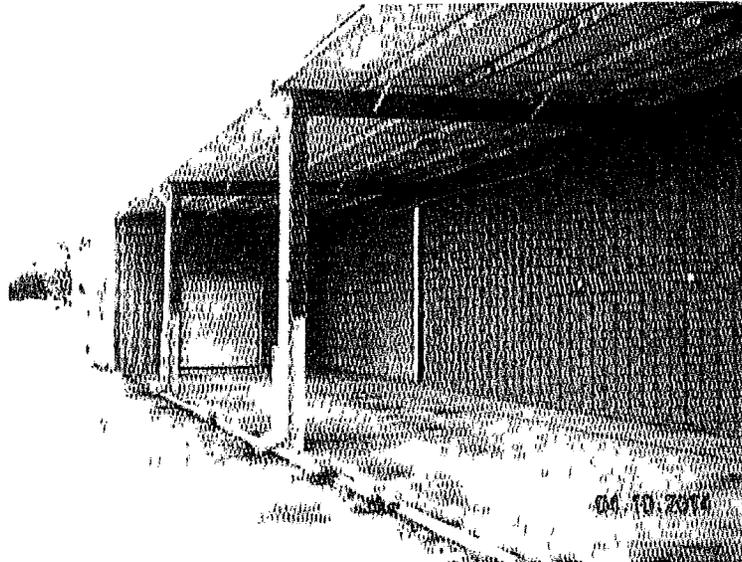
PHOTOGRAPH 8: Side of warehouse

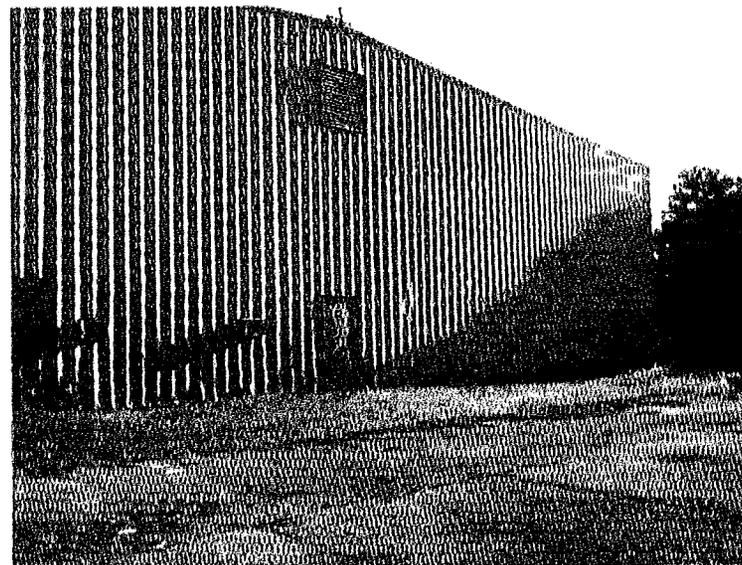
PHOTOGRAPH 9: Rear of warehouse

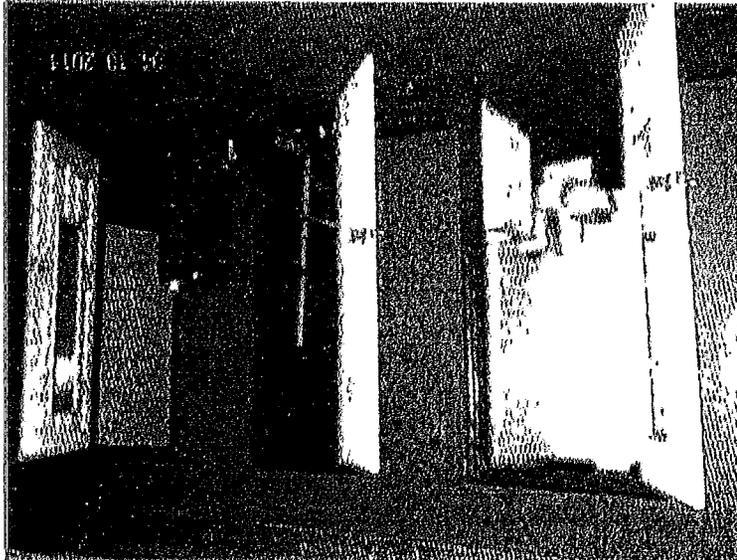
PHOTOGRAPH 1. Restrooms that will not be disturbed during future renovations

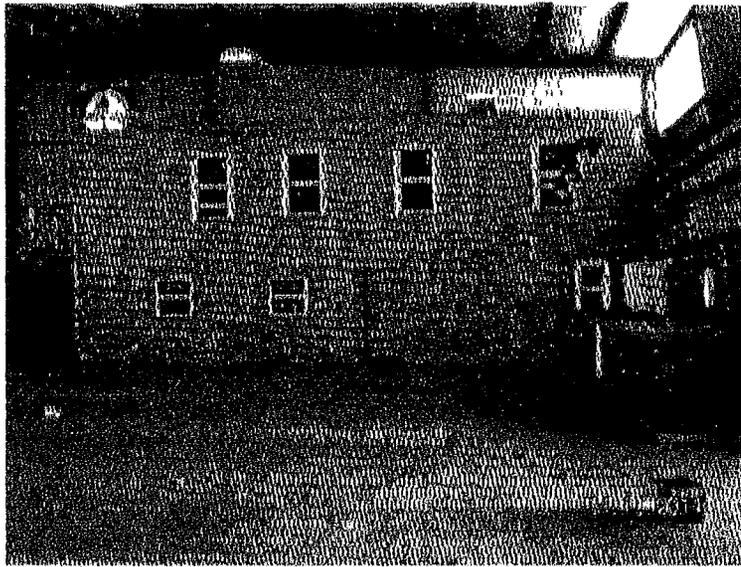
PHOTOGRAPH 4: Offices planning to be demolished inside the warehouse

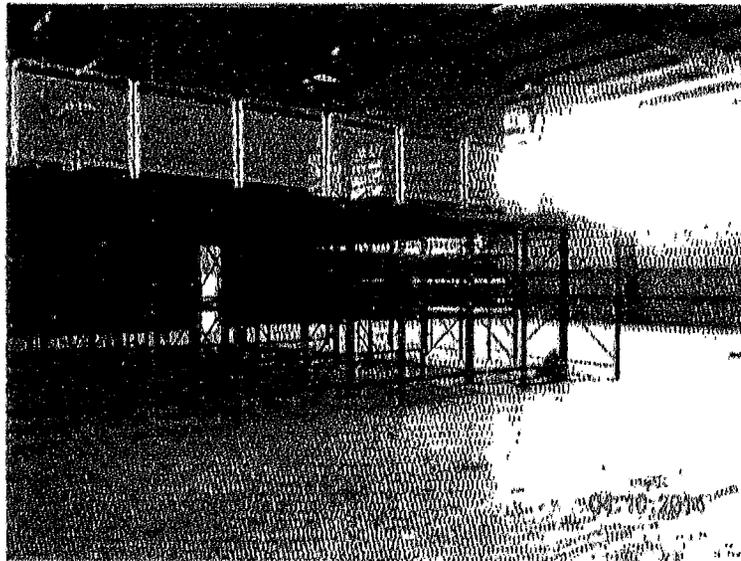
PHOTOGRAPH 5: Middle shelving inside the warehouse

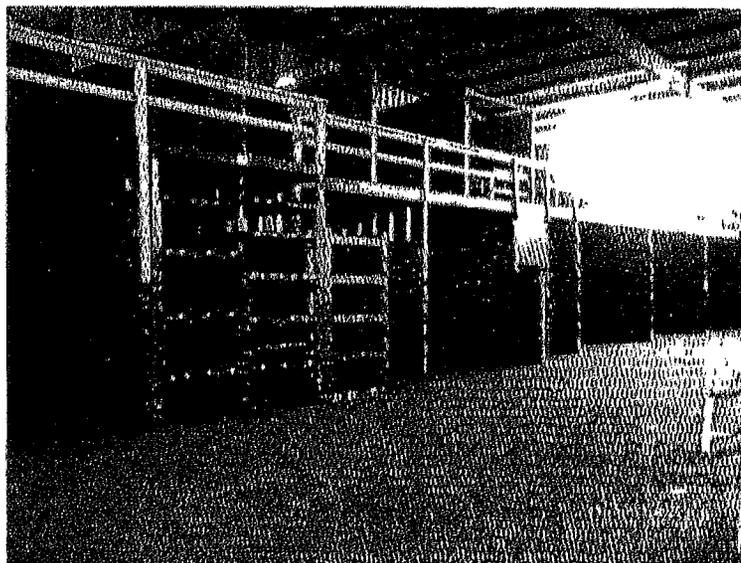
PHOTOGRAPH 6: Additional shelving inside the warehouse

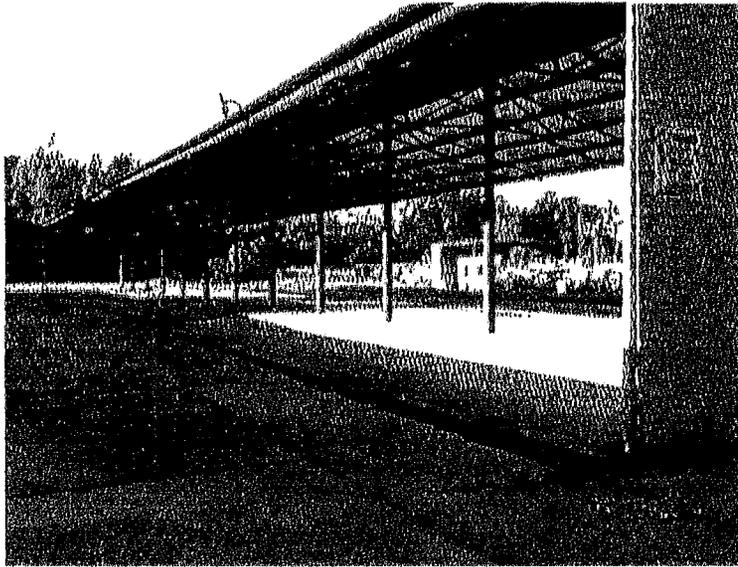
PHOTOGRAPH 7: Storage canopies in the rear of the property

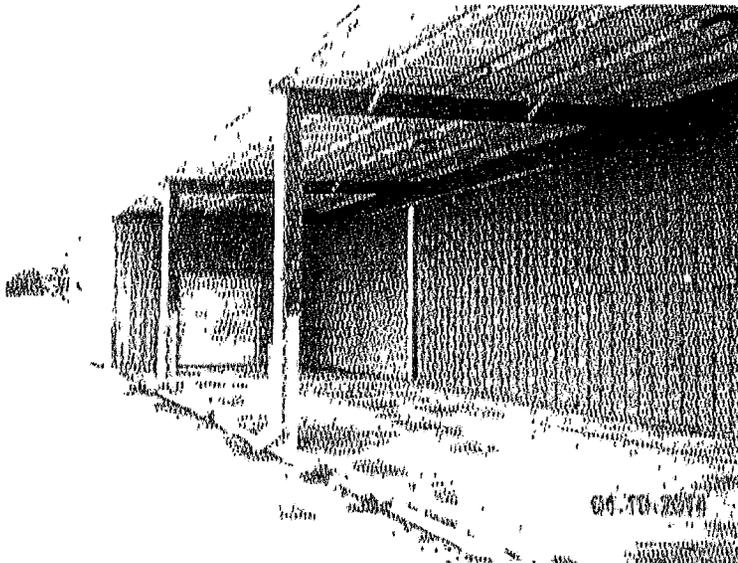
PHOTOGRAPH 8: Side of warehouse

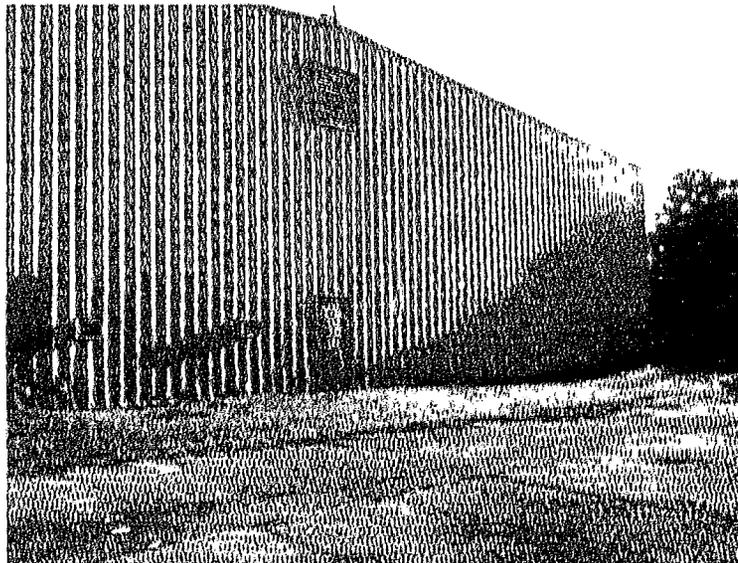
PHOTOGRAPH 9: Rear of warehouse
