**Test Report No: TJ2009-3 Rev. 3**

**SAMPLE ID:** Two shower bases identified by client as, "STD Cappuchino 616136 and STD Adobe 616135", were received in good condition on 1/14/08. This report also applies to sizes listed in Table 1.

**SUBJECT:** Testing to ASTM E-84

**TEST REQUESTED:** Perform standard flame spread and smoke density developed classification tests on the sample supplied by the Client in accordance with ASTM Designation E84-09a, "Standard Method of Test for Surface Burning Characteristics of Building Materials". The test procedure is equivalent to UL 723, ANSI/NFPA No. 255, and UBC No. 8-1.

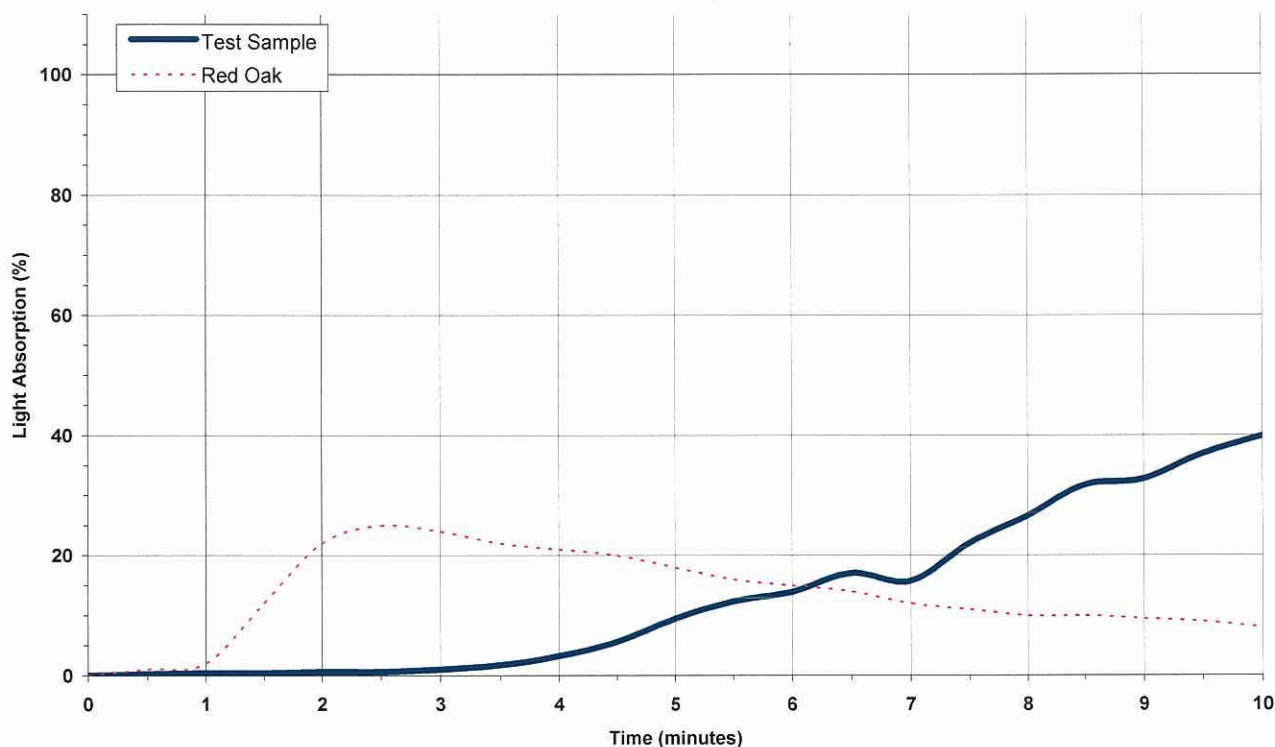
FIGURE 2. Smoke Developed

Smoke Developed Chart

| <u>Smoke Developed</u> | 90 |

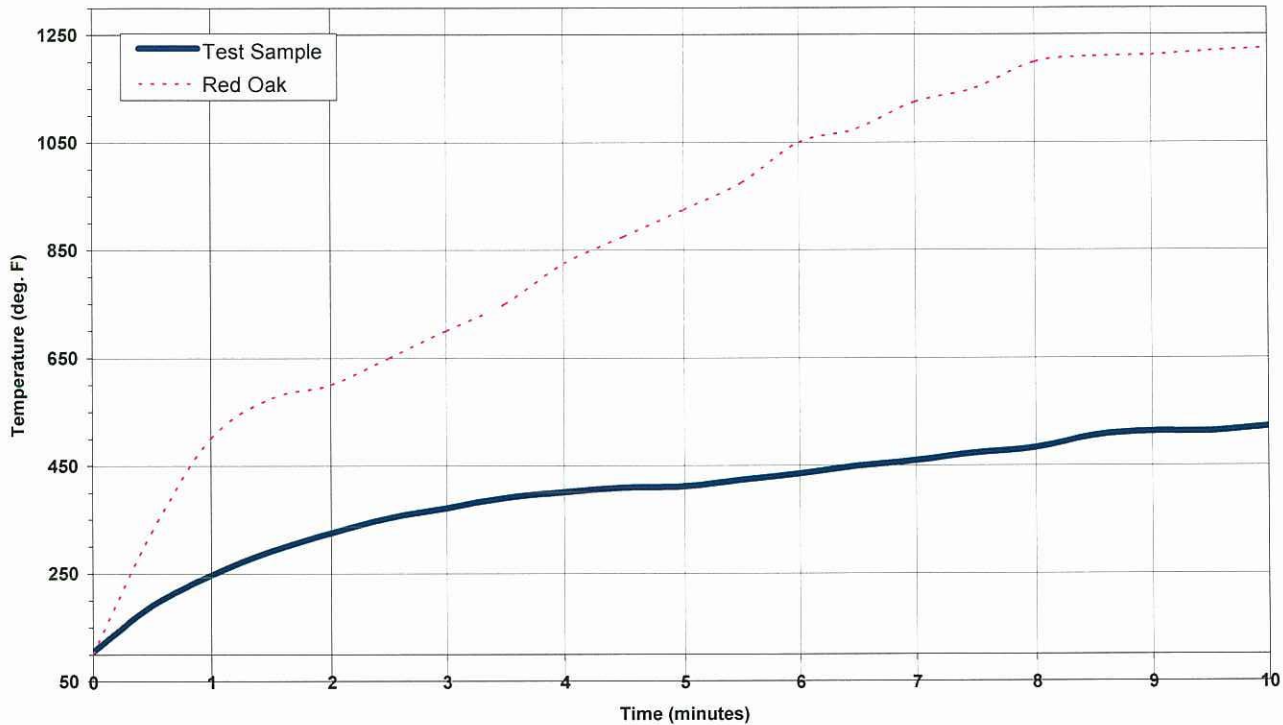
FIGURE 3. Temperature – 24 ft. Air Stream Thermocouple

### Temperature - Time Curve
