REINFORCING STEEL INSPECTION

REPORT NO.: 2648001RSI07012026AB

DATE: 7/1/2026  
PROJECT #: 26-480-01  
PROJECT: FPL Columbia Storm Processing Facility P2  
LOCATION: 1855 NW County Road 25A Lake City, FL  
CAL-TECH P.M.: Chad Day

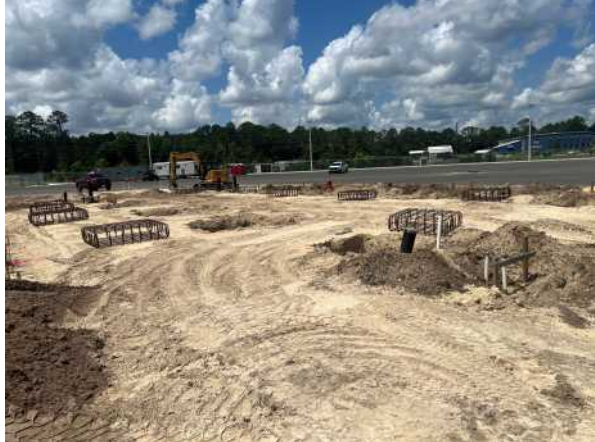
Picture 1: Overall view of isolated steel column foundation reinforcing steel placement

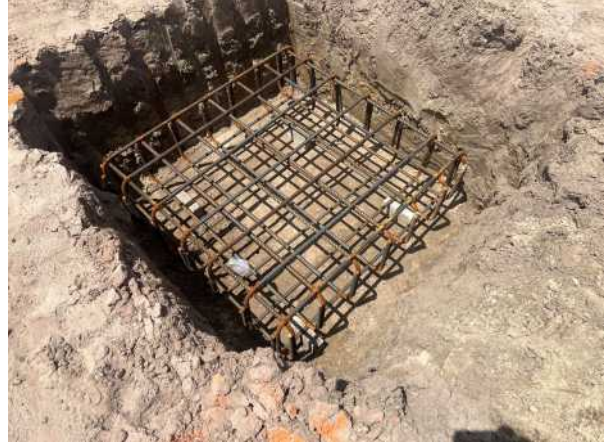
Picture 2: Close-up view of reinforcing steel placement for an isolated steel column foundation in accordance with Detail 7/S300.

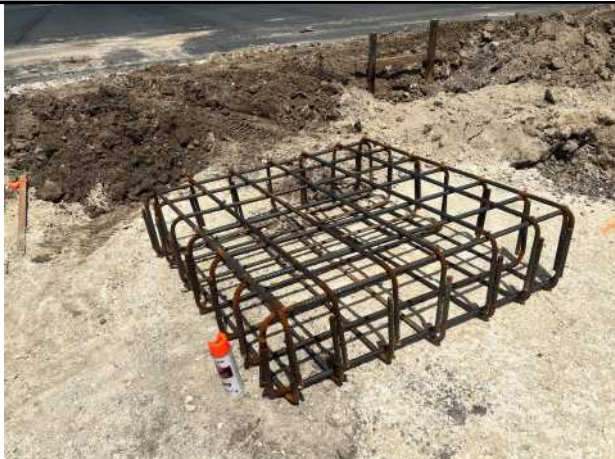
Picture 3: Close-up view of isolated steel column foundation reinforcing steel cage prior to placement, showing general bar configuration and assembly.

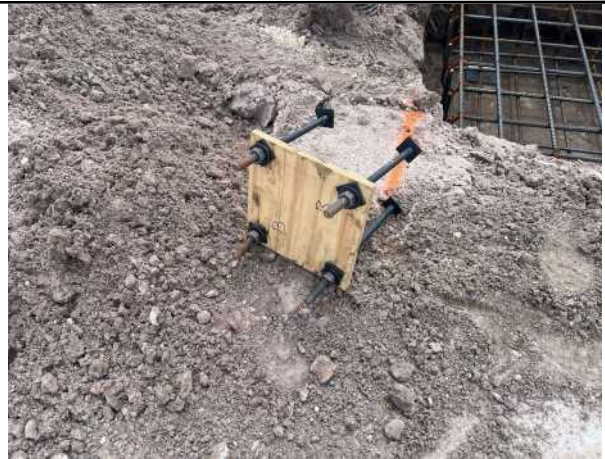
Picture 4: View of anchor rod template assembly staged for installation at an isolated steel column foundation location.
