Columbia County Building Permit

TYPE DEVELOPMENT FOUNDATION STAB. ESTIMATED COST OF CONSTRUCTION 124875.00

CLAIM No. 59-D210-403
 ALLISON RESIDENCE
 LAKE CITY, COLUMBIA COUNTY, FLORIDA
 GSE PROJECT No. 10299A

**SUMMARY REPORT OF A
SUBSIDENCE EXPLORATION**

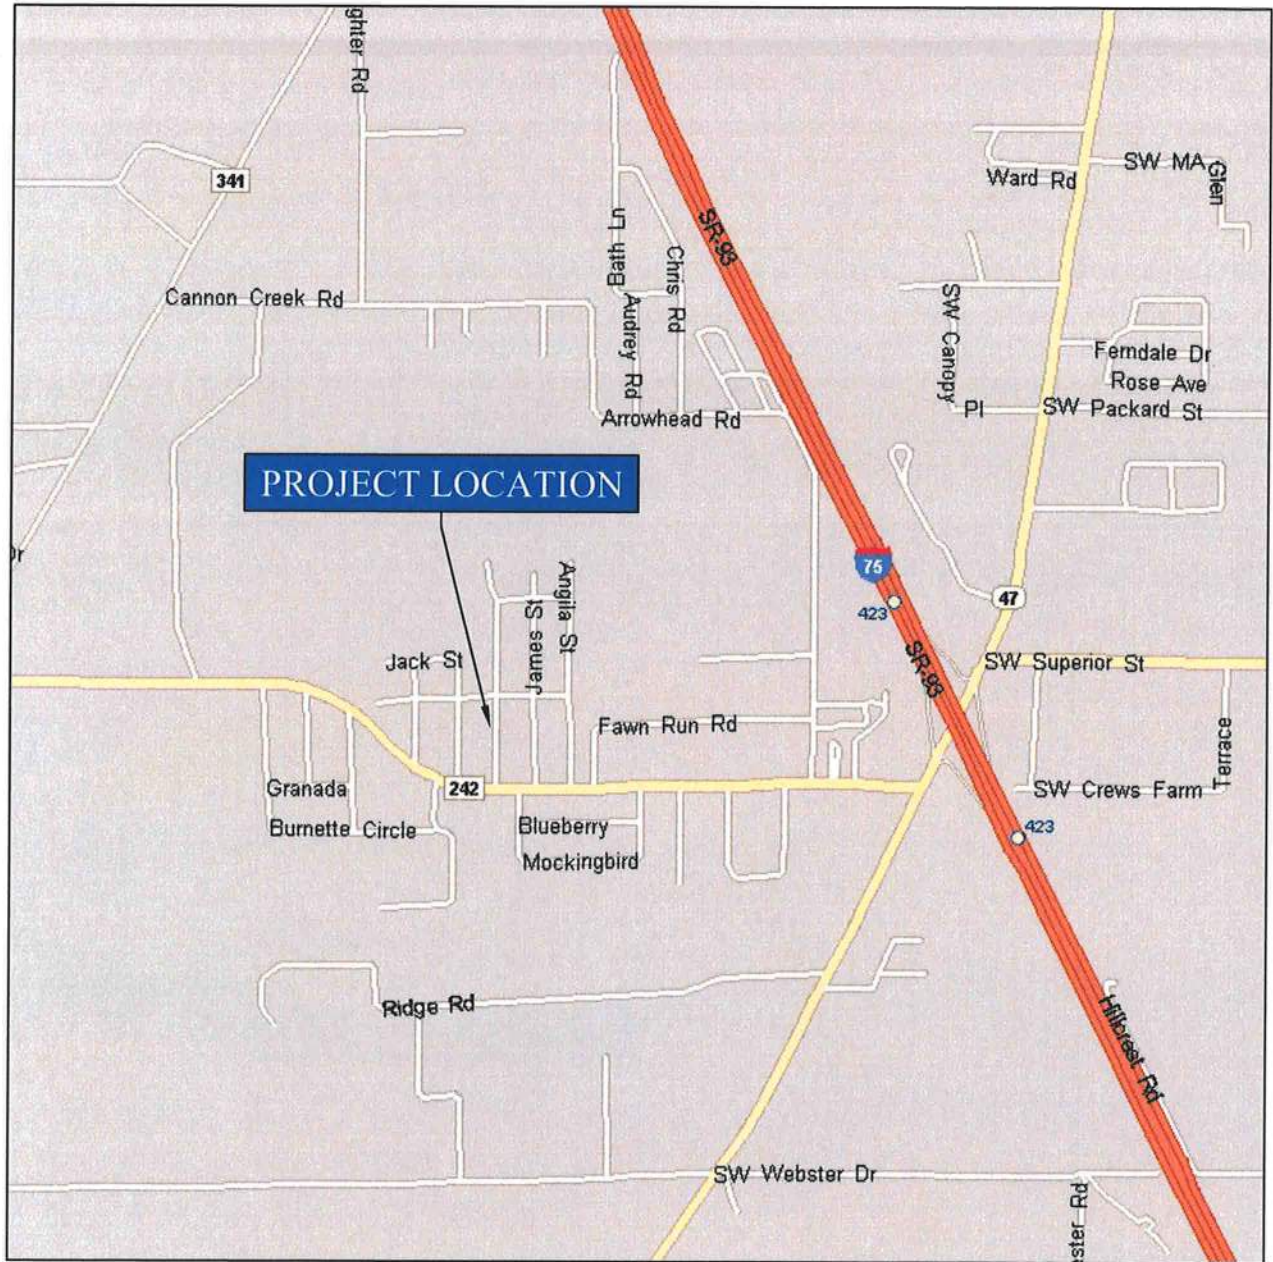
FIGURE
 3

Test pits were manually excavated at the residence in order to observe the foundation type and measure its dimensions and confirm the embedment depth. The location of the test pits are indicated on Figure 3.

One ERI anomaly was identified at the project site (Figure 3). The ERI anomaly was characterized by the localized occurrence of relatively less resistive soil materials at depth. These relatively less resistive sediments occurred at an estimated depth range of 10 to 25 ft bls. It is noted that no geological structures suggesting a possible downward raveling of sediments was observed within this area on either the GPR or ERI data. Accordingly, this ERI anomaly is likely associated with relic depositional or erosion activity, rather than possible karst activity.

Two test pits were excavated at the site to determine the foundation type and embedment depth. Figure 3 indicates the test pit locations.

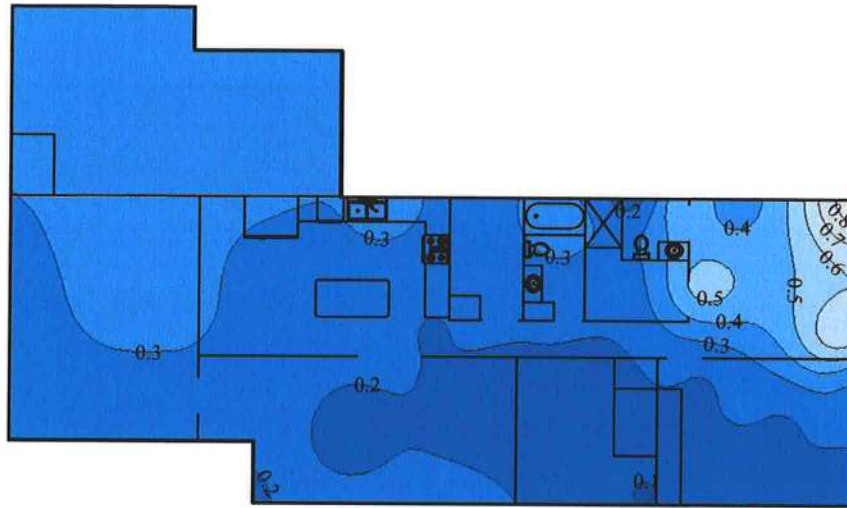
FIGURE
 4

A relative floor elevation survey of the interior floor of the residence was performed using a Zip Level Pro[®]. Data for the floor elevation survey was collected at random points in the rooms that were readily accessible. GSE does not move furniture to obtain the floor elevation data. Data points were limited due to inaccessibility within the interior of the home. The data is accurate to approximately 0.1 inch. The data is used in a computer model that plots contours of the relative elevation of the floor slab. The floor elevation survey map is not prepared by a licensed surveyor, and is not to be considered a survey as regulated by §472 Florida Statutes. The results of the relative floor elevation survey are provided on Figure 4.

The relative floor elevation survey results are provided on Figure 4.

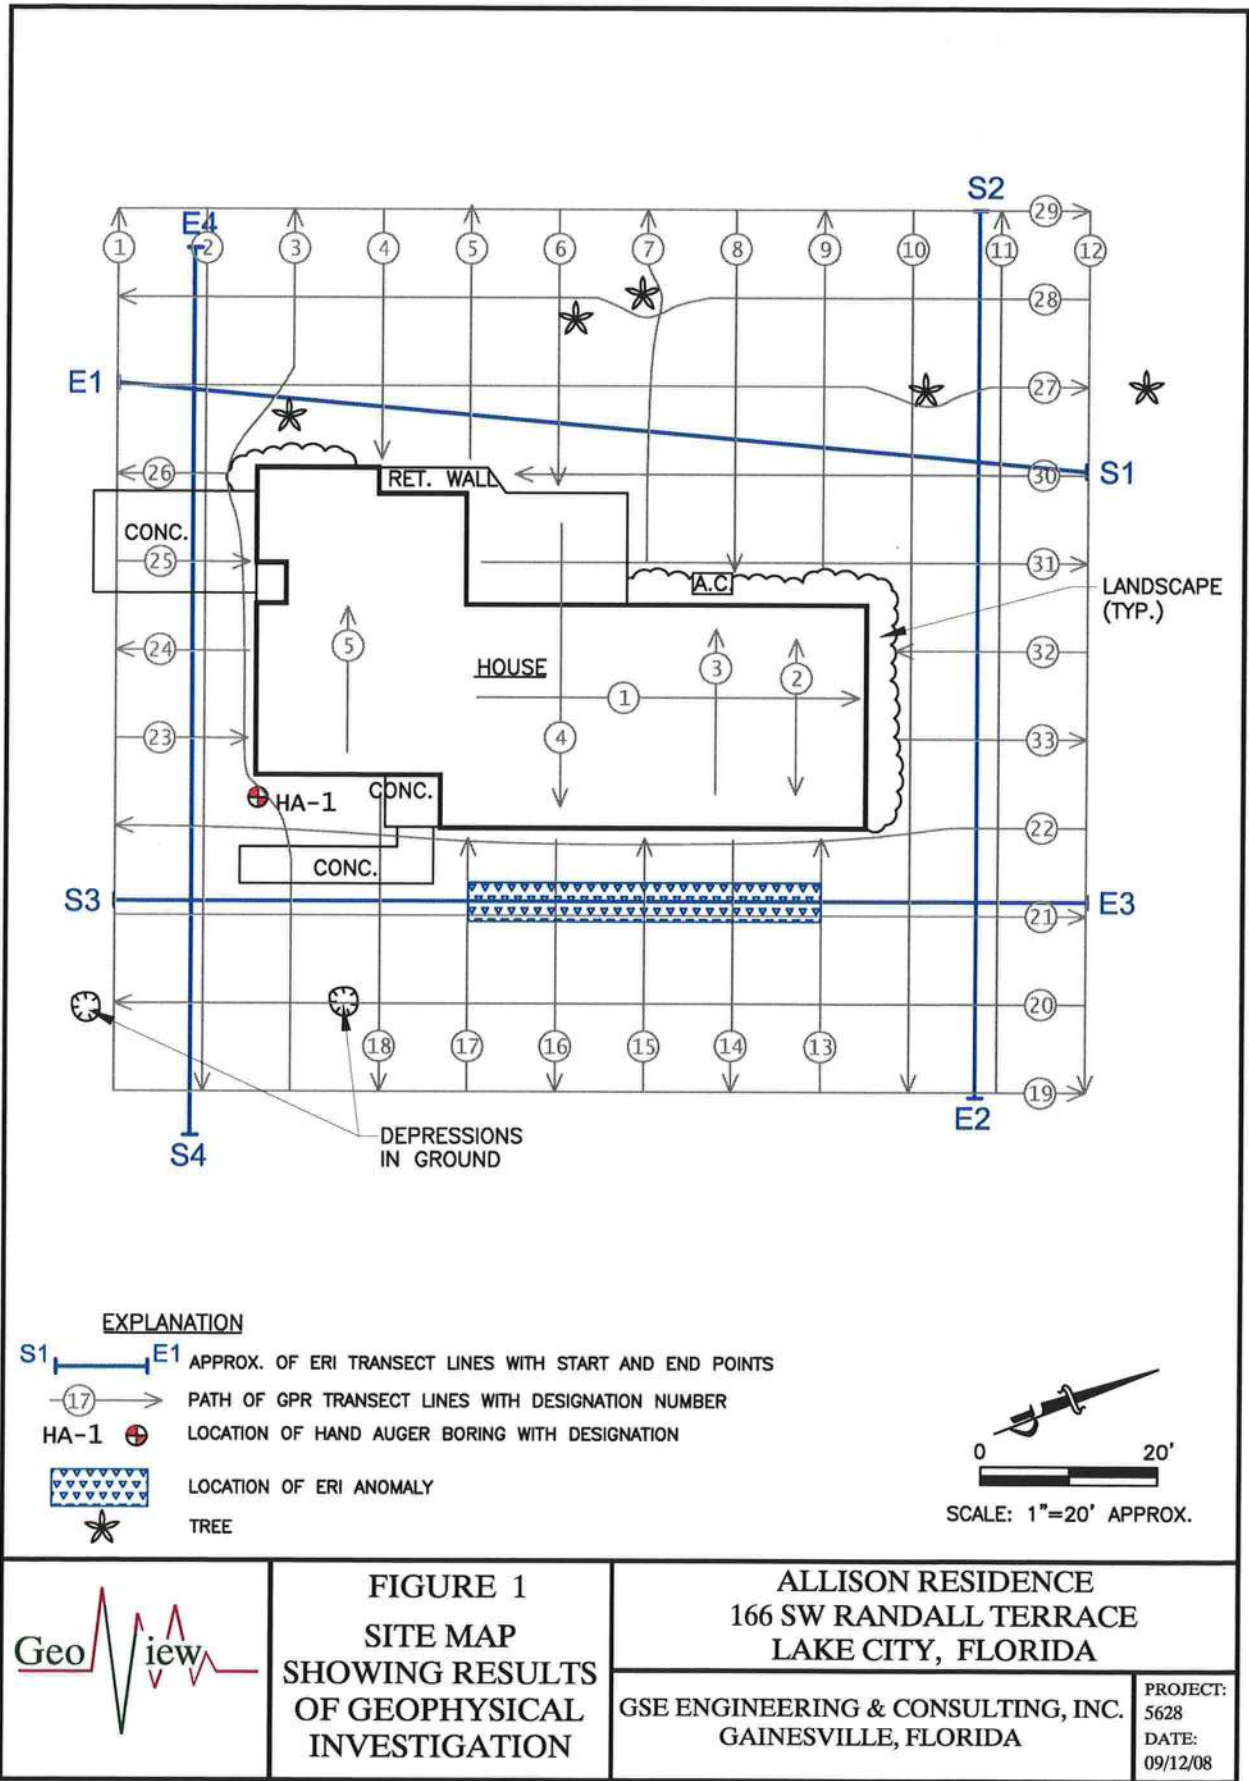
FIGURE 1
SITE MAP
SHOWING RESULTS
OF GEOPHYSICAL
INVESTIGATION

There was a very poor correlation between the GPR and ERI results in terms of identifying layers at similar ranges in depth. This lack of correlation is likely due to the inability of the ERI to resolve the near surface transition between the sandy and sandy clay as observed on the GPR data. The ERI method did identify an anomaly east of the residence. This anomaly is characterized by low resistivity sediments observed at depth. The lack of any soil disturbances observed on the GPR data supports the interpretation that the ERI anomaly is associated with relic depositional or erosion activity, rather than possible karst activity.
