PERMIT
000026894

PELHAM RESIDENCE
LAKE CITY, FLORIDA

SUBSIDENCE INVESTIGATION

Claim Number: 59D167-181

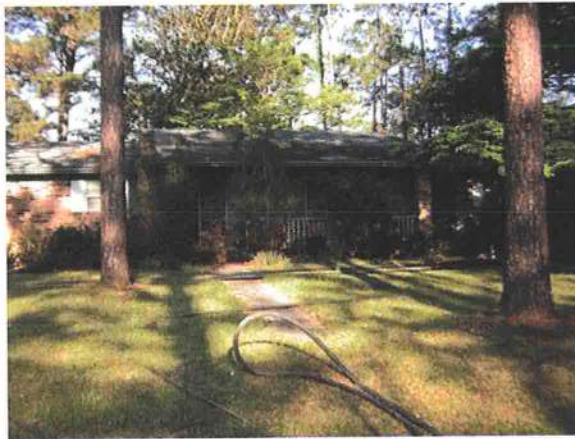
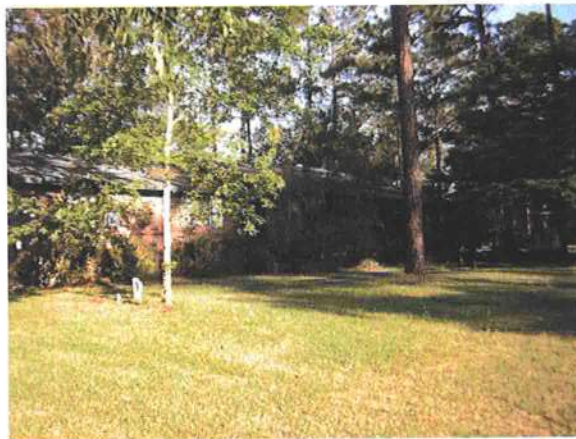
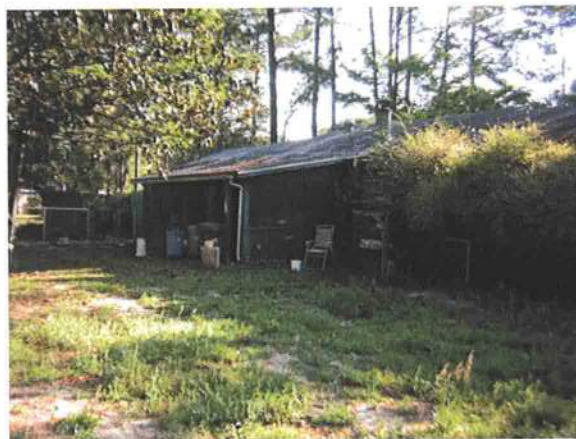
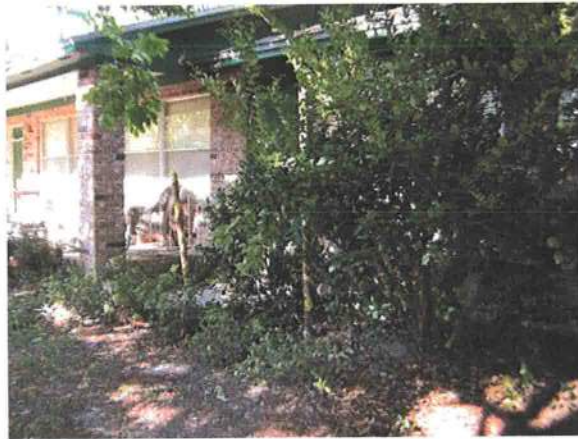
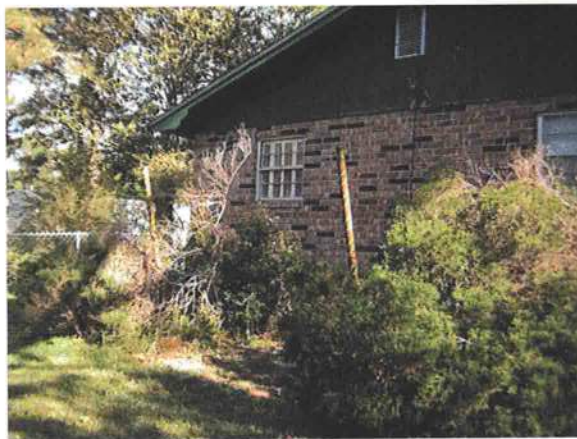
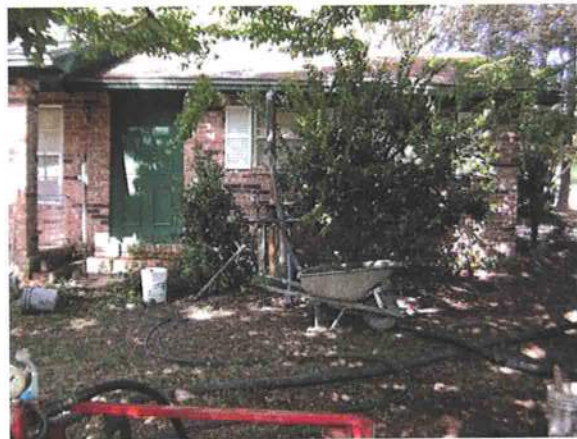
Based on the above information, it is our opinion that the deep injection grouting program has been completed in substantial compliance with SDII's engineering recommendations and local grouting practices. This grouting procedure was implemented to stabilize the subsurface conditions related to sinkhole activity in the immediate vicinity of the foundation of the structure. This procedure may not preclude development of new sinkhole activity in the future, however. Table 1 in the Appendix summarizes the grout injection, including estimated grout volume injected and initial depth of each point. Figure 2 illustrates the location and numbering of the grout points.

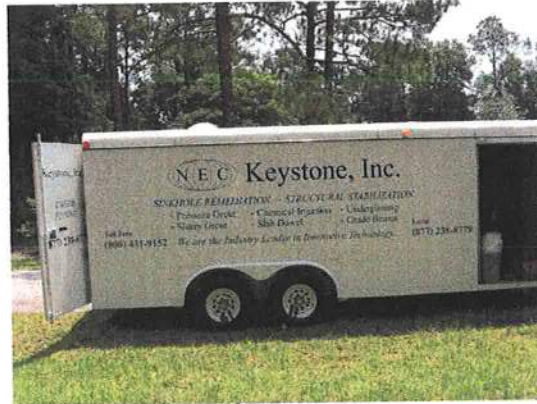
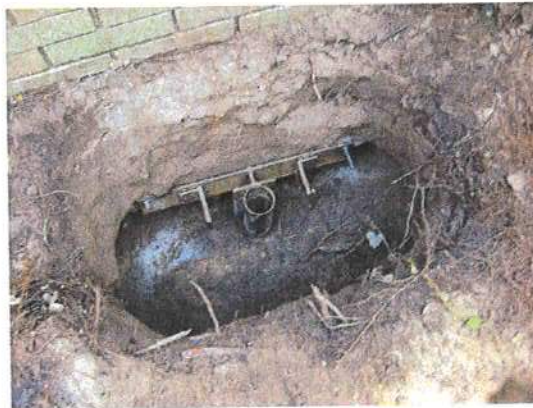
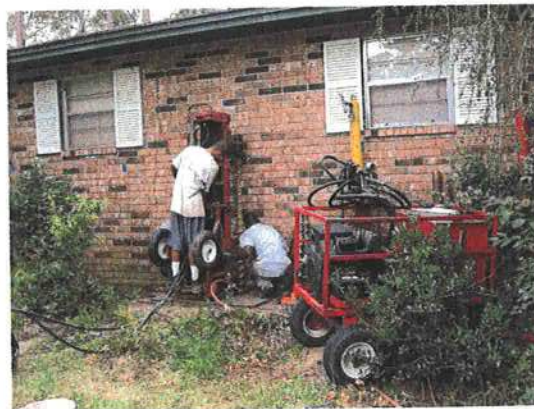
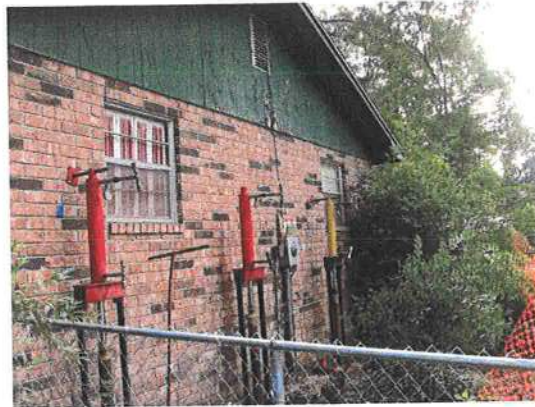
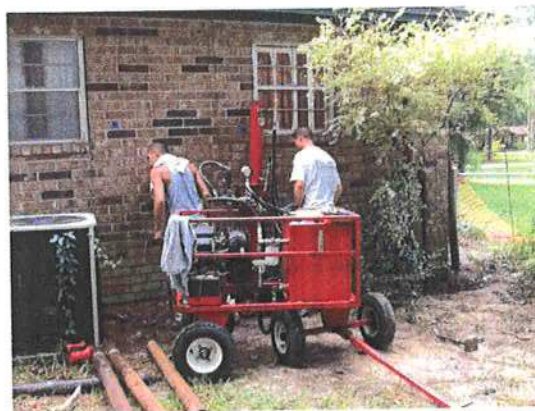
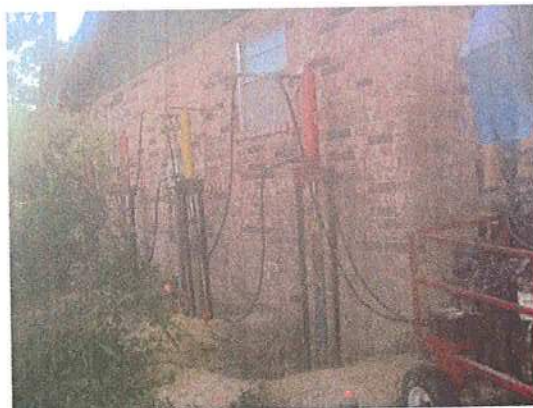
Based on our observations, the underpinning pile installations were documented as substantially complying with SDII's recommendations. Table 1 in the Appendix summarizes the pin pile installation. Figure 2 illustrates the location and numbering of the pin pile locations.
