For Office Use Only Applica	ition # 0907-15 Date Received	7-10-09 By 4 Permit # 27947
Zoning Official 61	Date 4-07.09 Flood Zone	Land Use RES In Devzoning RSF-2
FEMA Map # AVIA_ Eleva	tionMA MFEVA RiverV	Plans Examiner Date 7 (3/04
Comments Dwater Signat	use on Application	
NOC EH Deed or PA	Site Plan State Road of Parent P	arcel #
Dev Permit #	In Floodway / Letter of Auth. fro	om Contractor AF W Comp. letter
IMPACT FEES: EMS	FireCorr	Road/Code
School	= TOTAL

CLAIM No. 59-D215-335 HENDRICKSON RESIDENCE LAKE CITY, COLUMBIA COUNTY, FLORIDA GSE PROJECT No. 10314

Completion Report of Underpinning Remediation Hendrickson Residence – Lake City, Florida Claim No. 59-D215-335 SDII Project No. 3020180B

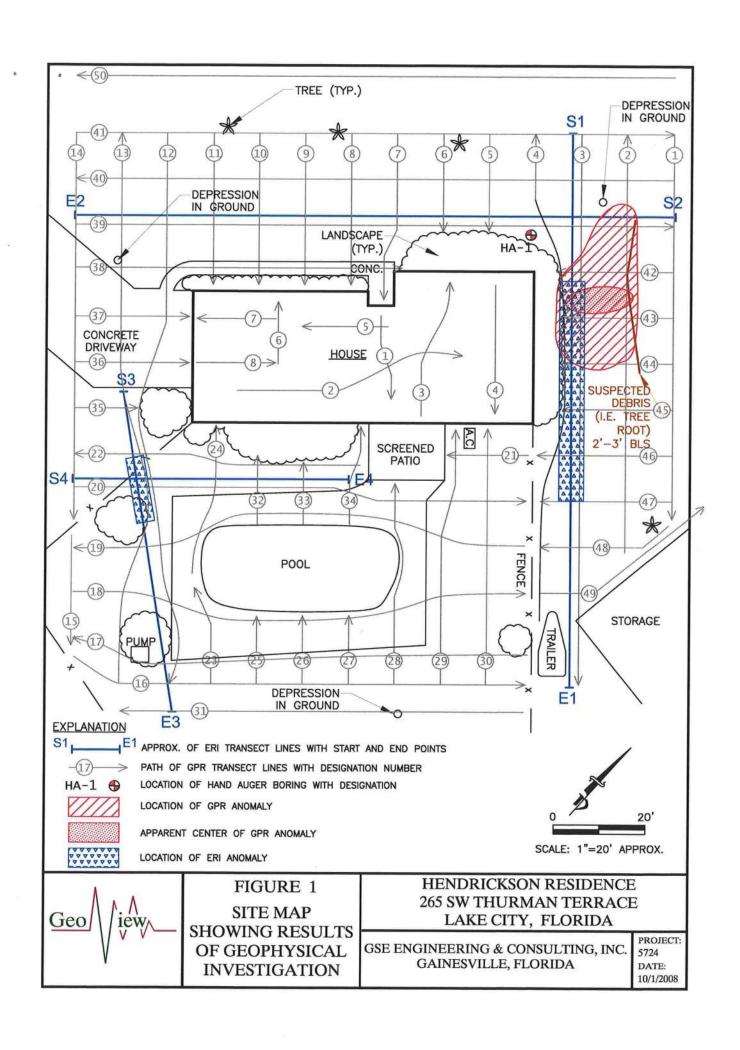
APPENDIX 1 FIGURE AND EXAMPLE OF GPR ANOMALY AND ERI TRANSECTS

One GPR anomaly area was identified north of the residence. The anomaly is semi-elliptical in shape with a total area of approximately 540 square ft. The apparent vertical relief of the upper portion of the anomaly area is 4 to 5 ft as characterized by the observed downwarping of the lower GPR reflector set. The apparent center of the feature is characterized as the area of maximum downwarping of the previously referenced GPR reflectors. It is noted that no disruption to the sediments overlying the downwarped GPR reflector was observed. This suggests that the GPR anomaly is likely associated with relic depositional or erosion activity, rather than possible karst activity.

In addition, the GPR data identified a linear feature within the GPR anomaly area at a depth range of 2 to 3 ft (Figure 1). This linear feature is most likely associated with buried debris (i.e. buried tree/root). No near-surface soil disturbances were observed directly below any of the small surface depressions located throughout the survey area. An example of the GPR data collected across the anomaly area is provided in Appendix 1. A discussion of the limitations of the GPR technique in geological characterization studies is provided in Appendix 2.
