Columbia County Building Permit

2. General description of Improvement: Pressure Grouting and Foundation
Underpinning For Ground Stabilization

SUBSIDENCE INVESTIGATION

MILLER RESIDENCE
 FORT WHITE, FLORIDA

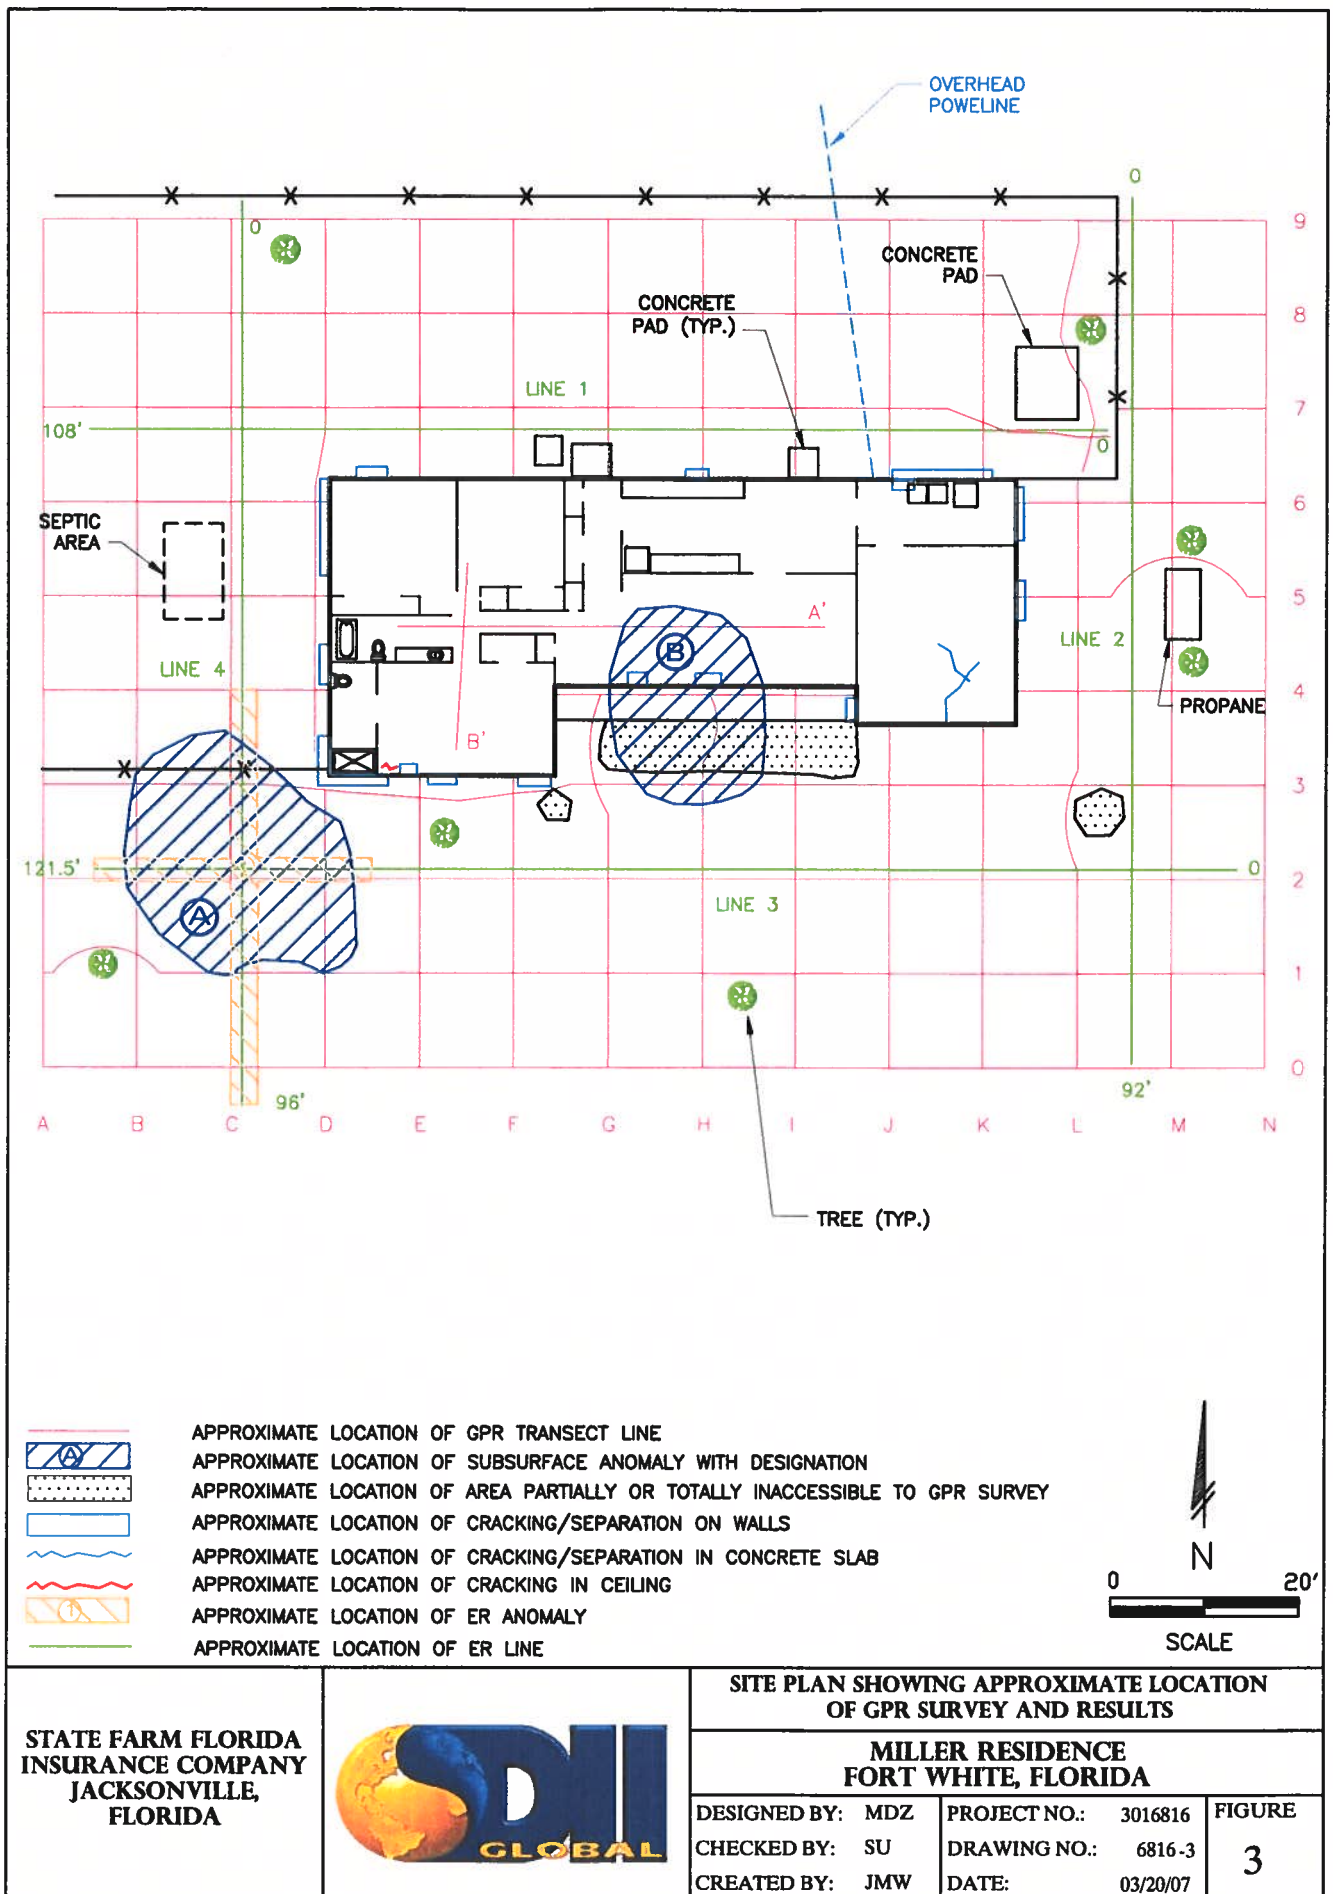
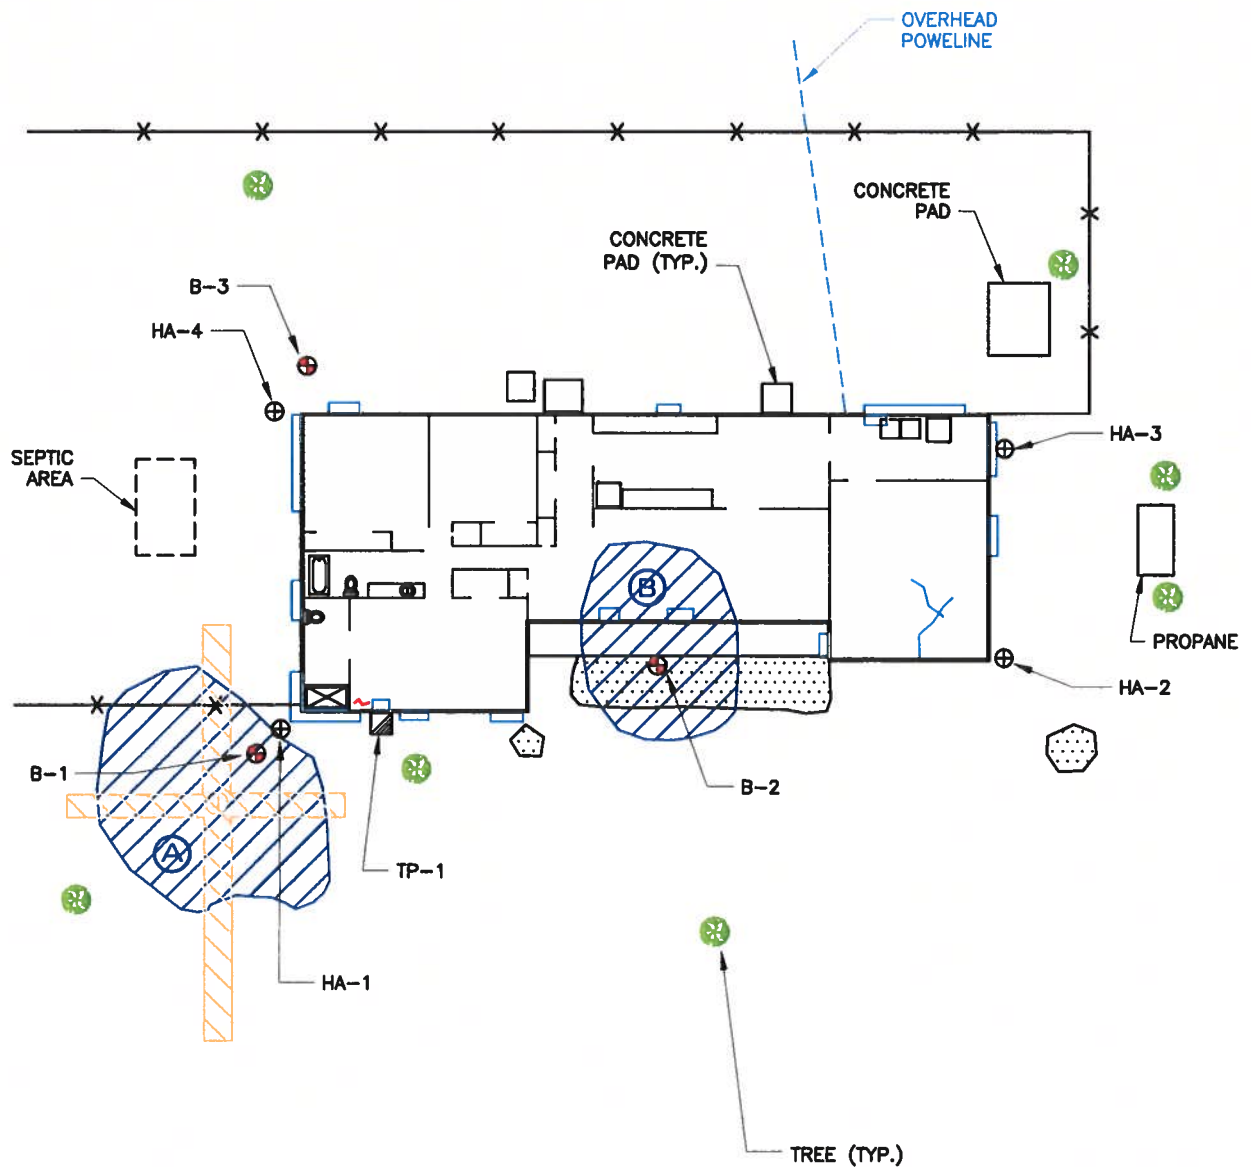
DESIGNED BY: MDZ	PROJECT NO.: 3016816	FIGURE 2
CHECKED BY: SU	DRAWING NO.: 6816-2	
CREATED BY: JMW	DATE: 03/20/07

The following paragraphs summarize the damage noted during the investigation. Approximate locations and photographs representative of the damage are illustrated in Figure 2.

Physical examination of the interior revealed that in the master bedroom located along the south elevation of the structure had hairline to 1/8-inch wide ceiling and wall cracks. The window located along the south elevation of the master bedroom was out of plumb. The living room located along the south elevation of the structure had hairline to 1/8-inch wide wall cracks near the window frame. The laundry room located at the northeast corner of the structure had hairline to 1/8-inch wide wall cracks. The garage located at the southeast corner of the structure had hairline to 1/8-inch wide slab cracks.

Physical examination of the exterior revealed that on the south elevation of the structure there were multiple hairline to 1/4-inch wide vertical, horizontal and stair step pattern wall cracks. The east elevation of the structure had hairline to 1/16-inch wide horizontal, vertical and stair step pattern wall cracks. The north elevation of the structure had hairline to 1/8-inch wide horizontal,

vertical and stair step pattern wall cracks. The west elevation of the structure had hairline to 1/8-inch wide horizontal, vertical and stair step pattern wall cracks.

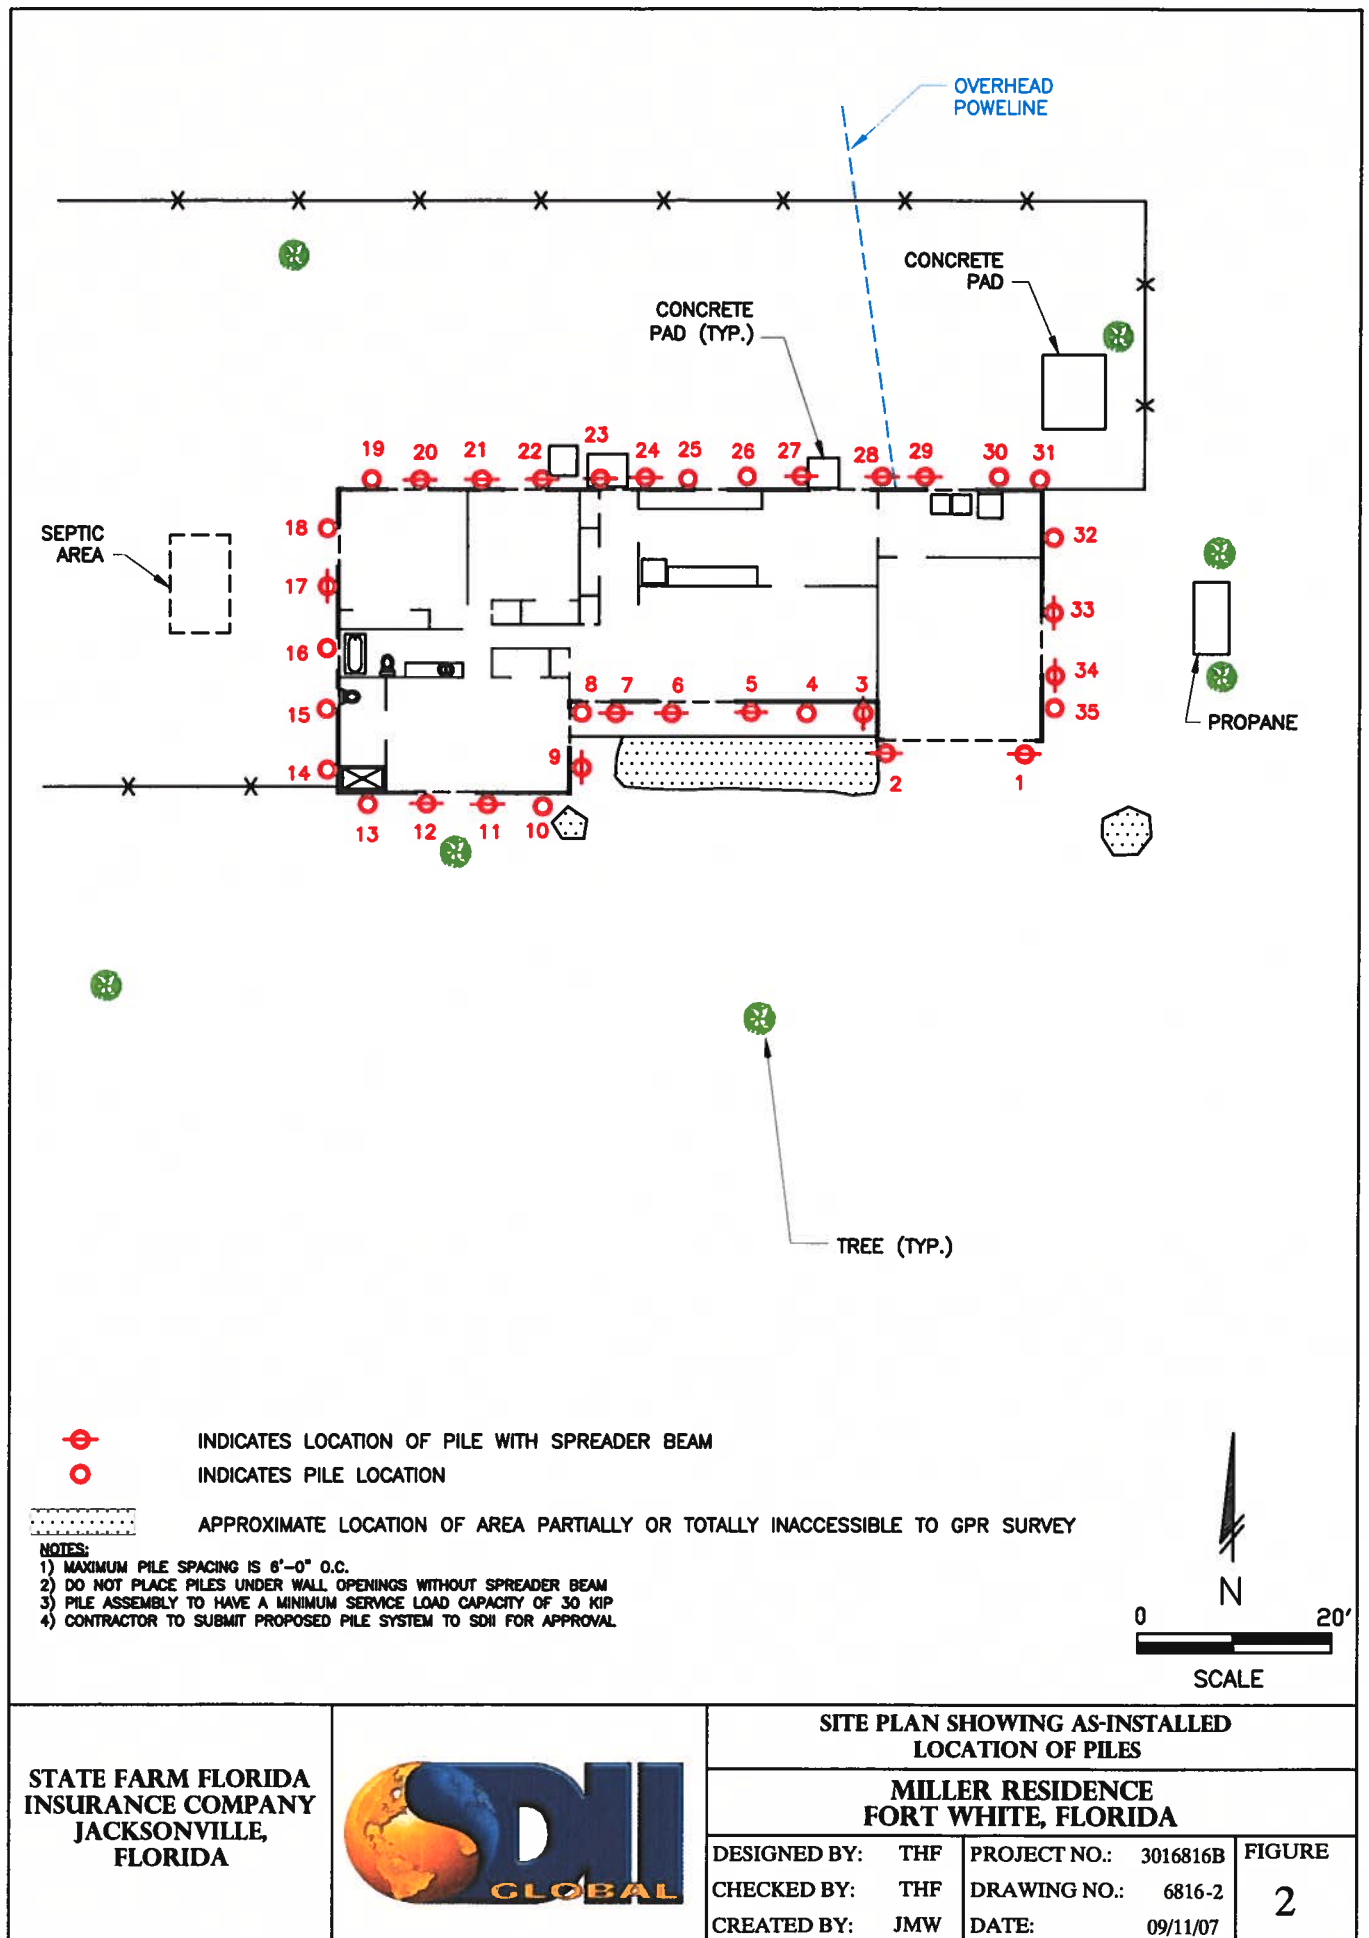
Based on our observations, the underpinning pile installations were documented as substantially complying with SDII's recommendations. Table 1 in the Appendix summarizes the pin pile installation. Figure 2 illustrates the location and numbering of the pin pile locations.
