**CONSTRUCTION MANAGEMENT REPORT  
LIMITED ASBESTOS RENOVATION SURVEY  
(PERFORMED ON APRIL 10, 2014)**

**FORMER LUMBER STORAGE FACILITY  
1824 W. HIGHWAY 90  
LAKE CITY, FLORIDA 32025**

**AGC ENVIRONMENTAL CONSULTING, INC.  
13762 W. STATE ROAD 84  
SUITE 408  
DAVIE, FLORIDA 33325  
PROJECT NO. AGC-14-1194**

SUBJECT: Limited Asbestos Renovation Survey for the

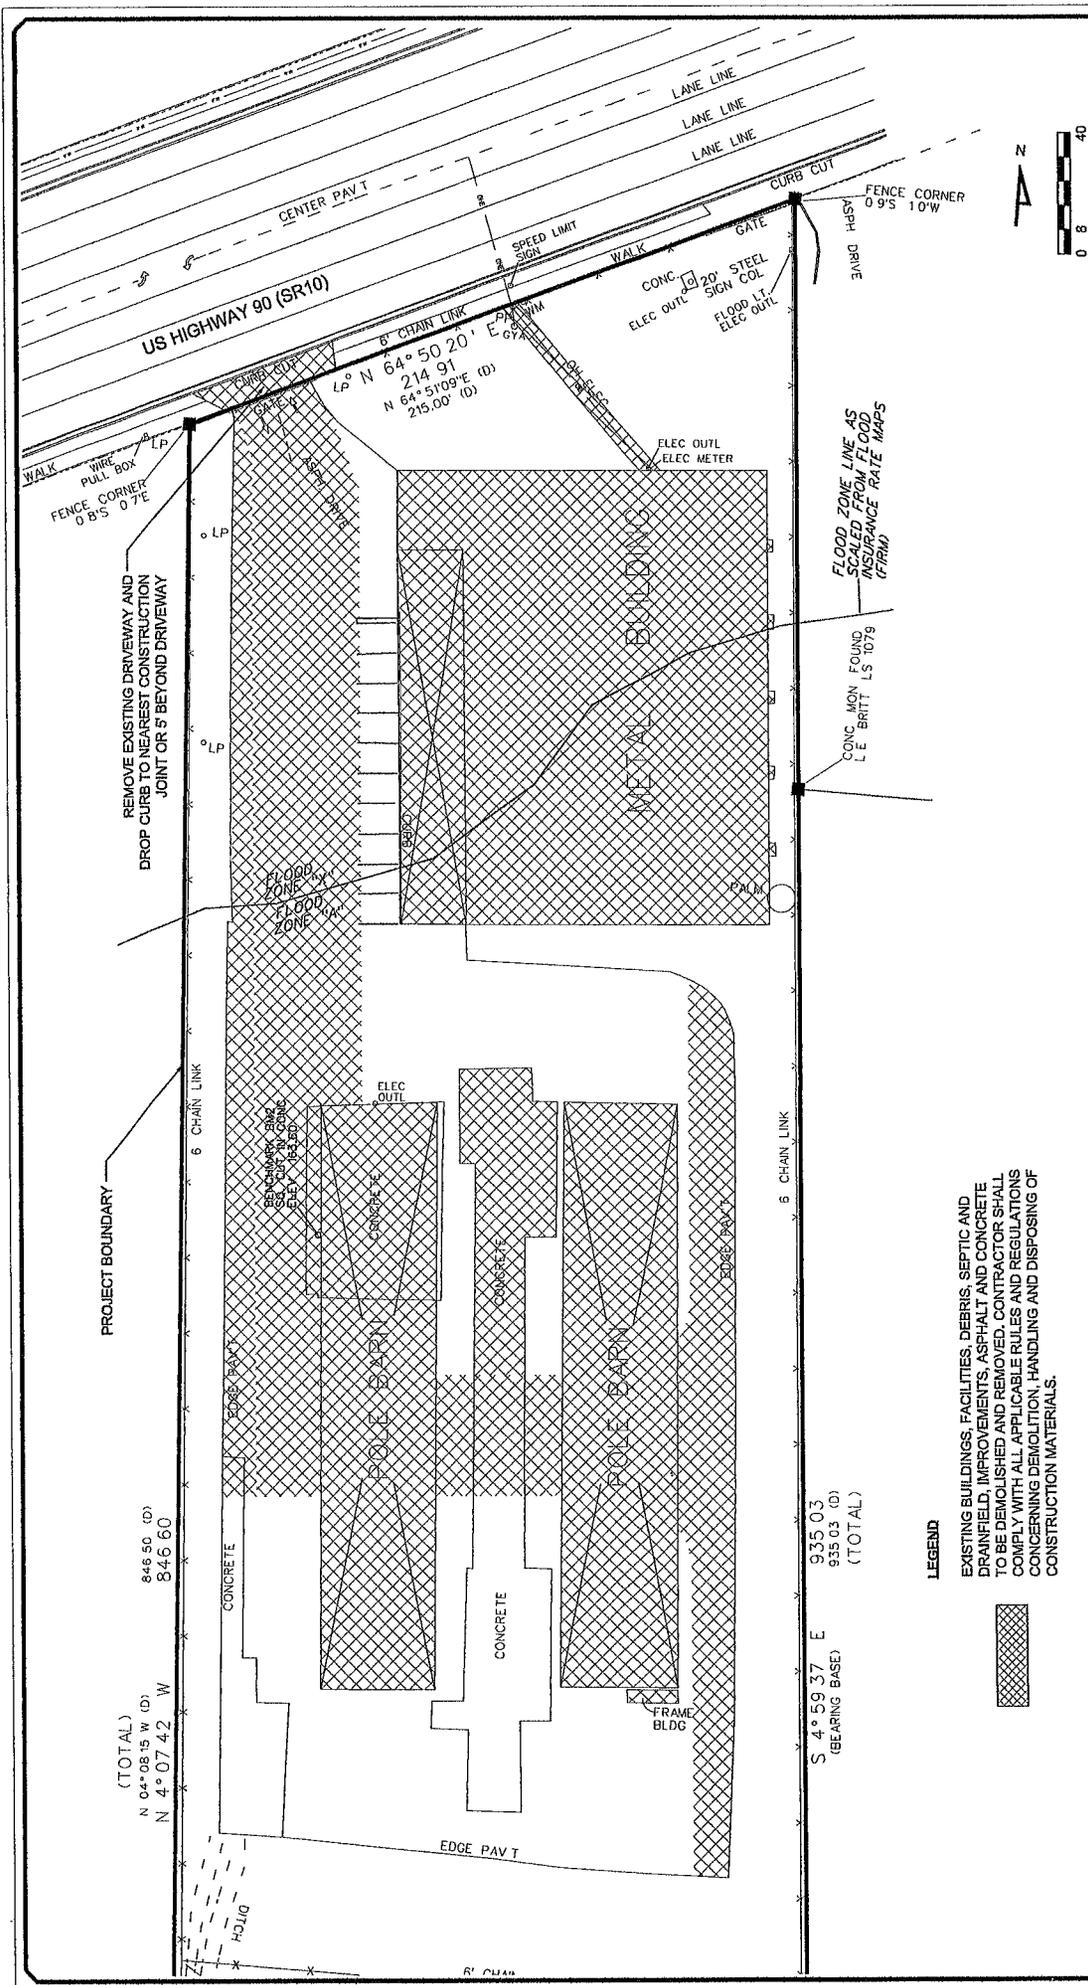
**LEGEND**  
 EXISTING BUILDINGS, FACILITIES, DEBRIS, SEPTIC AND DRAINFIELD, IMPROVEMENTS, ASPHALT AND CONCRETE TO BE DEMOLISHED AND REMOVED. CONTRACTOR SHALL COMPLY WITH ALL APPLICABLE RULES AND REGULATIONS CONCERNING DEMOLITION, HANDLING AND DISPOSING OF CONSTRUCTION MATERIALS.
