### BASIN OPERATION AND MAINTENANCE REQUIREMENTS

OPERATION & MAINTENANCE ENTITY: MOONSHINE ACRES RV PARK

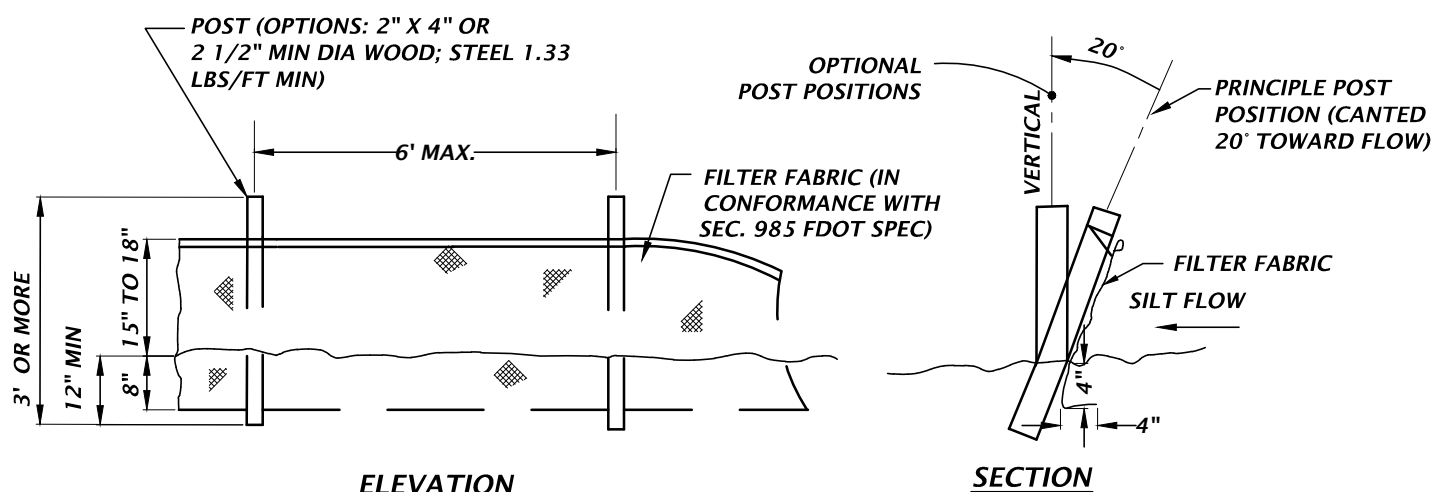
### TYPE III SILT FENCE DETAIL

NTS

THE SYSTEM SHALL BE REGULARLY INSPECTED AND MAINTAINED BY THE PERMITTEE TO INSURE THAT ALL EROSION IS CONTROLLED AND SOIL IS STABILIZED TO PREVENT SEDIMENT DISCHARGE TO WATERS IN THE STATE. ANY VEGETATION ESTABLISHED FOR EROSION CONTROL, SHALL BE PROPERLY MAINTAINED FOR FUNCTION.

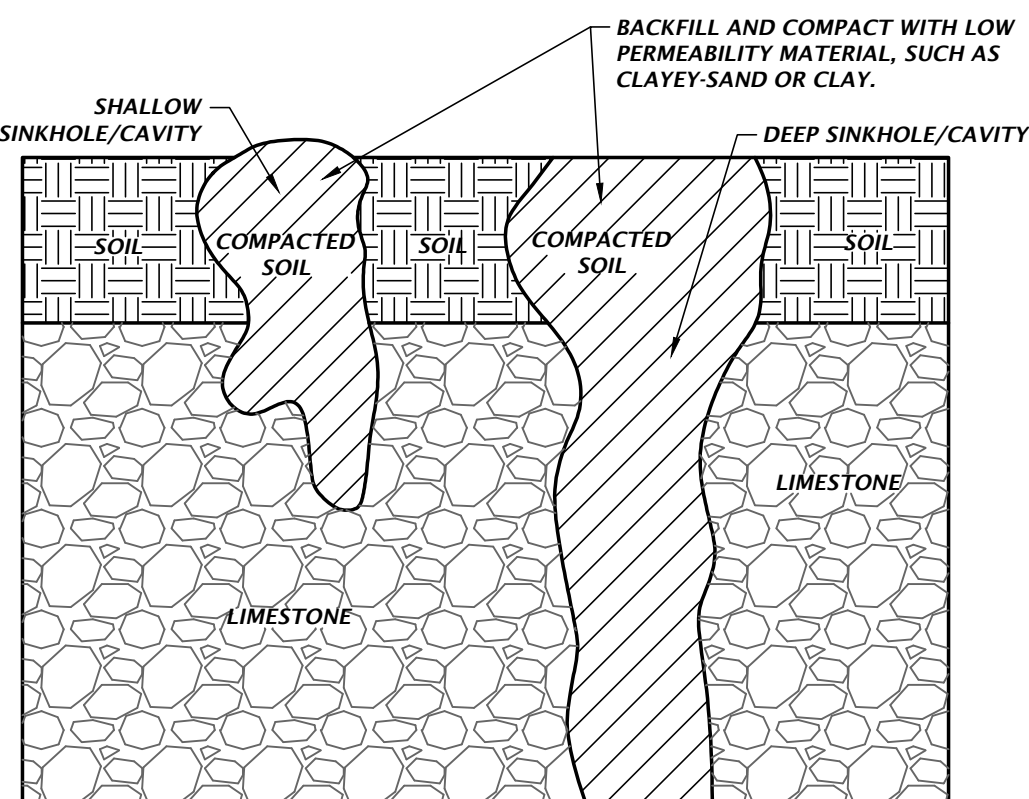
### SHALLOW AND DEEP SINKHOLE/CAVITY MAINTENANCE REPAIR DETAIL

NTS

ALL SWALES/BASINS SHALL BE INSPECTED MONTHLY FOR SINKHOLE OCCURRENCE. SHOULD A SINKHOLE OCCUR, THE AREA SHALL BE REPAIRED AS SOON AS POSSIBLE. REPAIR SHALL INCLUDE FILLING LIMEROCK SUCH AS ROAD BASE MATERIAL, CLAY/SAND MIXTURE, OR CONCRETE IF NECESSARY. A 3 FOOT DEEP CAP THAT EXTENDS 3 FEET BEYOND THE PERIMETER OF THE SINKHOLE SHALL BE CONSTRUCTED WITH CLAYEY SOILS. THE CLAYEY SOIL SHALL HAVE AT LEAST 20% PASSING THE NO. 200 SIEVE, COMPACTED TO 95% OF STANDARD PROCTOR, AND COMPACTED IN A WET CONDITION WITH MOISTURE 2% - 4% ABOVE OPTIMUM. THE CLAY SOIL CAP SHALL BE REGRADED TO PREVENT CONCENTRATION OF WATERS (PONDING) AND RE-VEGETATED.

- IF A SOLUTION PIPE SINKHOLE DOES FORM IN THE STORMWATER BASIN, THEN THE SINKHOLE SHALL BE REPAIRED BY BACKFILLING WITH MATERIAL OF LOWER PERMEABILITY MATERIAL, SUCH AS CLAYEY SAND OR CLAY. THE MATERIAL SHALL BE COMPACTED AND THE SINKHOLE REPAIR SHOULD BRING THE SURFACE BACK TO AN ELEVATION WHICH IS SLIGHTLY ABOVE THE ORIGINAL BOTTOM, CREATING A SMALL MOUND.

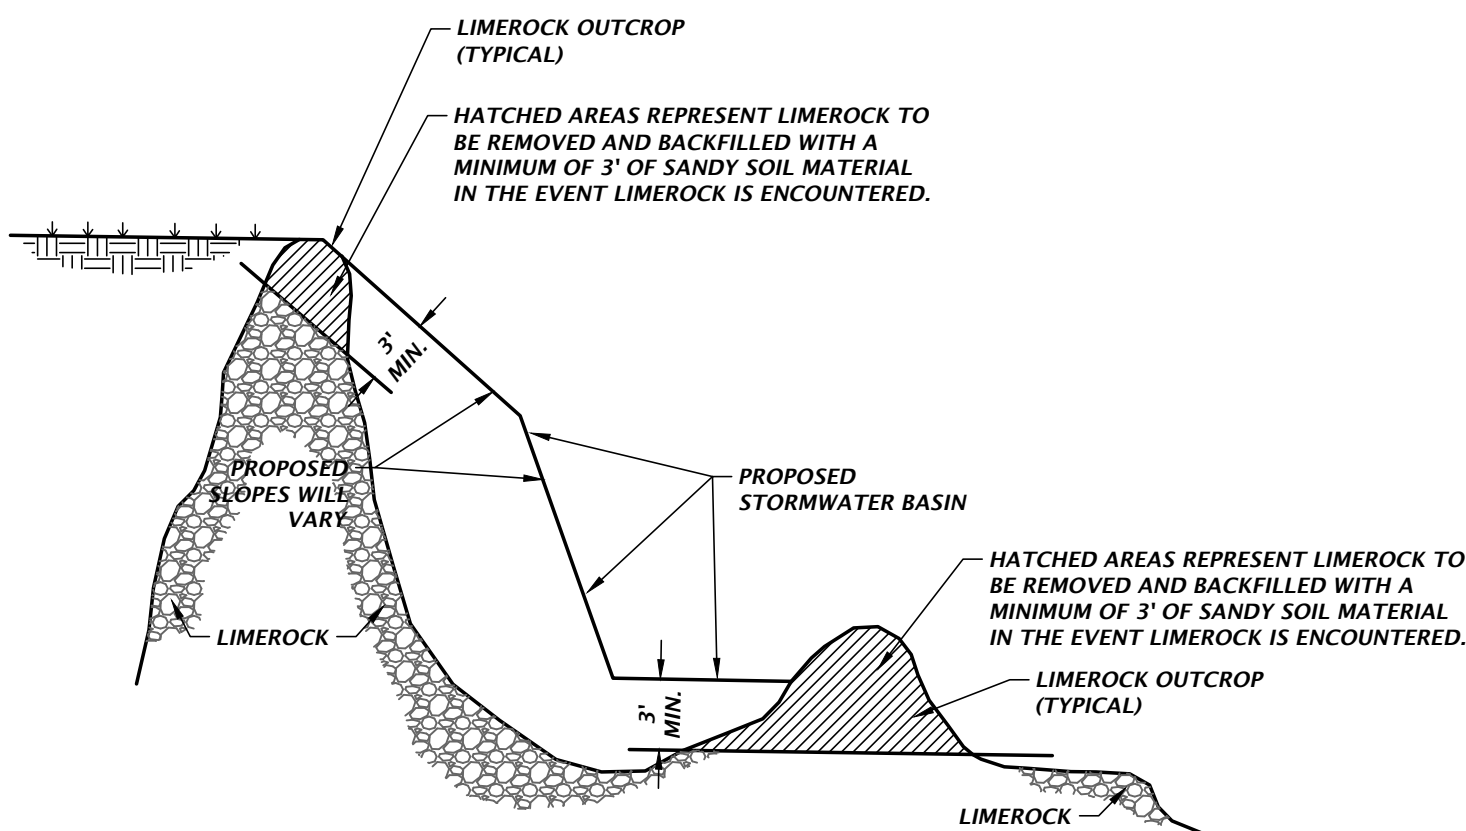
### LIMEROCK OUTCROP REMOVAL DETAIL

NTS

WHERE A CONTINUOUS LIMEROCK FORMATION IS ENCOUNTERED DURING EXCAVATION OF THE SWALES/BASINS, THE LIMEROCK SHALL BE OVER EXCAVATED BY 3 FEET, AN APPROVED GEO TEXTILE FABRIC SHALL BE PLACED IN THE EXCAVATION AND BACKFILLED WITH SANDY SOILS IN A LOOSE CONDITION.

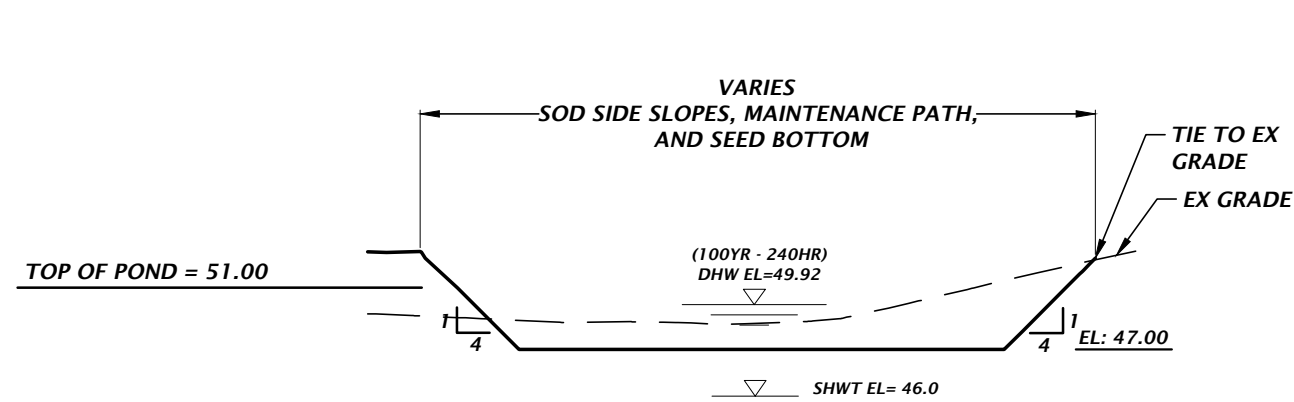
### STORMWATER MANAGEMENT FACILITY #1 CROSS SECTION A-A

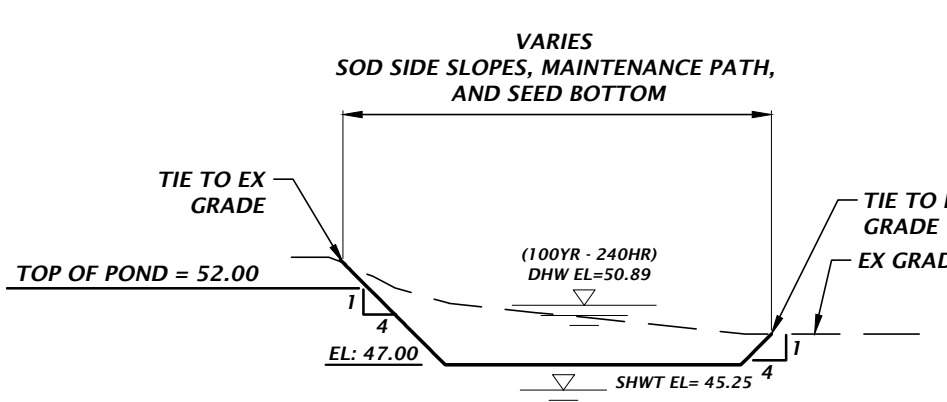
### STORMWATER MANAGEMENT FACILITY #2 CROSS SECTION B-B

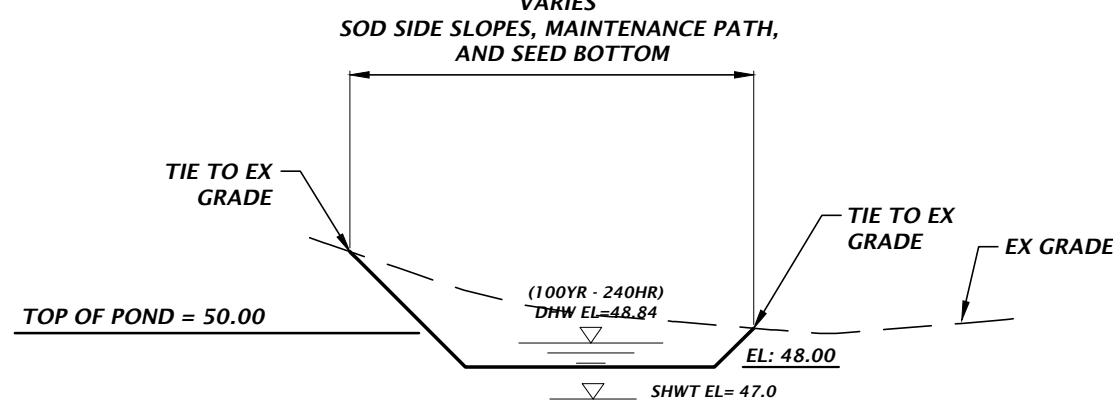
### STORMWATER MANAGEMENT FACILITY #3 CROSS SECTION C-C

- IN AREAS WHERE CLAY-RICH SOILS ARE PRESENT AT THE BASIN BOTTOM, WE RECOMMEND THESE SOILS BE UNDERCUT A MINIMUM OF 2 FEET AND BACKFILLED WITH THE ON-SITE SANDS AND SANDS WITH SILT (SP, SP-SM) HAVING A MAXIMUM OF 12 PERCENT SOIL FINES PASSING THE NO. 200 SIEVE. THE INTENT OF THIS UNDERCUTTING AND REPLACEMENT IS TO PROVIDE A MORE UNIFORM SAND "BLANKET" AT THE BASIN BOTTOM THAT ALLOWS THE MIGRATION OF WATER TO THE DEEPER DEPOSITS OF SAND. THIS SAND BLANKET WILL ALSO REDUCE THE POTENTIAL FOR CLAY FINES LEACHING OUT OF THE SOILS WHEN WATER IS PRESENT IN THE BASIN THAT CAN RESULT IN A THIN LAYER OF CONFINING TYPE MATERIAL ON THE BASIN BOTTOM THAT CAN REDUCE THE EFFECTIVENESS OF THE BASIN.
