# ROOF SYSTEM REPAIR NOTES:

**EXISTING & REMODEL  
 PLANS**

**MCKINZEY REMODEL**

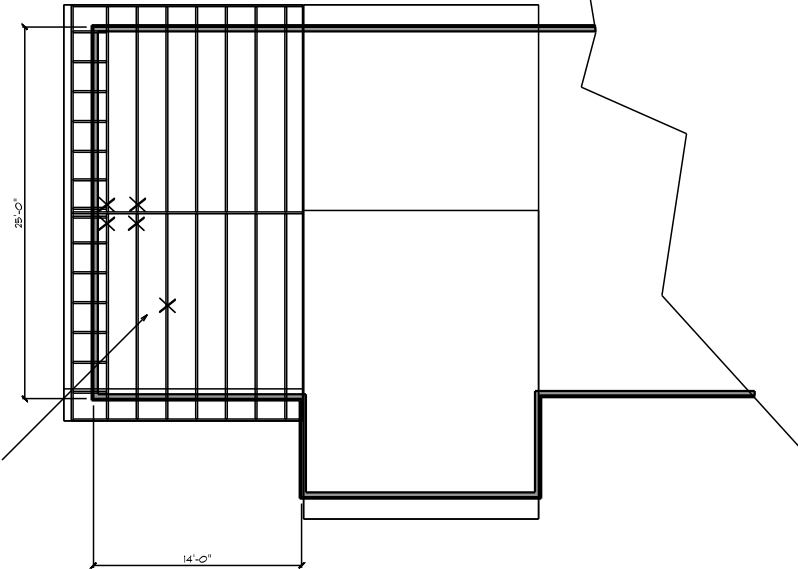
DETAIL 1

RAFTERS TO BE REPAIRED MARKED WITH (X) AT DAMAGED OR BROKEN AREA

THIS RAFTER WILL HAVE A CONTINUOUS REPAIR TO BOTH SIDES DUE TO LOCATION OF BREAK.

1. REPLACE RIDGE BEAM
2. REPAIR BROKEN RAFTER. (SEE DETAIL 1.)
3. INSTALL NEW COLLAR TIES.
4. INSTALL 1/2" PLYWOOD AS NEEDED NAILED 4" O.C. ALONG EDGES AND 8" O.C. IN THE FIELD
5. INSTALL NEW METAL ROOFING OVER TITANIUM UNDERLAYMENT

## 2X6 RAFTER REPAIR:

ADD 2X6 S.Y.P MINIMUM OF 8' TO BOTH SIDES OF DAMAGED RAFTERS (5)  
 NAIL WITH 12 PENNY NAILS 2 ROWS 6" O.C.  
 RE NAIL ROOF WITH 8D .131 NAILS 4" ALONG EDGES AND 8" IN FIELD
