**EXISTING & REMODEL
 PLANS**

SHEET NO.
 8

MCKINZEY REMODEL

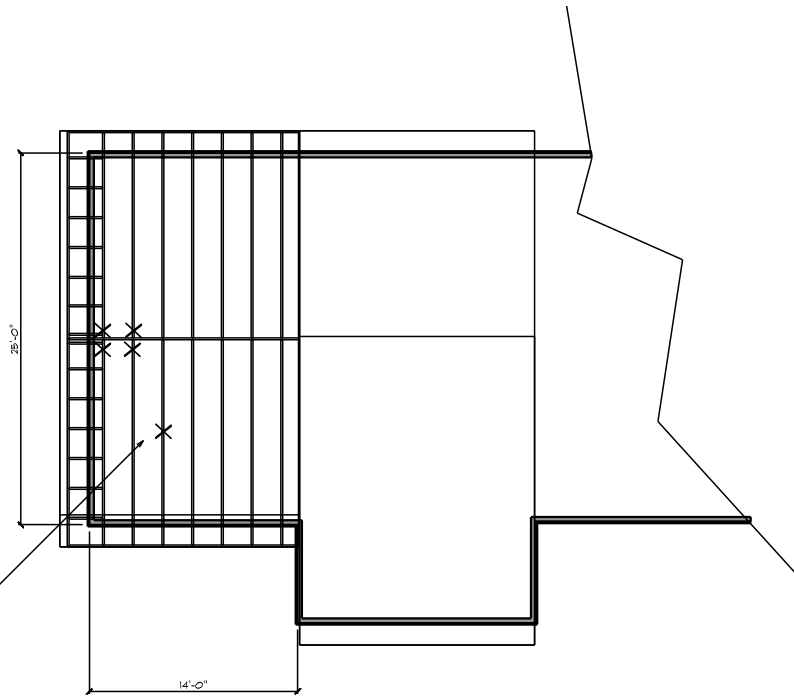
RAFTERS TO BE REPAIRED MARKED WITH (X) AT DAMAGED OR BROKEN AREA

THIS RAFTER WILL HAVE A CONTINUOUS REPAIR TO BOTH SIDES DUE TO LOCATION OF BREAK.

1. REPLACE RIDGE BEAM
2. REPAIR BROKEN RAFTER. (SEE DETAIL 1.)
3. INSTALL NEW COLLAR TIES.
4. INSTALL 1/2" PLYWOOD AS NEEDED NAILED 4" O.C. ALONG EDGES AND 8" O.C. IN THE FIELD
5. INSTALL NEW METAL ROOFING OVER TITANIUM UNDERLAYMENT
