ROOF SYSTEM REPAIR NOTES:

EXISTING & REMODEL  
 PLANS

MCKINZEY REMODEL

SHEET NO.  
 8

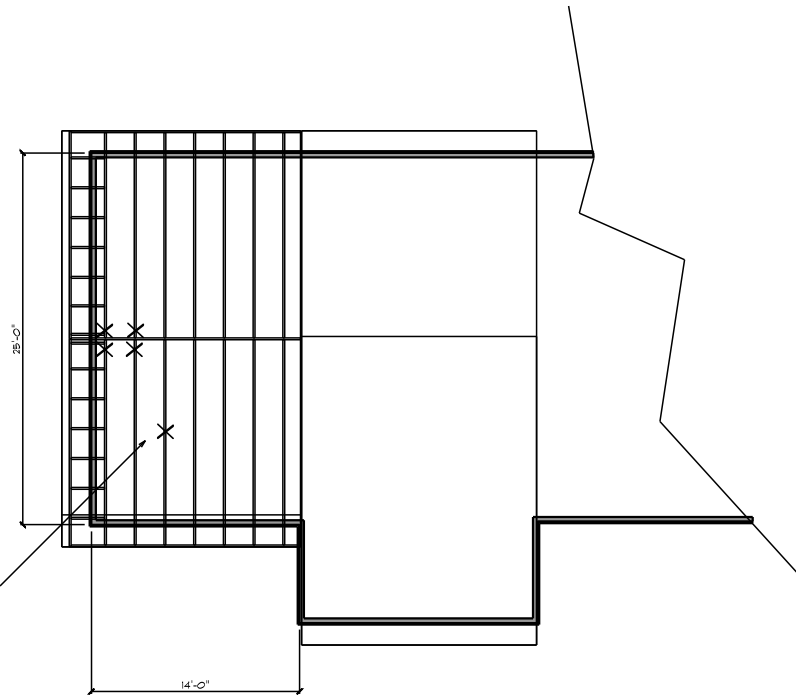
DETAIL 1

RAFTERS TO BE REPAIRED MARKED WITH (X) AT DAMAGED OR BROKEN AREA

THIS RAFTER WILL HAVE A CONTINUOUS REPAIR TO BOTH SIDES DUE TO LOCATION OF BREAK.

2X6 RAFTER REPAIR:

ADD 2X6 S.Y.P. MINIMUM OF 8' TO BOTH SIDES OF DAMAGED RAFTERS (5)  
 NAIL WITH 12 PENNY NAILS 2 ROWS 6" O.C.  
 RE NAIL ROOF WITH 8D .131 NAILS 4" ALONG EDGES AND 8" IN FIELD

1. REPLACE RIDGE BEAM
2. REPAIR BROKEN RAFTER. (SEE DETAIL 1.)
3. INSTALL NEW COLLAR TIES.
4. INSTALL 1/2" PLYWOOD AS NEEDED NAILED 4" O.C. ALONG EDGES AND 8" O.C. IN THE FIELD
5. INSTALL NEW METAL ROOFING OVER TITANIUM UNDERLAYMENT
