# COLUMBIA COUNTY

## Comprehensive Safety Action Plan

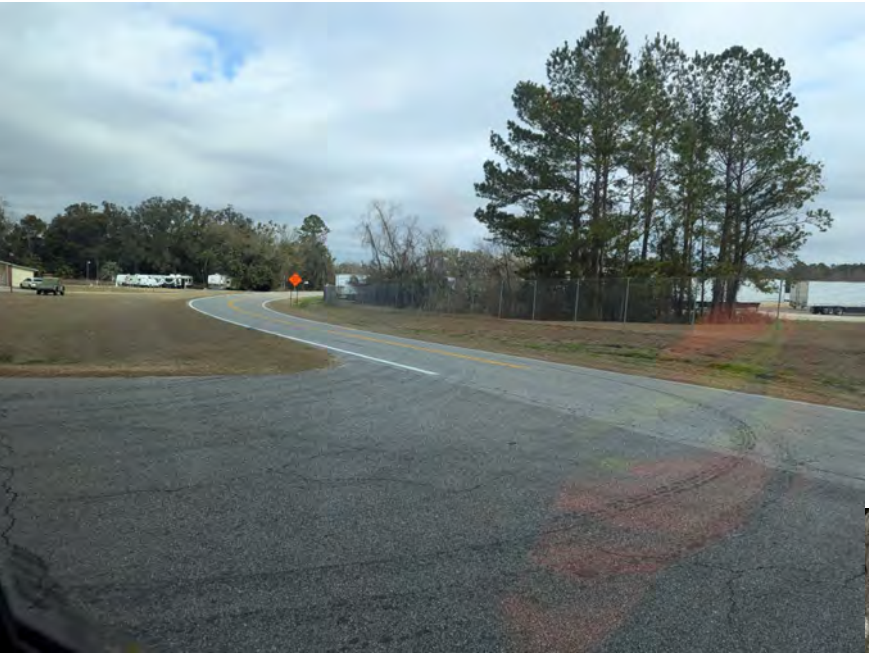
CURVE ON NORTHERN END NEAR US-41

| Countermeasure | Scale/Timeframe | Justification |
|---|---|---|
| A. Install centerline and edge line rumble strips | Short | Frequency of off-road crashes.<br>Observed tire marks on grass shoulders. |

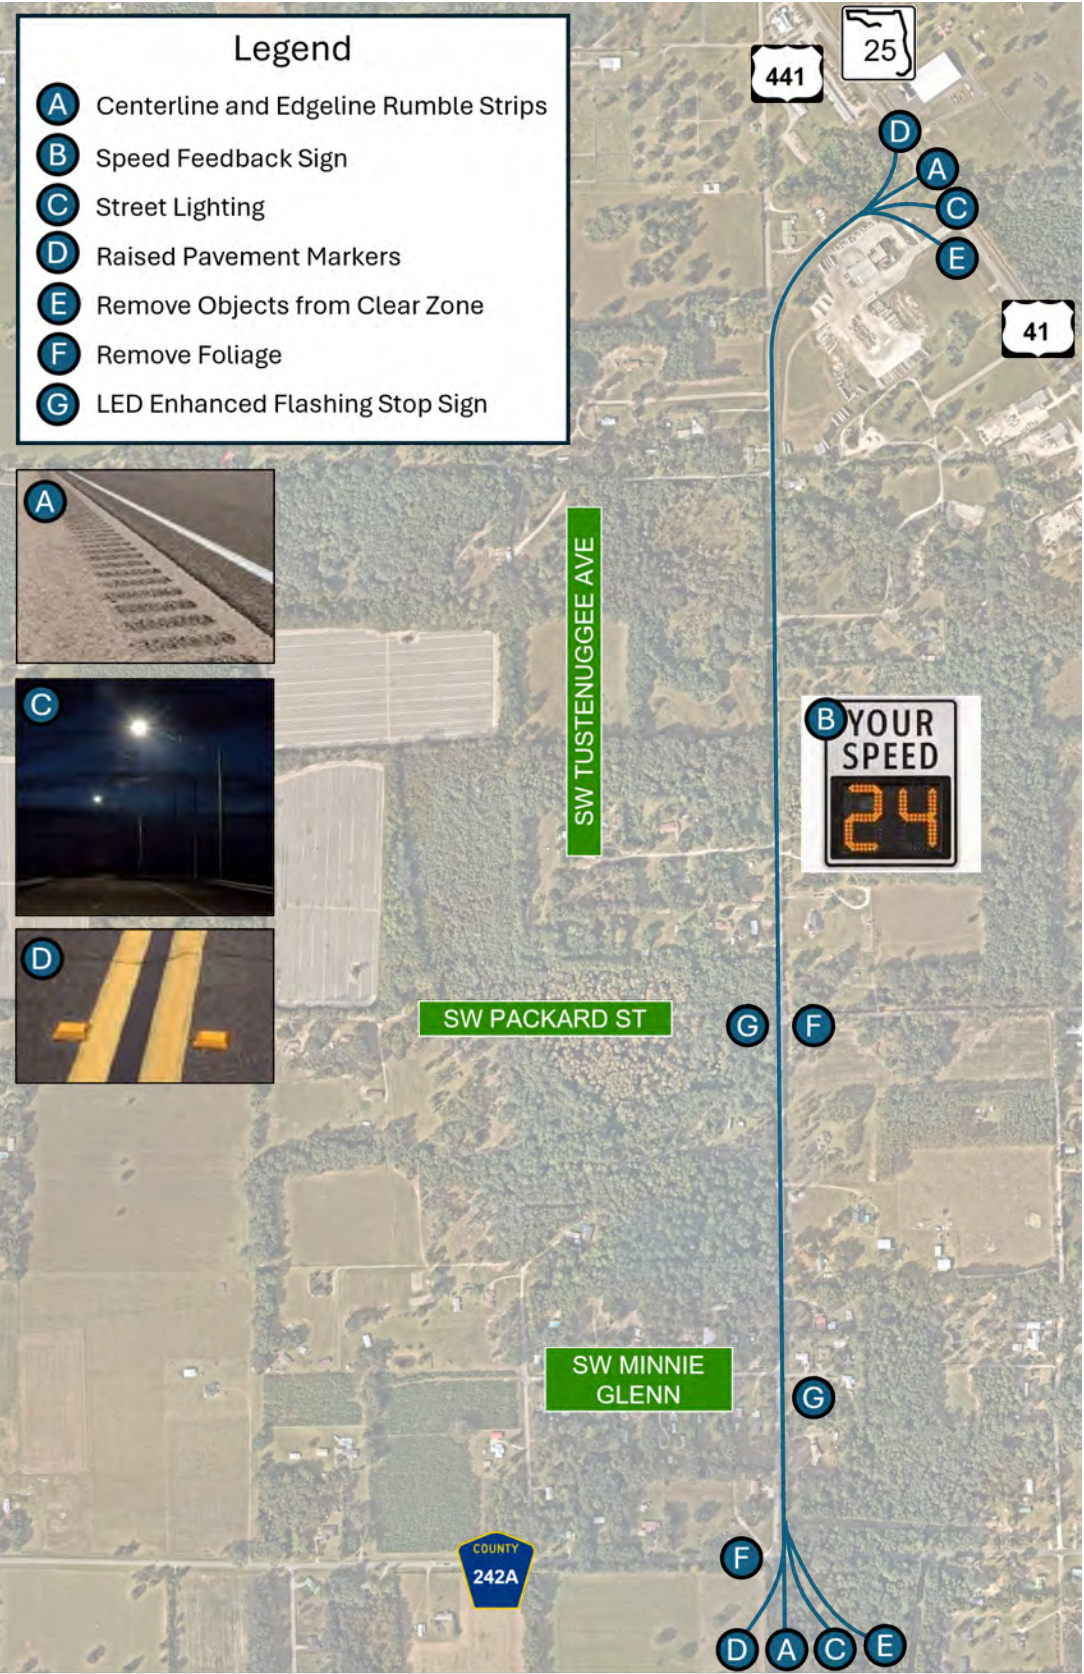
Map 17: Proposed Countermeasures, Priority 1

| Countermeasure | Scale/Timeframe | Justification |
|---|---|---|
| B. Speed feedback signs | Short | Observed high speeds and minimal driver friction. |
| C. Install street lighting | Medium | All fatal and serious injury crashes occurred in dark – not lighted conditions. |
| D. Raised pavement markers | Short | Multiple off-road crashes in dark – not lighted conditions. |
| F. Remove/Maintain foliage | Short | Observed sight distance limitations on minor street approaches. |
| G. Install LED enhanced flashing stop signs | Medium | Frequency of intersection crashes.<br>Lack of lighting in the area creates poor visibility of signs. |

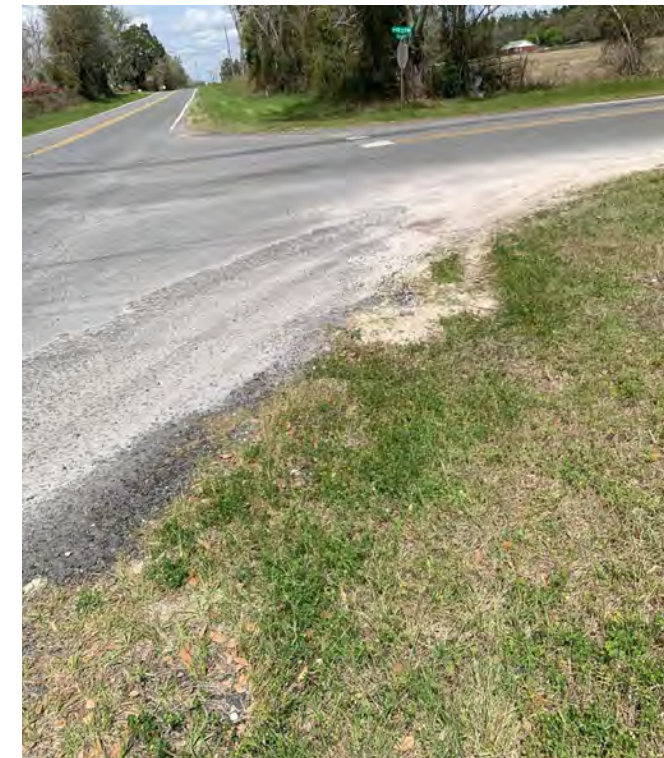
RIGHT-TURN RUTTING FOR NORTHBOUND RIGHT-TURN MOVEMENT AT SW TUSTENUGGEE AVENUE AND SW CR 240

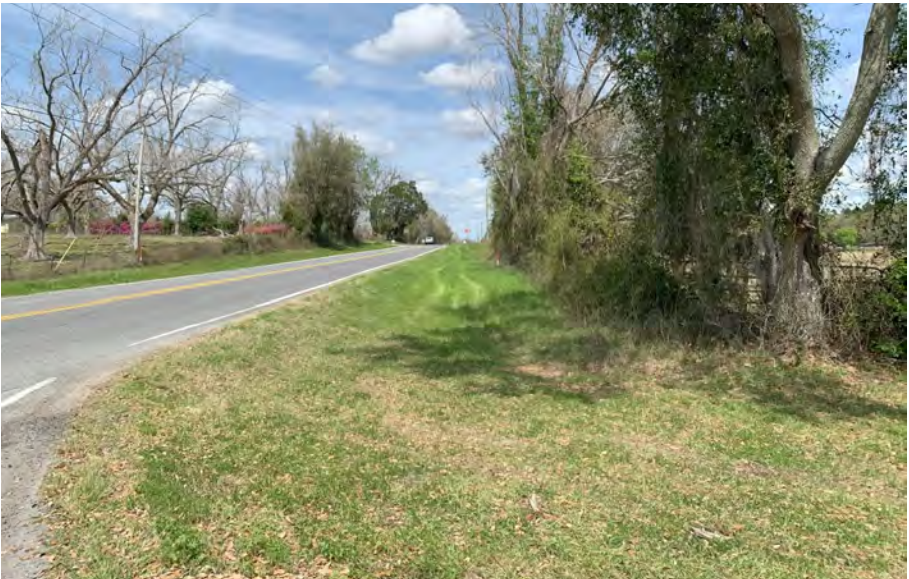
VIEW OF SOUTHBOUND VEHICLES FROM WESTBOUND APPROACH AT INTERSECTION OF SW TUSTENUGGEE AVENUE AND SW CR 240

| Countermeasure | Scale/Timeframe | Justification |
|---|---|---|
| K. Install intersection lighting | Short | Observed minimal lighting at the intersections of SW Tustenuggee Avenue with CR 240 and NW Herlong Street |

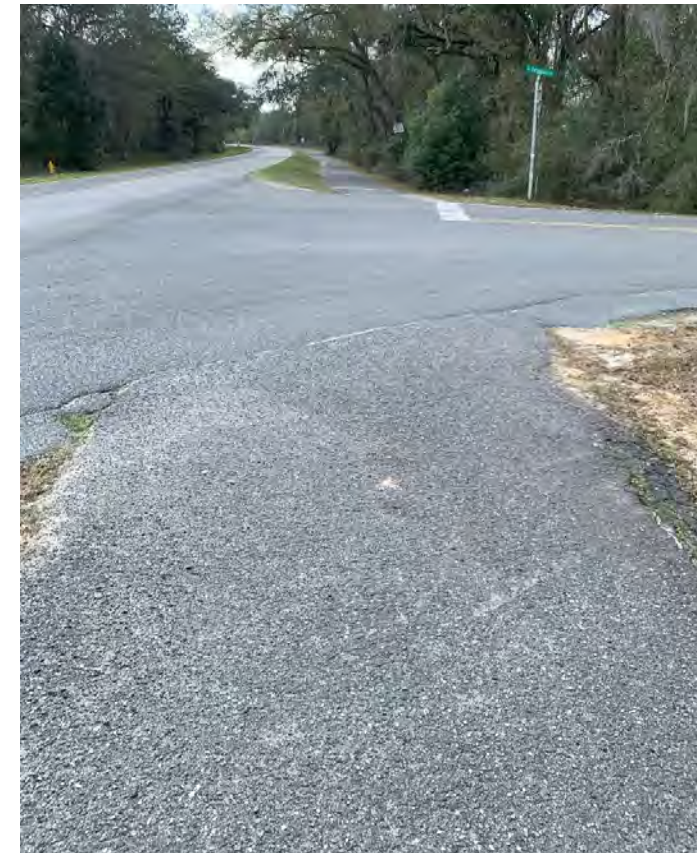
NO MARKINGS FOR SHARED USE PATH

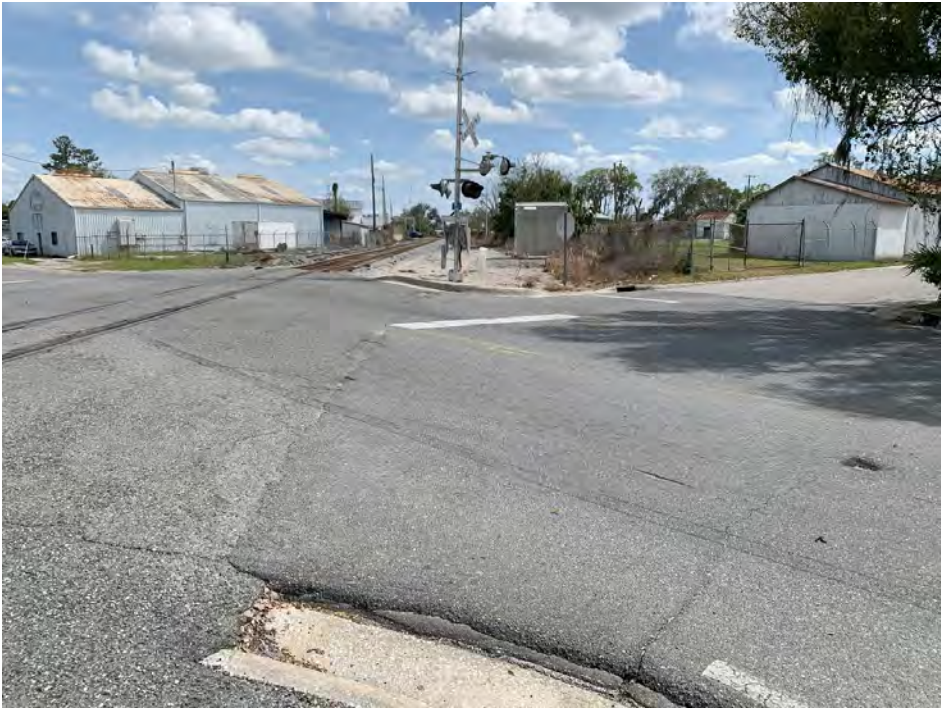
AWKWARD INTERSECTION APPROACHES AT RAILROAD CROSSING

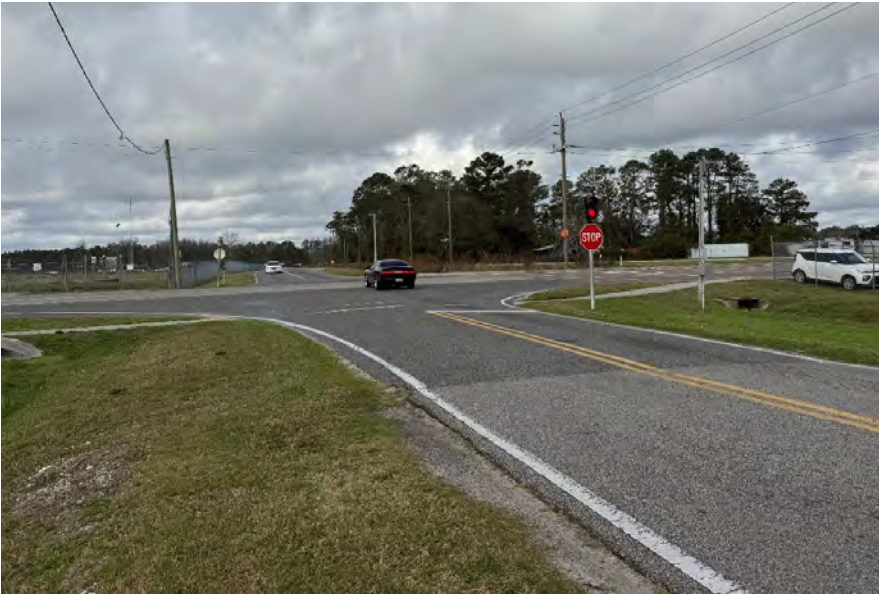
INTERSECTION OF SW BASCOM NORRIS DRIVE AND SW MARY ETHEL LANE (LOOKING WEST)

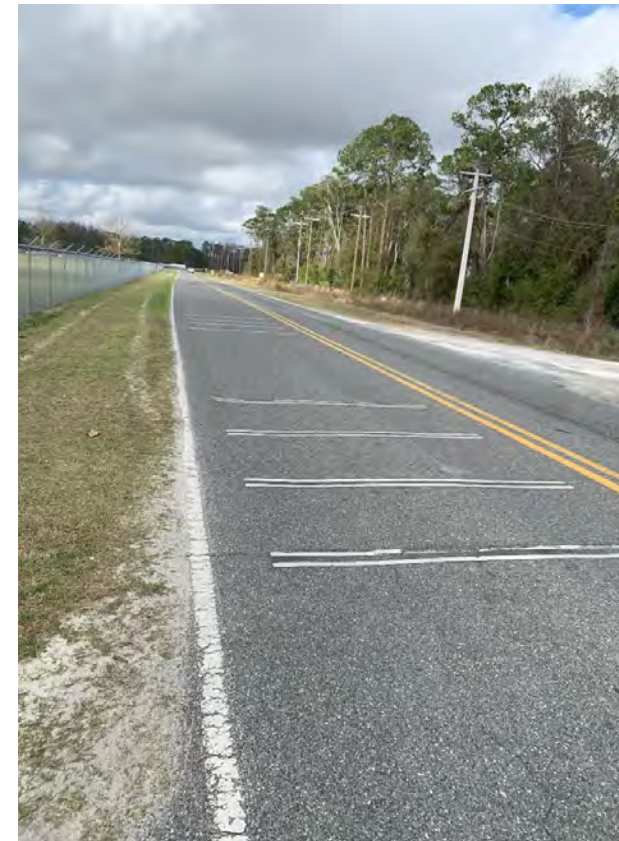
WORN RUMBLE STRIPS ON EB APPROACH

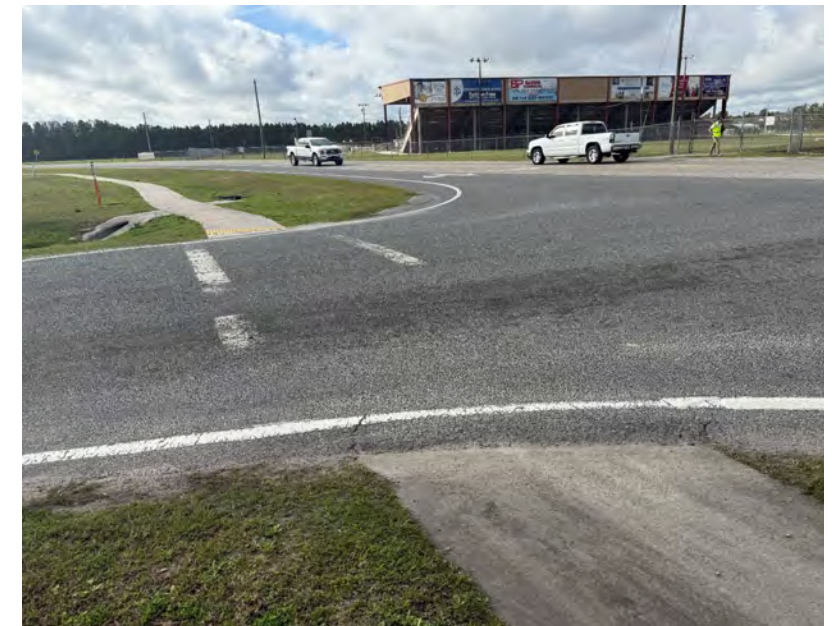
WORN CROSSWALK MARKINGS ON WB APPROACH

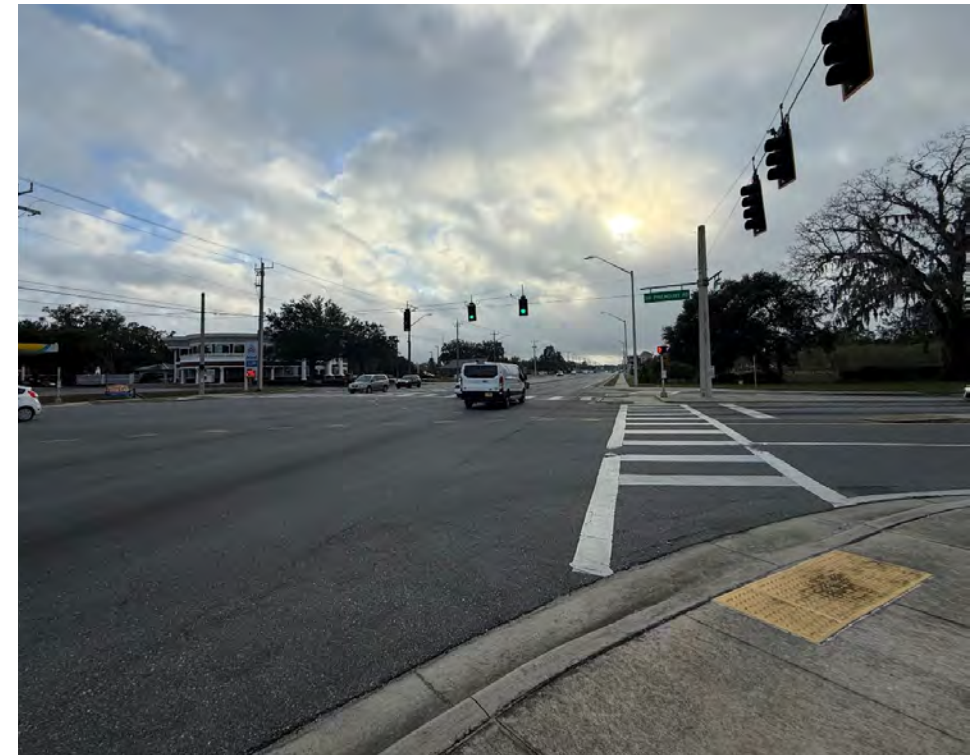
PEDESTRIAN SIGNALS AT CHANNELIZING ISLAND (DOES NOT COVER THE ENTIRE PEDESTRIAN CROSSING)

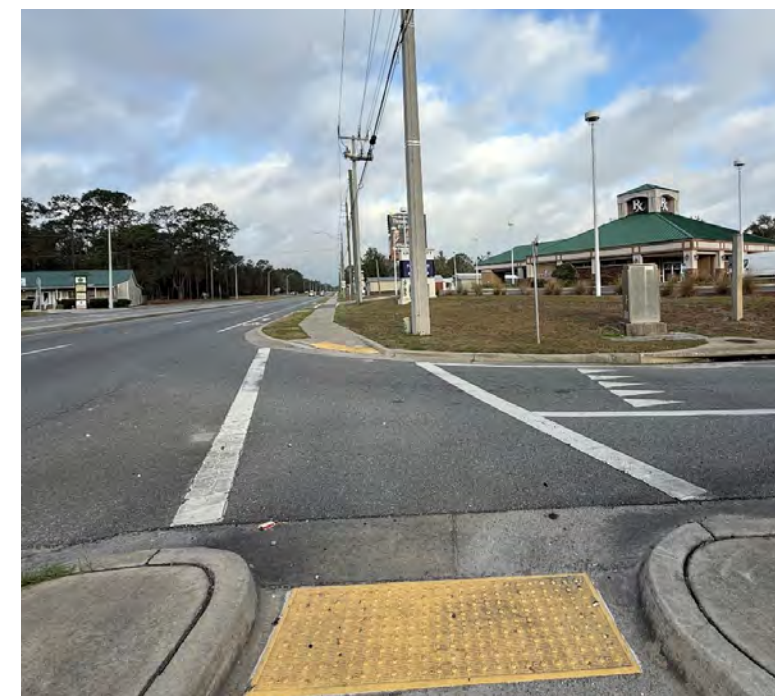
MISSING PEDESTRIAN MARKINGS ON NORTHERN LEG

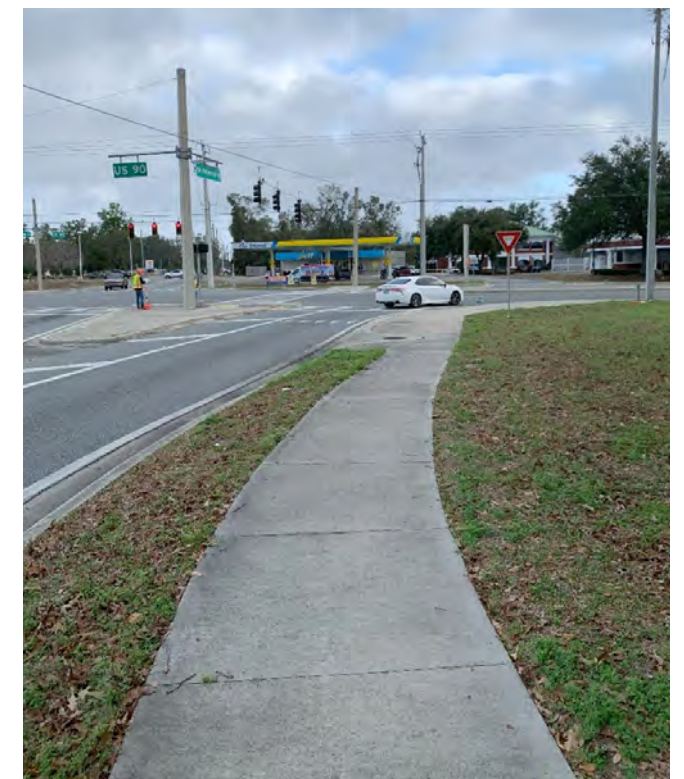
VIEW OF CHANNELIZED RIGHT TURN ISLAND

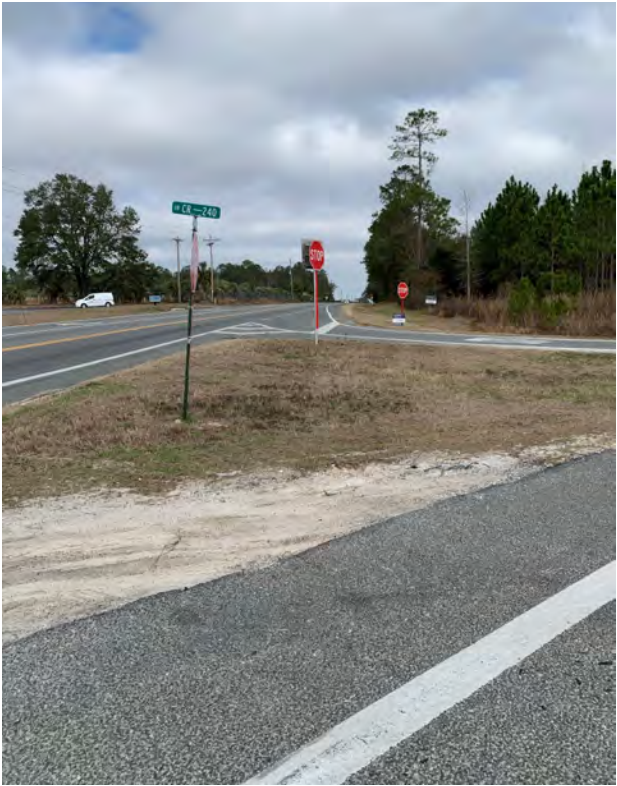
HILL TO THE NORTH OBSTRUCTS VIEW OF VEHICLES TRAVELING WESTBOUND, WESTBOUND RIGHT VEHICLES FURTHER BLOCKS VIEW OF SOUTHBOUND VEHICLES

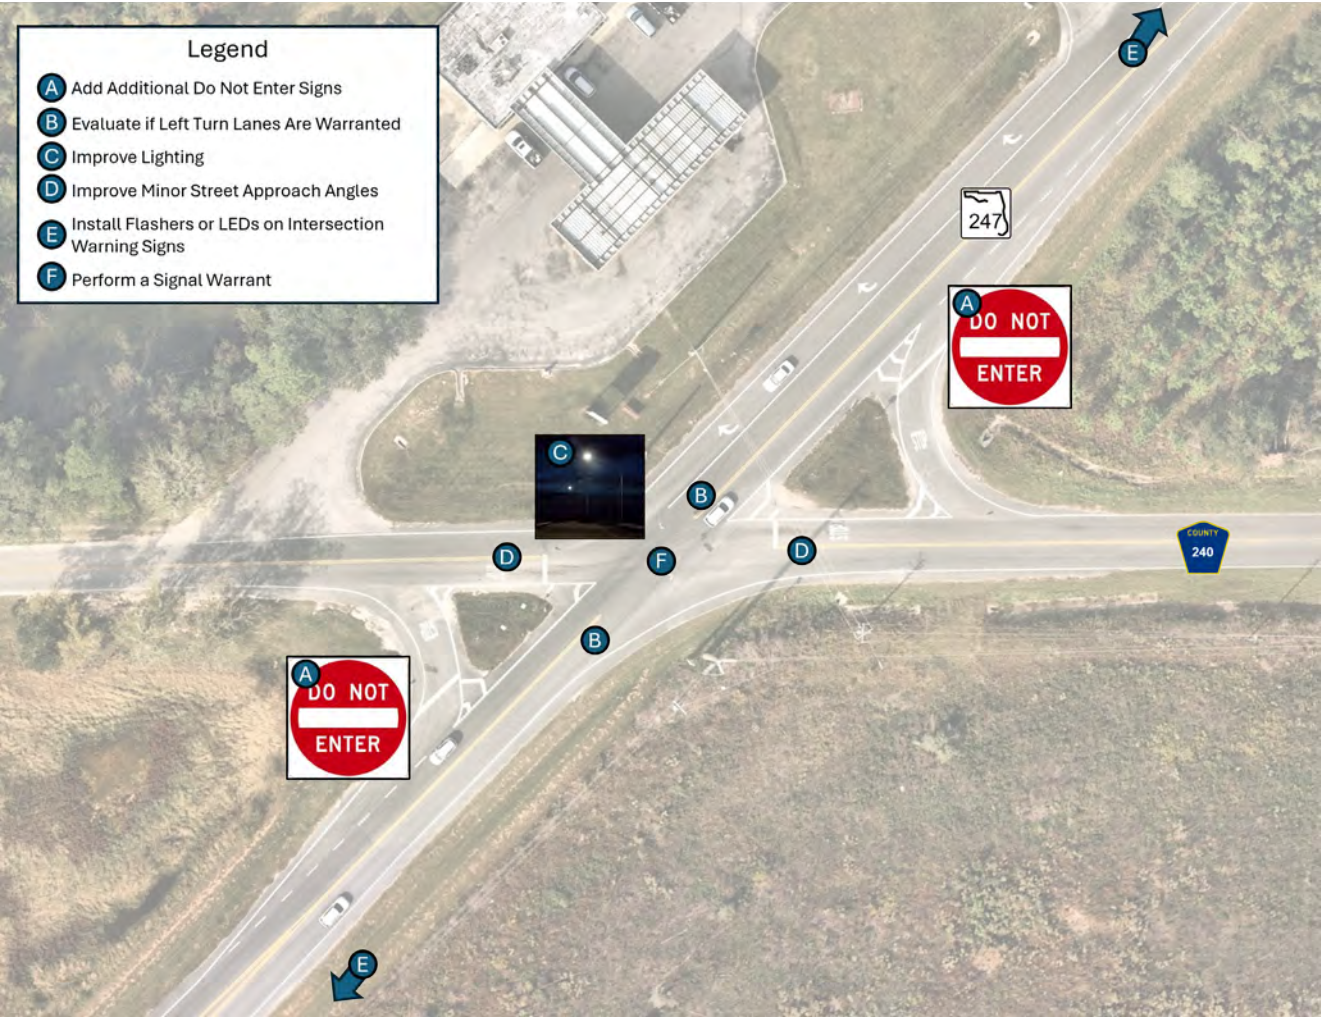
Map 31: Proposed Countermeasures, Priority 8

| Countermeasure | Scale/Timeframe | Justification |
|---|---|---|
| F. Perform a signal warrant | Short | Safety suggestion provided from FSU DURP Study. |

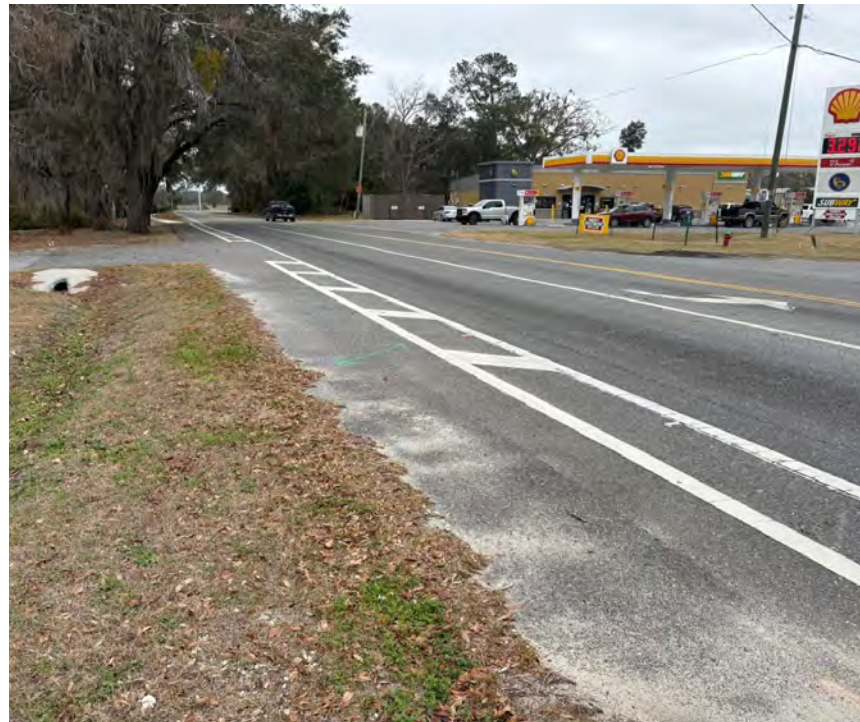
MISSING SECTION OF SIDEWALK

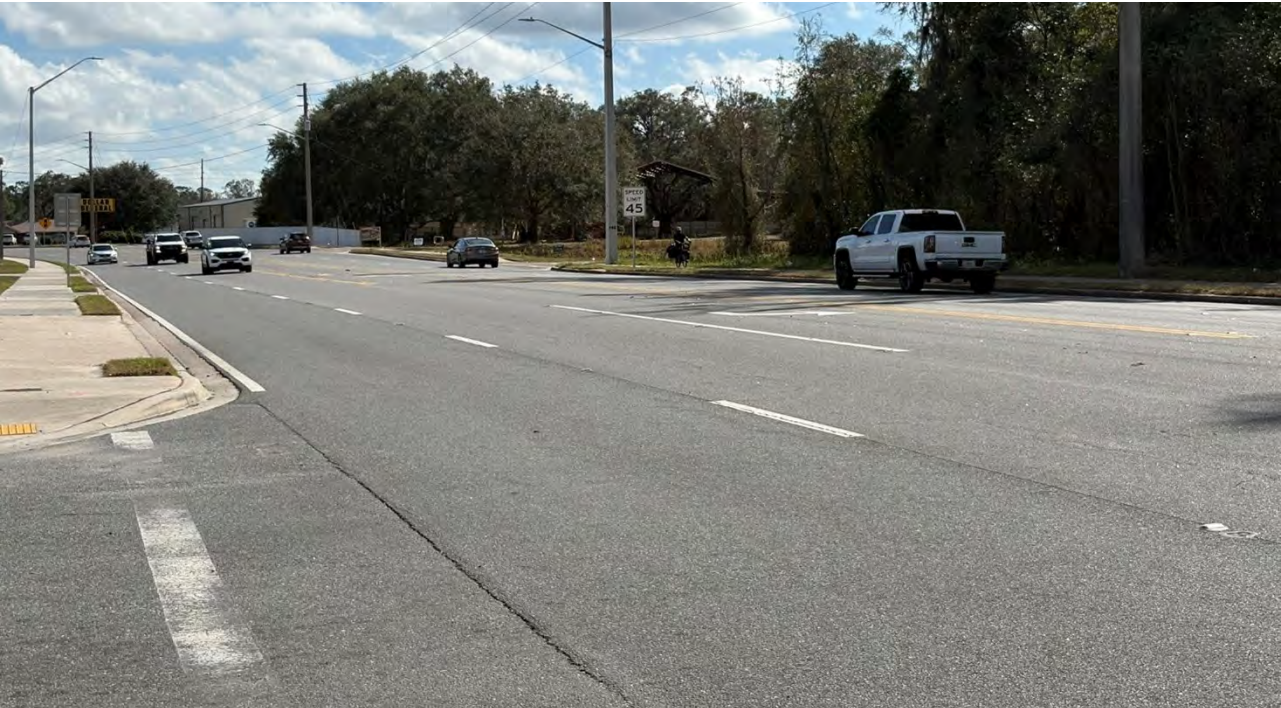
BICYCLIST UTILIZING SIDEWALK

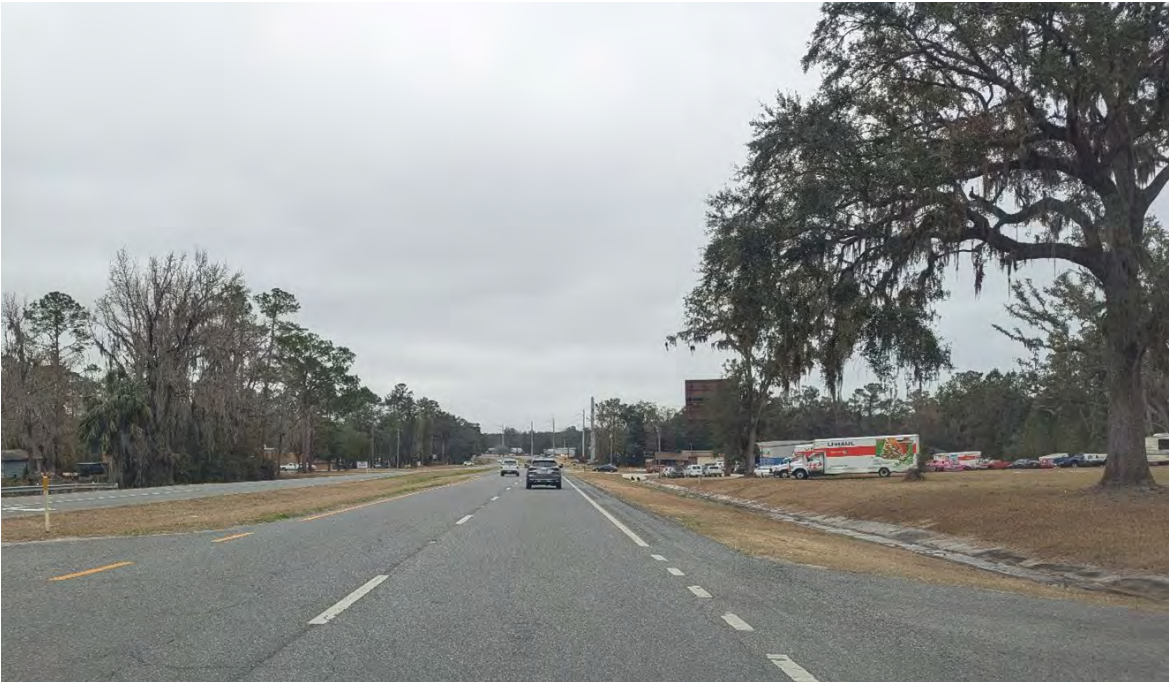
LACK OF LIGHTING

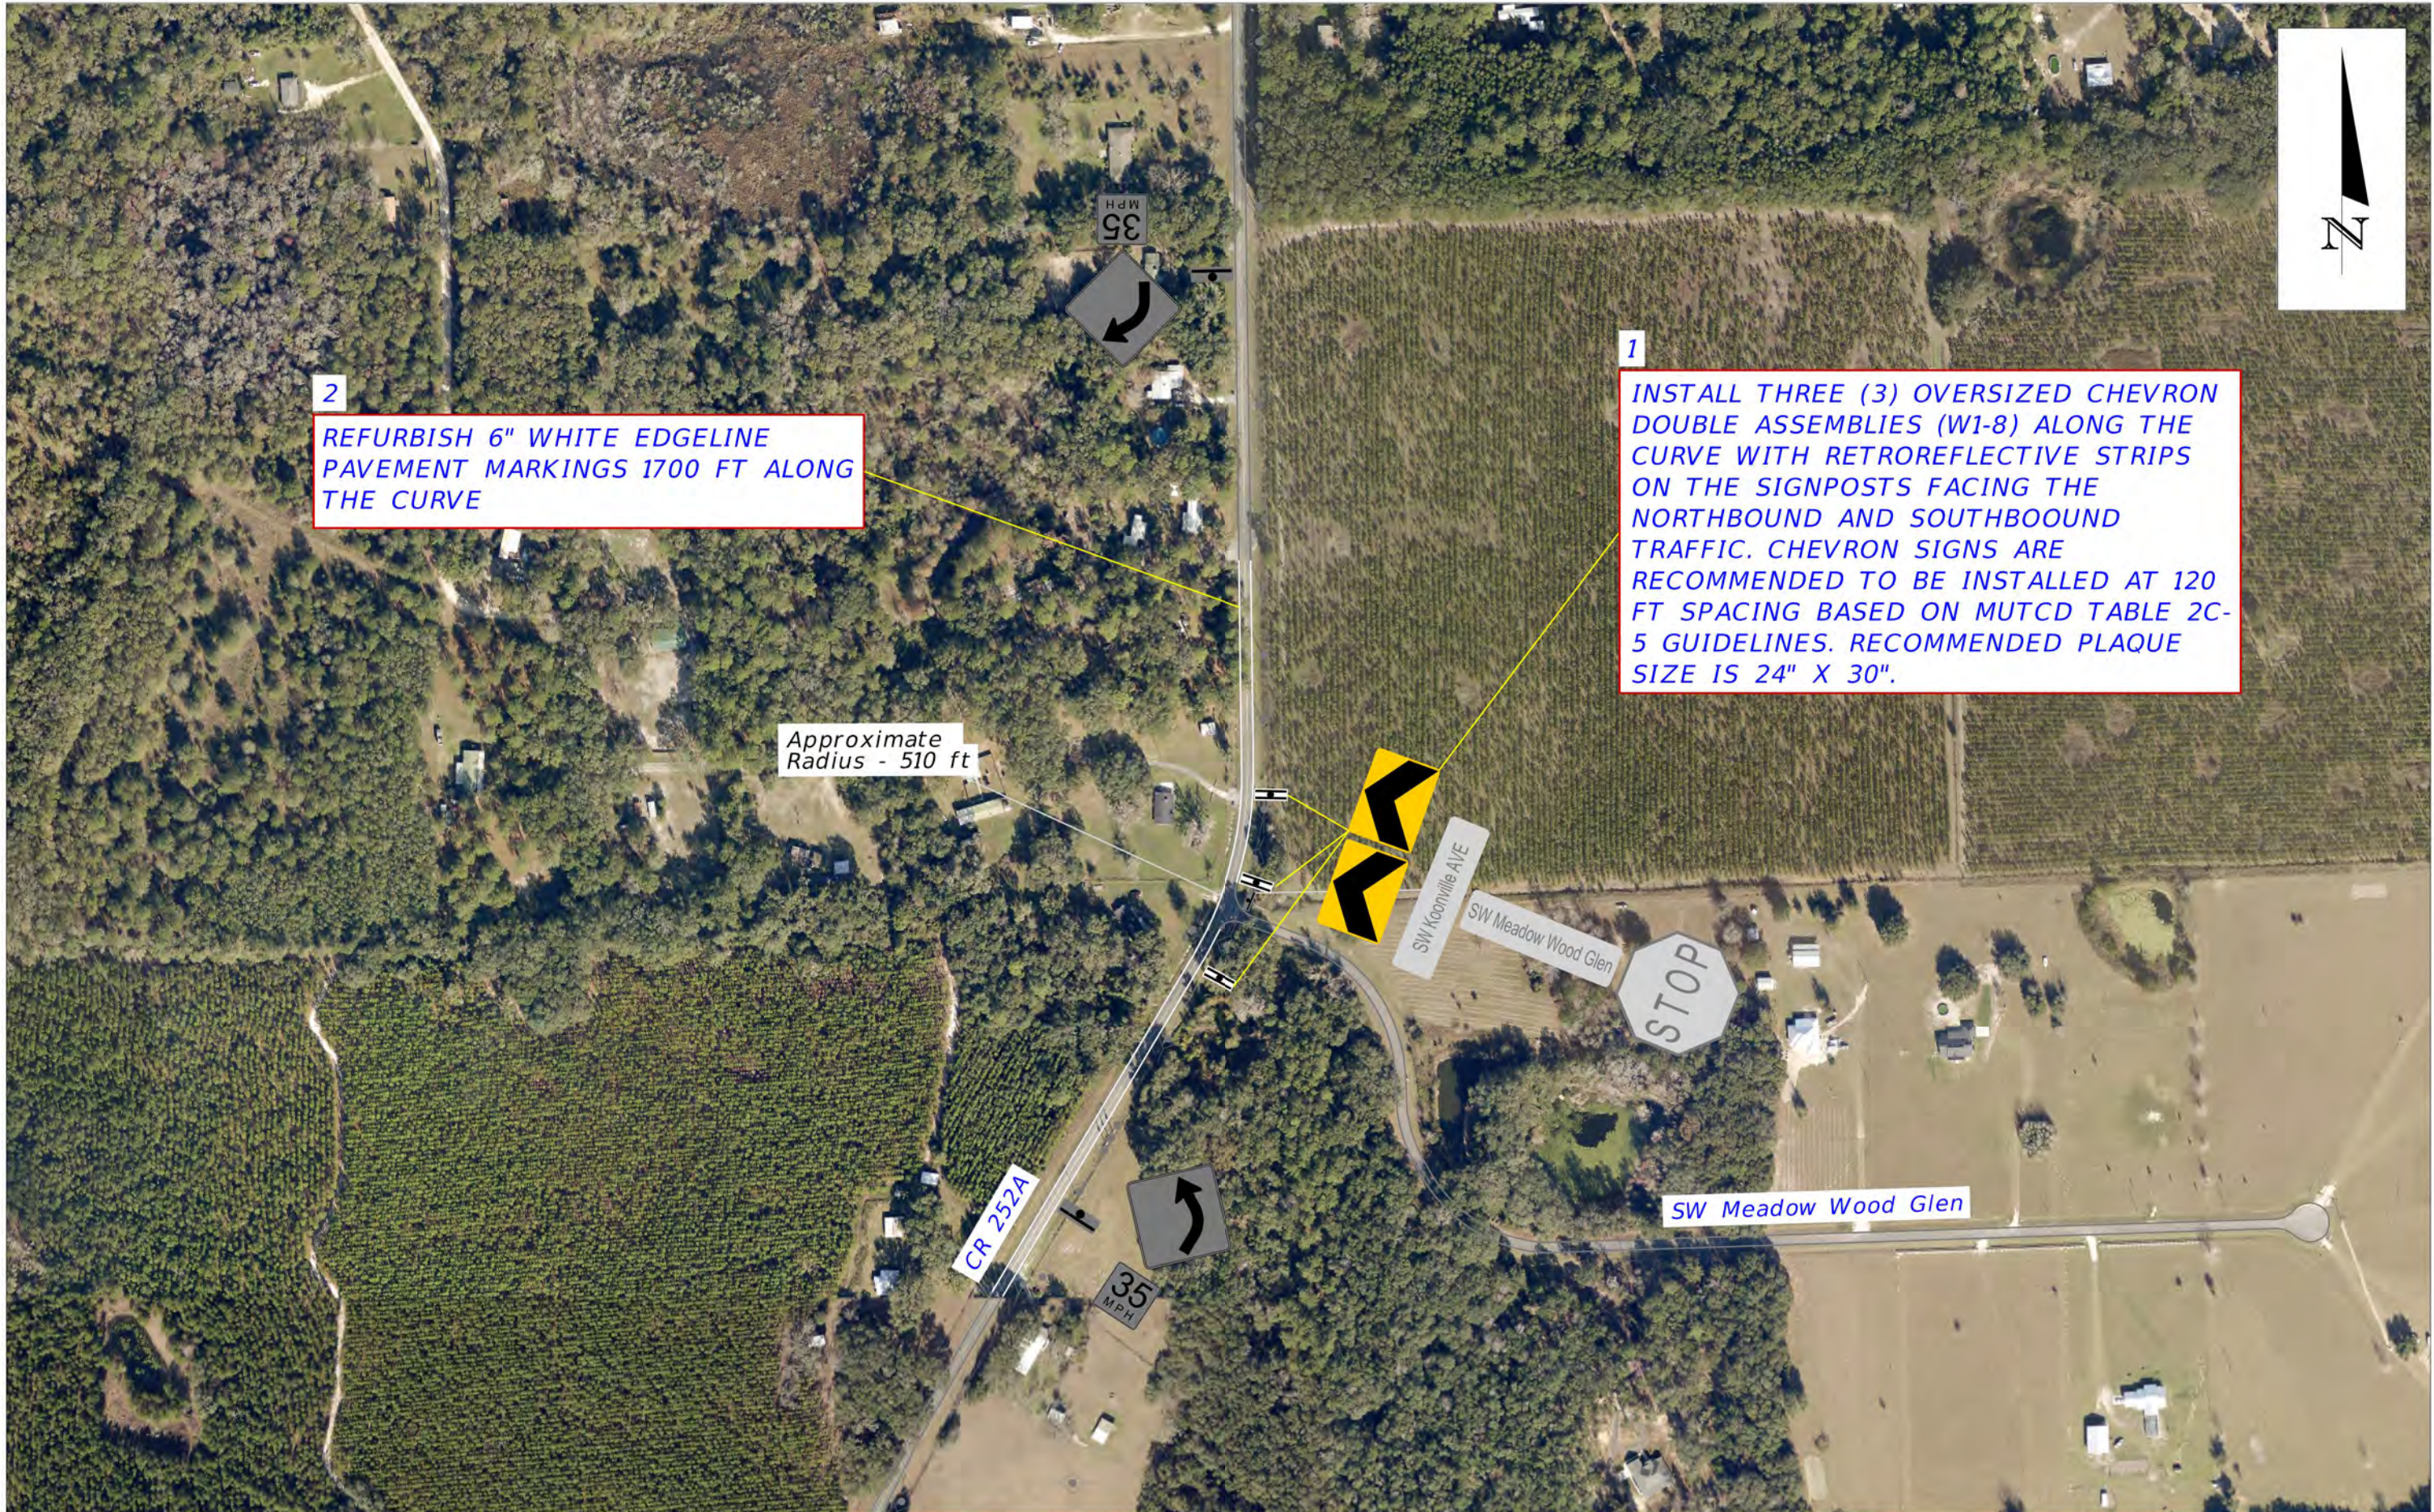
2  
REFURBISH 6" WHITE EDGELINE  
PAVEMENT MARKINGS 1700 FT ALONG  
THE CURVE
