# ROOF SYSTEM REPAIR NOTES:

**EXISTING & REMODEL  
 PLANS**

**MCKINZEY REMODEL**

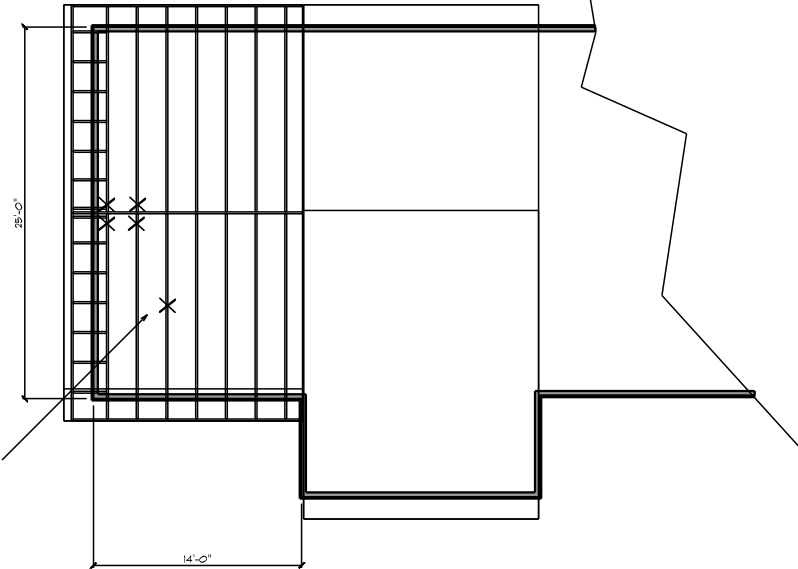
RAFTERS TO BE REPAIRED MARKED WITH (X) AT DAMAGED OR BROKEN AREA

THIS RAFTER WILL HAVE A CONTINUOUS REPAIR TO BOTH SIDES DUE TO LOCATION OF BREAK.

1. REPLACE RIDGE BEAM
2. REPAIR BROKEN RAFTER. (SEE DETAIL 1.)
3. INSTALL NEW COLLAR TIES.
4. INSTALL 1/2" PLYWOOD AS NEEDED NAILED 4" O.C. ALONG EDGES AND 8" O.C. IN THE FIELD
5. INSTALL NEW METAL ROOFING OVER TITANIUM UNDERLAYMENT
