ROOF PANEL DETAILS

LAKE CITY, FLORIDA

SIDEWALL PANEL DETAILS

ENDWALL PANEL DETAILS

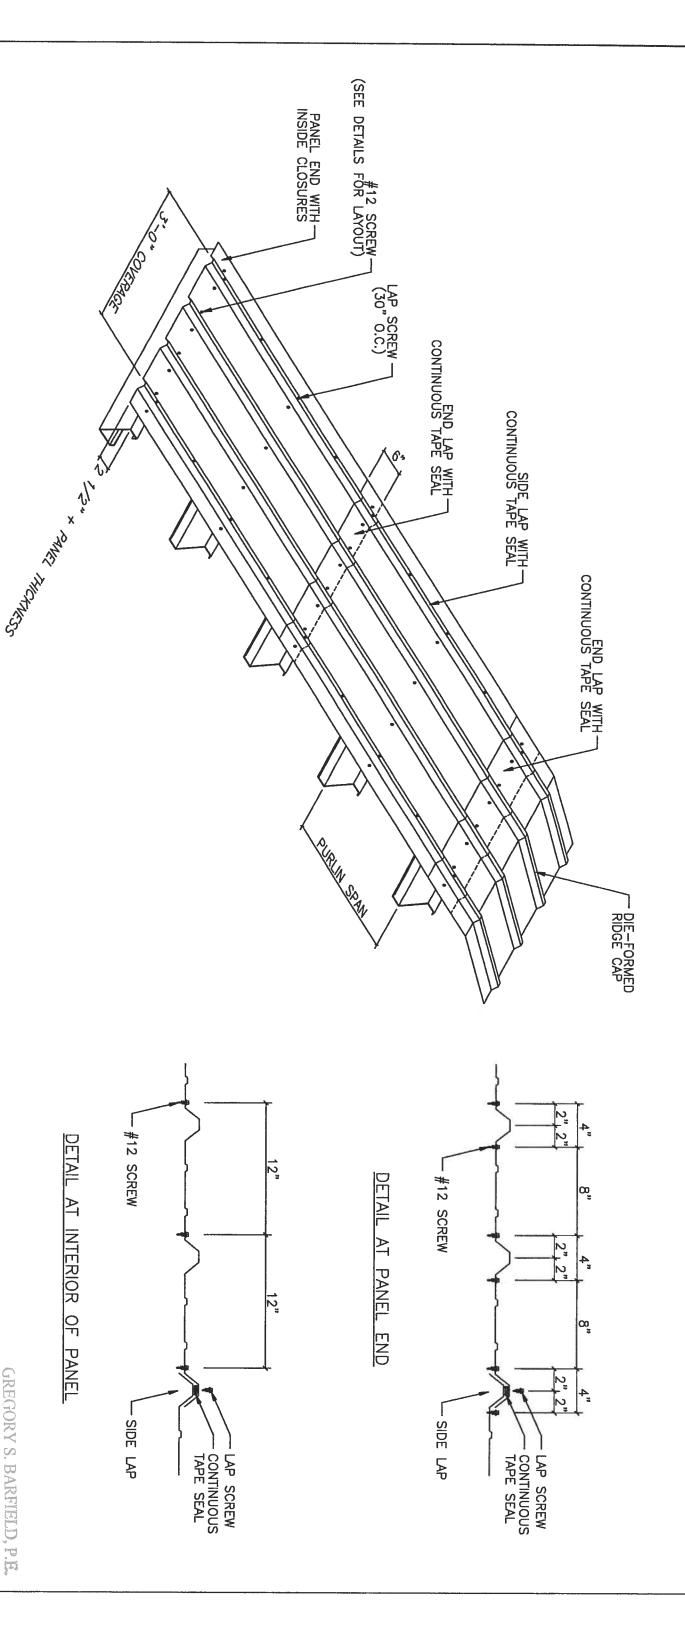
[1] ALL END LAPS MUST BE A MINIMUM OF 6".

[2] METAL SHAVINGS MUST BE SWEPT FROM THE ROOF EACH DAY

DURING ERECTION TO PREVENT SURFACE RUSTING.

[4] #12 SCREWS ARE USED TO ATTACH THE PANEL TO THE PURLINS. #14 LAP SCREWS ARE USED AT THE PANEL—TO— PANEL ATTACHMENTS. ALL FASTENERS ARE SELF—DRILLING.

[3] TAPE SEAL MUST BE APPLIED WITH NO GAPS OR BREAKS.

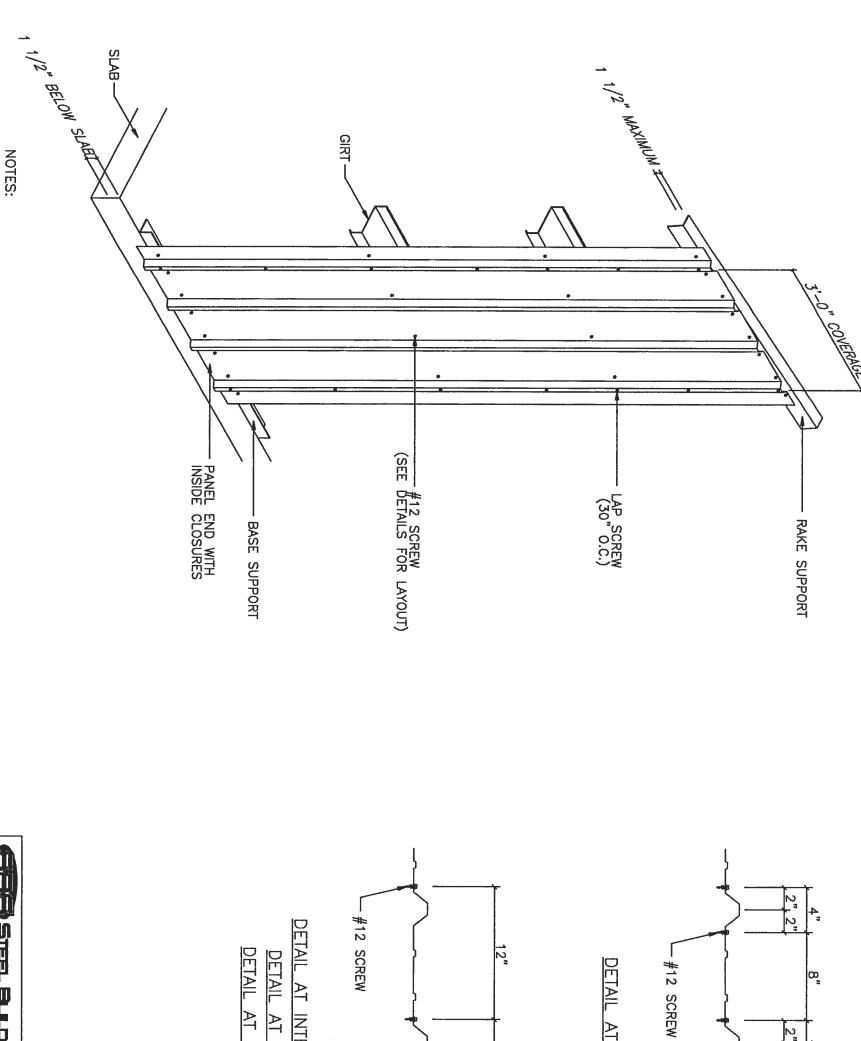
AT PANEL

END

SIDE LAP

LAP SCREW

[1] METAL SHAVINGS MUST BE SWEPT FROM THE ROOF EACH DAY DURING ERECTION TO PREVENT SURFACE RUSTING.

#12 SCREWS ARE USED TO ATTACH THE PANEL TO THE PURLINS. #14 LAP SCREWS ARE USED AT THE PANEL-TO-

PANEL ATTACHMENTS. ALL FASTENERS ARE SELF-DRILLING.

AT PARTIAL WALL

AT HEADER/SILL

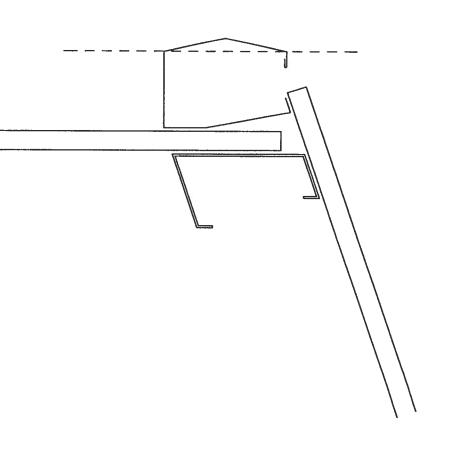
GUTTER INSTALLATION DETAIL

DO NOT INSTALL GUTTER WITH OUTSIDE FACE PERPENDICULAR TO THE GROUND.

INSTALL GUTTER WITH OUTSIDE FACE PERPENDICULAR TO THE ROOF.

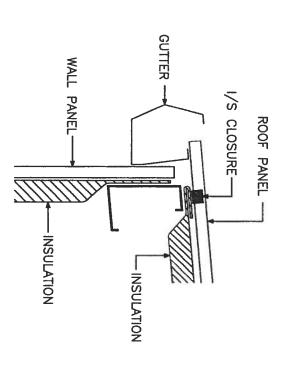
NOTE: FOLD ROOF INSULATION BACK 3" TO 6". EAVE DETAIL

CAUTION: FAILURE TO FOLD FACING OF INSULATION BACK FROM THE PANEL EDGE AT THE BASE AND EAVE COULD RESULT IN PANEL DAMAGE AND WILL VOID THE PANEL WARRANTY.

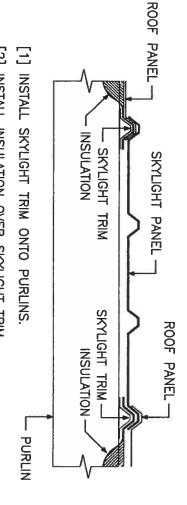
SKYLIGHT TRIM DETAIL

- [2] INSTALL INSULATION OVER SKYLIGHT TRIM.
- [3] INSTALL ROOF PANEL AND SKYLIGHT PANEL OVER INSULATION.
- [4] CUT OUT INSULATION FLUSH TO SKYLIGHT TRIM WITH A RAZOR KNIFE.
