Precise Aerial Roof Measurement Report

296 SW Buttercup Dr, Lake City, FL 32024

Report Details	Roof/Wall Details	Report Contents
Report:62989098	Total Roof Area =2,901 sq ft Total Roof Facets =11 Predominant Pitch =6/12 Number of Stories <=1 Total Ridges/Hips =211 ft Total Valleys =81 ft Total Rakes =44 ft Total Eaves =224 ft Total Wall Area = 2031.2 sq ft Total Wall Facets = 25 Total Penetrations =6 Total Penetrations Perimeter = 52 ft Total Siding Area = 1687.3 sq ft Total Masonry Area = 343.9 sq ft	Images2Structure Number Labels5Length Diagram6Pitch Diagram7Area Diagram8Notes Diagram9Penetrations Diagram103D Wall Area Diagram11Alternate 3D Wall View13Window and Door Diagram15Elevation Diagrams17Report Summary21Wall Measurement Summary23

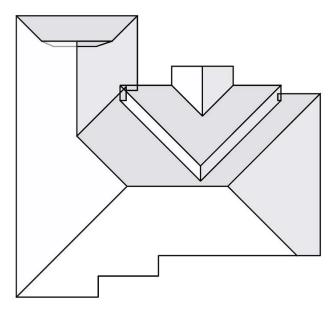
In this 3D model, facets appear as semi-transparent to reveal overhangs.

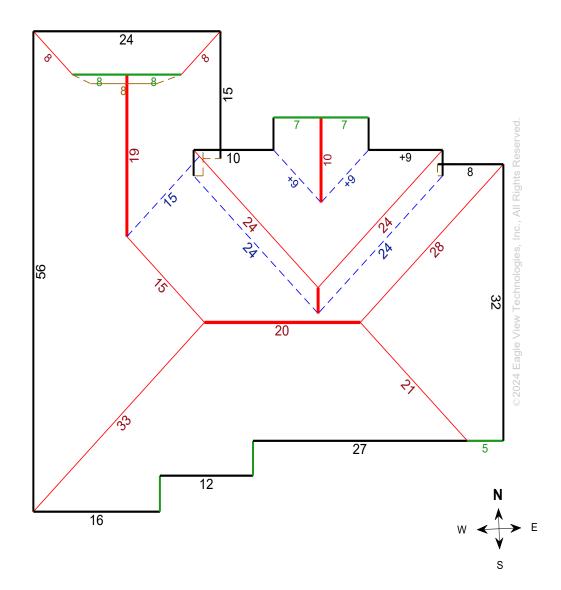
Length DiagramShaded areas should be verified

Total Line Lengths:

Ridges = 52 ft Hips = 159 ft Valleys = 81 ftRakes = 44 ftEaves = 224 ft Flashing = 11 ft Step flashing = 13 ft Parapets = 0 ft

<u>Note</u>: This diagram contains segment lengths (rounded to the nearest whole number) over 5 feet. In some cases, segment labels have been removed for readability. Plus signs preface some numbers to avoid confusion when rotated (e.g. +6 and +9).

Ridges = 52 ft (4 Ridges)
Hips = 159 ft (8 Hips).

Valleys = 81 ft (5 Valleys)
Rakes[†] = 44 ft (7 Rakes)
Eaves/Starter[‡] = 224 ft (14 Eaves)
Drip Edge (Eaves + Rakes) = 268 ft (21 Lengths)
Parapet Walls = 0 (0 Lengths).
Flashing = 11 ft (4 Lengths)
Step flashing = 13 ft (5 Lengths)
Total Penetrations Area = 26 sq ft
Total Roof Area Less Penetrations = 2,875 sq ft
Total Penetrations Perimeter = 52 ft
Predominant Pitch = 6/12

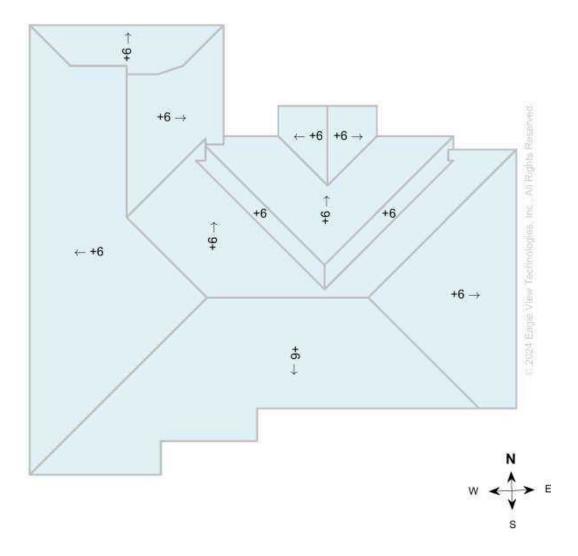
Pitch Diagram

Pitch values are shown in inches per foot and arrows indicate slope direction. The predominant pitch on this roof is 6/12.

Note: This diagram contains labeled pitches for facet areas larger than 20 square feet In some cases, pitch labels have been removed for readability. Plus signs preface some numbers to avoid confusion when rotated (e.g. +6 and +9). Blue shading indicates a pitch of 3/12 and greater.

Areas per Pitch	
Roof Pitches	6/12
Area (sq ft)	2900.3
% of Roof	100%

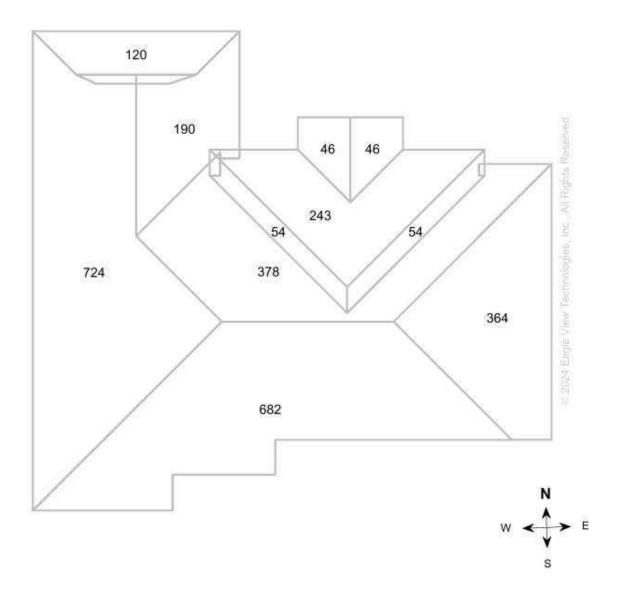
Area Diagram

Total Area = 2,901 sq ft, with 11 facets.

Note: This diagram shows the square feet of each roof facet (rounded to the nearest foot). The total area in square feet, at the top of this page, is based on the non-rounded values of each roof facet (rounded to the nearest square foot after being totaled).

Pitch(inches per foot)											
Facet	0	2	4	6	8	10	12	14	16	18	20
Α	41.5	42.1	43.7	46.4	49.9	54.0	58.7	63.8	69.2	74.8	80.7
В	41.5	42.1	43.7	46.4	49.9	54.0	58.7	63.8	69.2	74.8	80.7
С	47.9	48.6	50.5	53.6	57.6	62.4	67.7	73.6	79.8	86.4	93.1
D	47.9	48.6	50.5	53.6	57.6	62.4	67.7	73.6	79.8	86.4	93.1
Е	107.0	108.5	112.8	119.6	128.6	139.3	151.3	164.4	178.3	192.9	208.0
F	170.0	172.3	179.2	190.1	204.3	221.3	240.4	261.2	283.3	306.5	330.4
G	217.5	220.5	229.3	243.2	261.4	283.1	307.6	334.2	362.5	392.1	422.7
Н	325.6	330.1	343.2	364.0	391.3	423.8	460.5	500.3	542.7	587.0	632.9
I	337.9	342.6	356.2	377.8	406.1	439.8	477.9	519.2	563.2	609.2	656.8
J	610.3	618.7	643.3	682.3	733.5	794.4	863.1	937.8	1017.2	1100.2	1186.2
K	647.2	656.1	682.2	723.6	777.8	842.5	915.3	994.5	1078.7	1166.8	1257.9
Total	2594	2630	2735	2901	3118	3377	3669	3986	4324	4677	5042

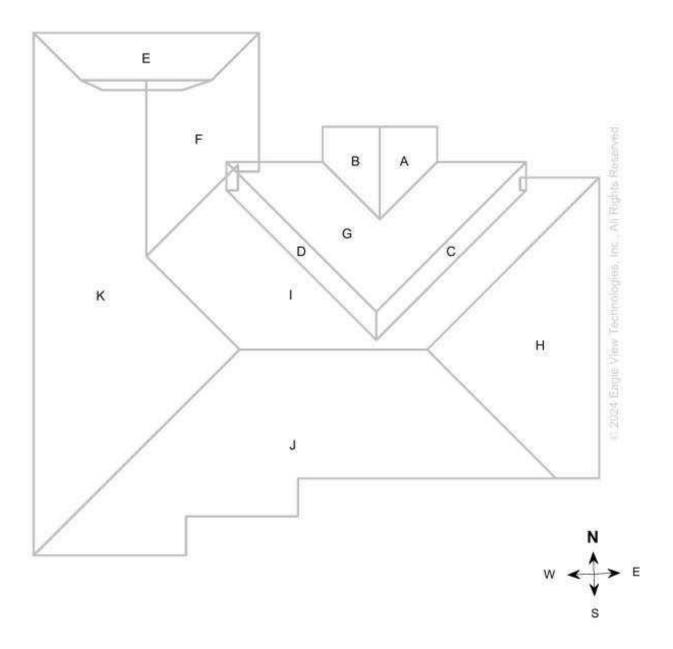
Notes Diagram

Roof facets are labeled from smallest to largest (A to Z) for easy reference.

$\underline{\text{Note}}\textsc{:}$ On-site verification of yellow shaded areas is needed. Details are on the Summary Page.

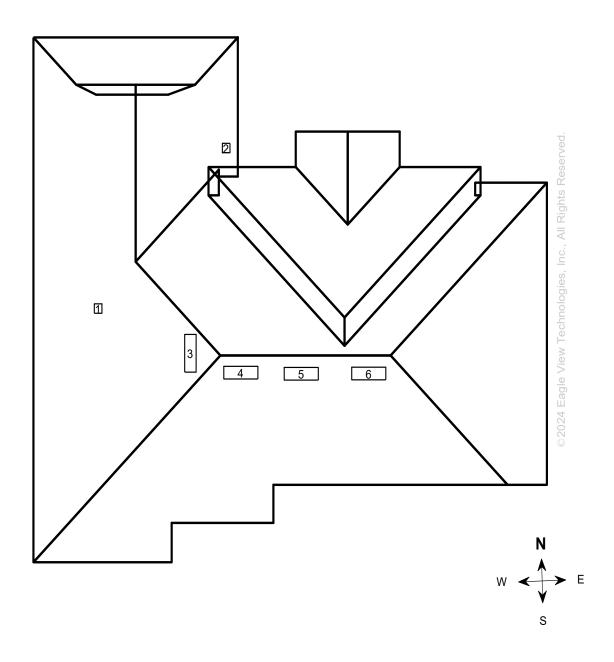
Penetrations Notes DiagramPenetrations are labeled from smallest to largest for easy reference.

Total Penetrations = 6 Total Penetrations Perimeter = 52 ft Total Penetrations Area = 26 sq ft Total Roof Area Less Penetrations = 2,875 sq ft

Penetrations	1-2	3-6				
Area (sq ft)	1	6				
Perimeter (ft)	4	11

Any measured penetration smaller than 3x3 feet may need field verification. Accuracy is not guaranteed. The total penetration area is not subtracted from the total roof area.

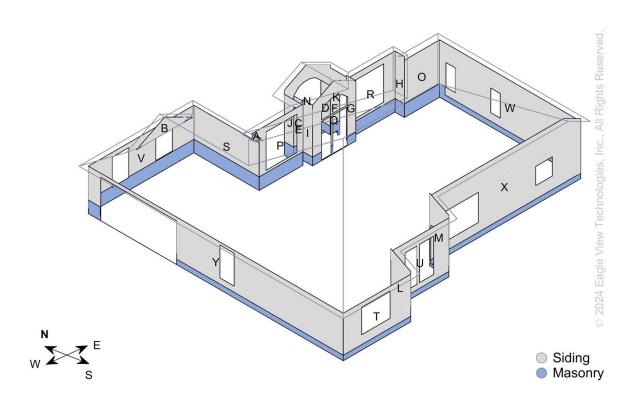
Wall Area DiagramTotal Wall Area = 2031.2 sq ft, with 25 facets.

Total Wall Area with Windows and Doors = 2516.0 sq ft

North		
Wall	Siding Wall Area (ft²)	Masonry Wall Area (ft²)
V	99.6	54.4
0	59.3	18.4
В	17.5	0.0
N	53.8	9.8
Р	36.8	22.8
R	43.4	25.4
Q	55.4	7.1
F	14.7	3.6
Е	14.7	3.4
Total	395.2	144.9

South		
Wall	Siding Wall Area (ft²)	Masonry Wall Area (ft²)
Χ	317.9	31.7
U	80.6	12.2
Т	79.0	14.2

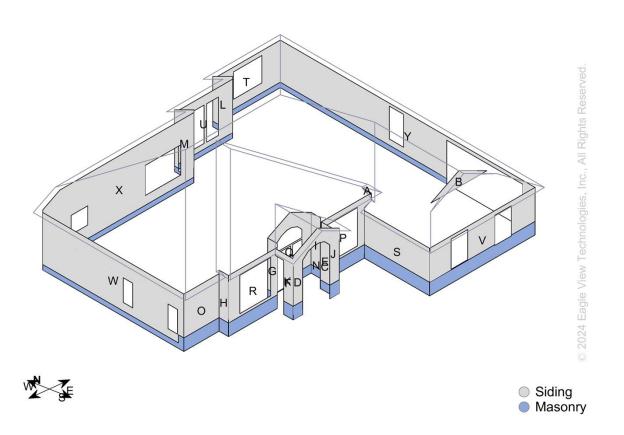
Alternate Wall View

Total Wall Area = 2031.2 sq ft, with 25 facets.

Total Wall Area with Windows and Doors = 2516.0 sq ft

Note: Window & door measurements include trim.

Wall	Siding Wall Area (ft²)	Masonry Wall Area (ft²)
V	99.6	54.4
0	59.3	18.4
В	17.5	0.0
N	53.8	9.8
Р	36.8	22.8
R	43.4	25.4
Q	55.4	7.1
F	14.7	3.6
E	14.7	3.4
Total	395.2	144.9

Wall	Siding Wall Area (ft²)	Masonry Wall Area (ft²)
С	14.7	3.2
S	85.2	34.1
Н	17.3	4.9
M	26.0	2.6
L	38.4	4.2
K	19.5	4.9
I	19.1	3.2
W	261.7	31.3
Total	481.9	88.4

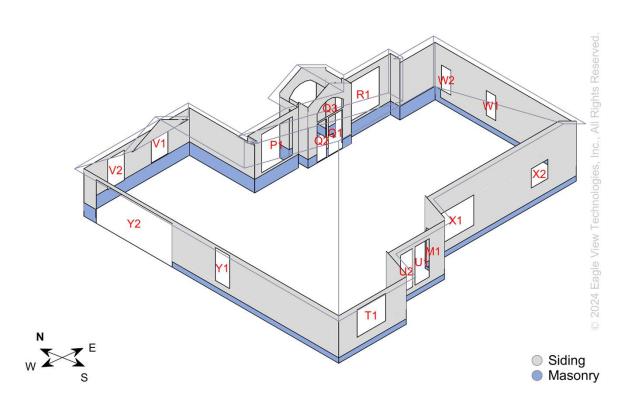
Window and Door DiagramTotal Window and Door Area = 484.2 sq ft, with 17 windows and doors

Total Window and Door Perimeter = 355.9 ft

1401 (11			
Window/Door	Area (ft²)	Perimeter (ft)	Dimensions W x H (ft)
P1	45.5	27.0	6.5 x 7.0
Q1	21.0	20.0	3.0 x 7.0
Q2	14.0	18.0	2.0 x 7.0
Q3	13.5	14.9	5.5 x 2.9
R1	45.5	27.0	6.5 x 7.0
V1	19.3	18.0	3.5 x 5.5
V2	19.2	18.0	3.5 x 5.5
Total	178.0	142.9	n/a

Window/Door	Area (ft²)	Perimeter (ft)	Dimensions W x H (ft)			
M1	21.0	20.0	3.0 x 7.0			
W1	9.0	13.0	2.0 x 4.5			
W2	9.0	13.0	2.0 x 4.5			
Total	39.0	46.0	n/a

Window/Door	Area (ft²)	Perimeter (ft)	Dimensions W x H (ft)		
Y1	18.0	18.0	3.0 x 6.0		
Y2	127.2	48.0	16.0 x 8.0		
Total	145.2	66.0	n/a

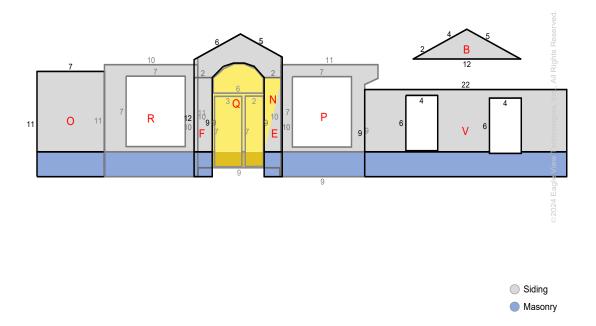
North Elevation Diagram

Top of Siding Walls = 89.0 ft Bottom of Siding Wall = 79.6 ft

Wall	Siding Wall Area (ft²)	Masonry Wall Area (ft²)	Window & Door Area (ft²)	Window & Door Perimeter (ft)	Window & Door Count
V	99.6	54.4	38.5	36.0	2
0	59.3	18.4	0	0	0
В	17.5	0.0	0	0	0
N	53.8	9.8	0	0	0
Р	36.8	22.8	45.5	27.0	1
R	43.4	25.4	45.5	27.0	1
Q	55.4	7.1	48.5	52.9	3
F	14.7	3.6	0	0	0
Е	14.7	3.4	0	0	0
Total	395.2	144.9	178.0	142.9	7

<u>Note</u>: On-site verification of yellow shaded areas is needed. Details are on the Wall Measurement Summary Page. This diagram shows segment lengths rounded to the nearest whole number. The window & door and wall area in square feet (rounded to the nearest tenth) is based on the actual (non-rounded) value of each segment length.

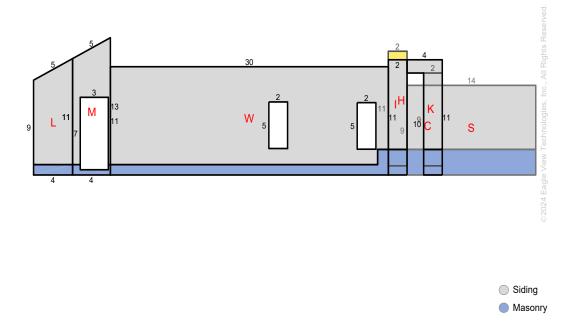
East Elevation Diagram

Top of Siding Walls = 62.5 ft Bottom of Siding Walls = 61.5 ft

Wall	Siding Wall Area (ft²)	Masonry Wall Area (ft²)	Window & Door Area (ft²)	Window & Door Perimeter (ft)	Window & Door Count
С	14.7	3.2	0	0	0
S	85.2	34.1	0	0	0
Н	17.3	4.9	0	0	0
M	26.0	2.6	21.0	20.0	1
L	38.4	4.2	0	0	0
K	19.5	4.9	0	0	0
I	19.1	3.2	0	0	0
W	261.7	31.3	18.0	26.0	2
Total	481.9	88.4	39.0	46.0	3

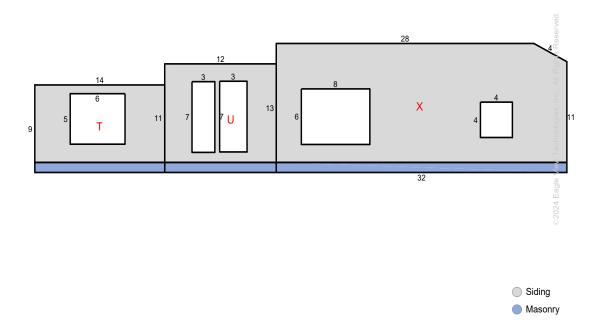
South Elevation Diagram

Top of Siding Walls = 58.8 ft Bottom of Siding Walls = 58.2 ft

Wall	Siding Wall Area (ft²)	Masonry Wall Area (ft²)	Window & Door Area (ft²)	Window & Door Perimeter (ft)	Window & Door Count
Χ	317.9	31.7	53.5	40.0	2
U	80.6	12.2	38.5	39.0	2
Т	79.0	14.2	30.0	22.0	1
Total	477.5	58.1	122.0	101.0	5

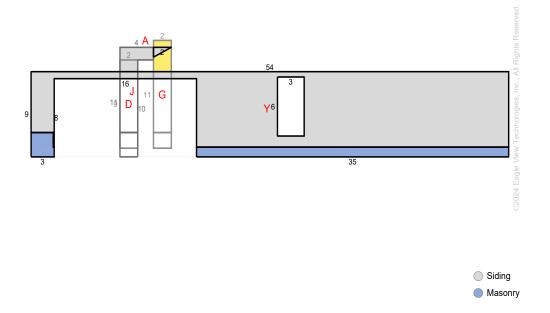
West Elevation Diagram

Top of Siding Walls = 63.5 ftBottom of Siding Walls = 63.7 ft

Wall	Siding Wall Area (ft²)	Masonry Wall Area (ft²)	Window & Door Area (ft²)	Window & Door Perimeter (ft)	Window & Door Count
J	19.5	4.9	0	0	0
D	14.7	3.2	0	0	0
Α	1.0	0.0	0	0	0
G	18.8	3.2	0	0	0
Υ	278.7	41.2	145.2	66.0	2
Total	332.7	52.5	145.2	66.0	2
