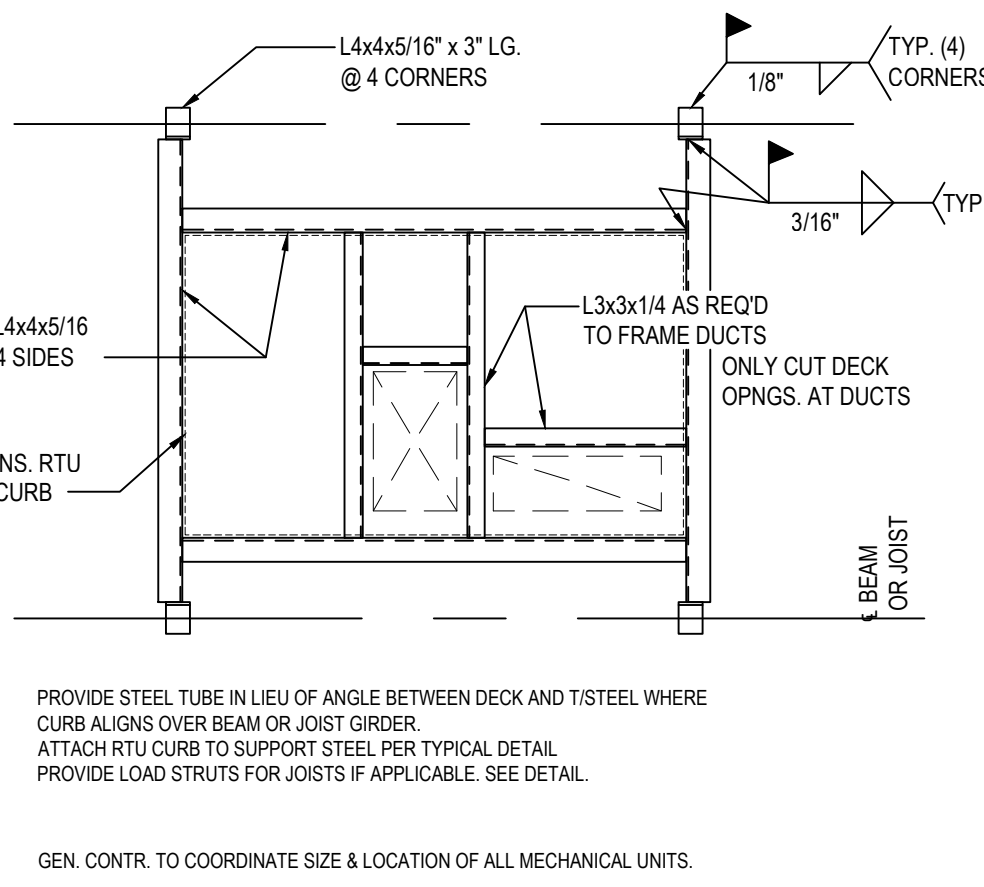
1 | DETAIL

TYPICAL RTU SUPPORT
